Service log R-1490/URR , Serial number: 266

Date: 26-Aug-2003 , Service period May-Aug-2003, By: Virgil Cheng,vr2xgm

Service log R-1490/URR , Serial number: 466
Service period : Dec-2003 to Feb-2004, By: Virgil Cheng, vr2xgm

Service log R-1490/URR , Serial number: 466
Service period : 28/30-Dec-2006, By: Virgil Cheng, vr2xgm

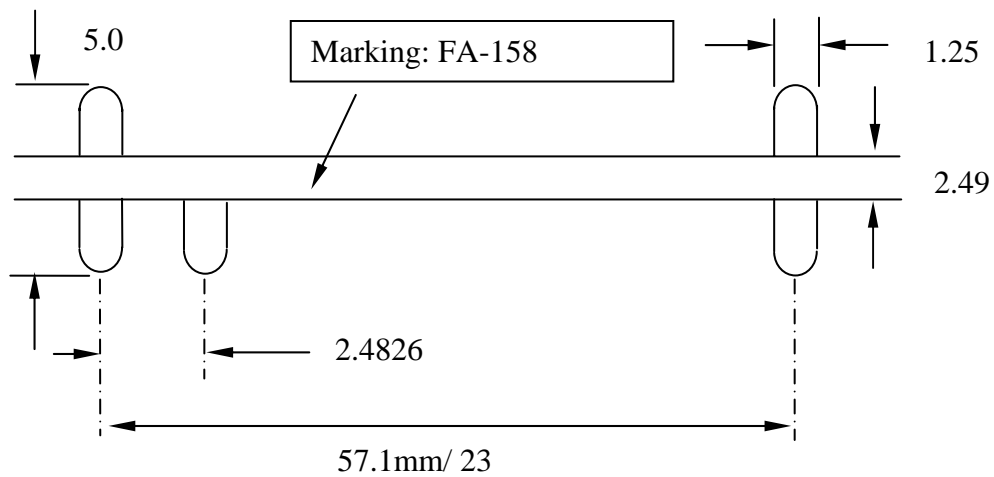
R-1490/URR MHz Tuning mechanism toothed belt,12-Jun-2003

Measured total length: 394mm

Calculated #teeth: 158.7, this matches marking "FA-158", select parts with 158 teeth.

Applicable Replacements:

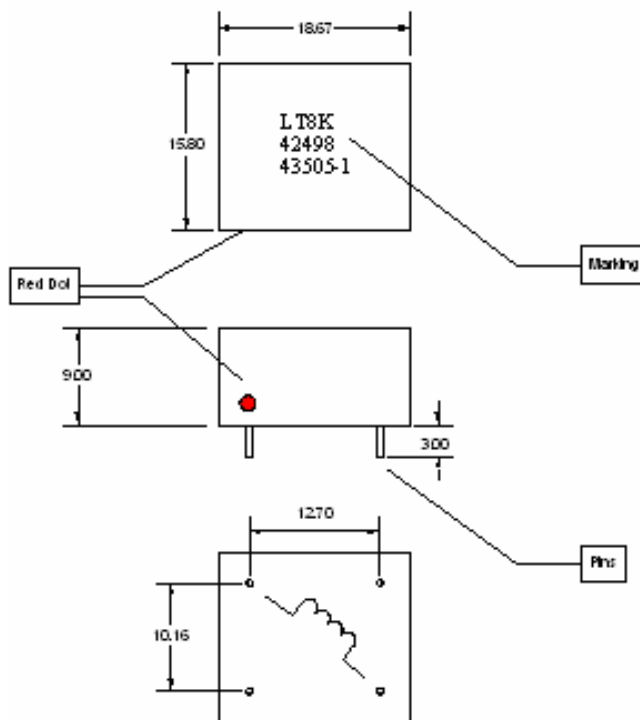
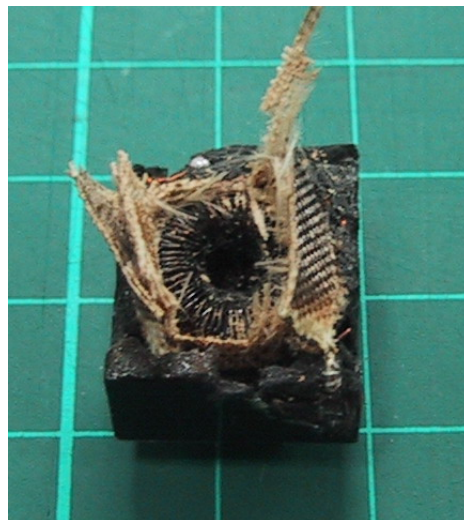
Inductor, moulded, PCB mount, located on Rear deck supply decoupling board A1A3A3

Core: Toroid
OD 11.3
ID 6.25
HT 4.24
Material: Unknown
Estimated MPP or amorphous
Winding: Dia 0.28 (AWG30), 105T
Wire length 1530mm
AL value: 90nH/Turn Sq

Inductance: 1mH
DC Current @80% inductance: 0.34A

DC Resistance: 0.65 Ohm

Unloaded Parallel resonance Frequency: 1.5MHz

Construction:
Wound toroid 90 deg cross-wrapped in two layers of fibre glass tape
Whole assembly was encapsulated with soft Epoxy inside a thin-walled package frame.

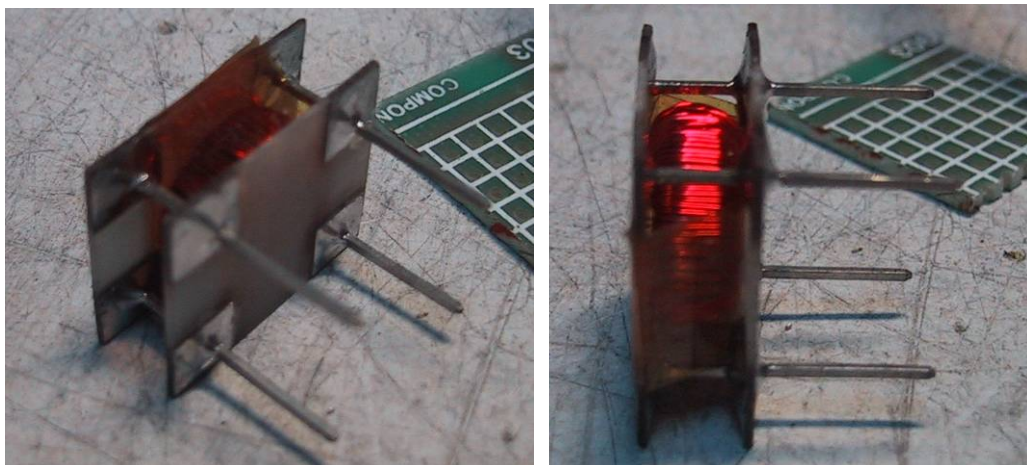
Rewound part and Re-constructed to fit existing footprint. Used on unit S/N:466

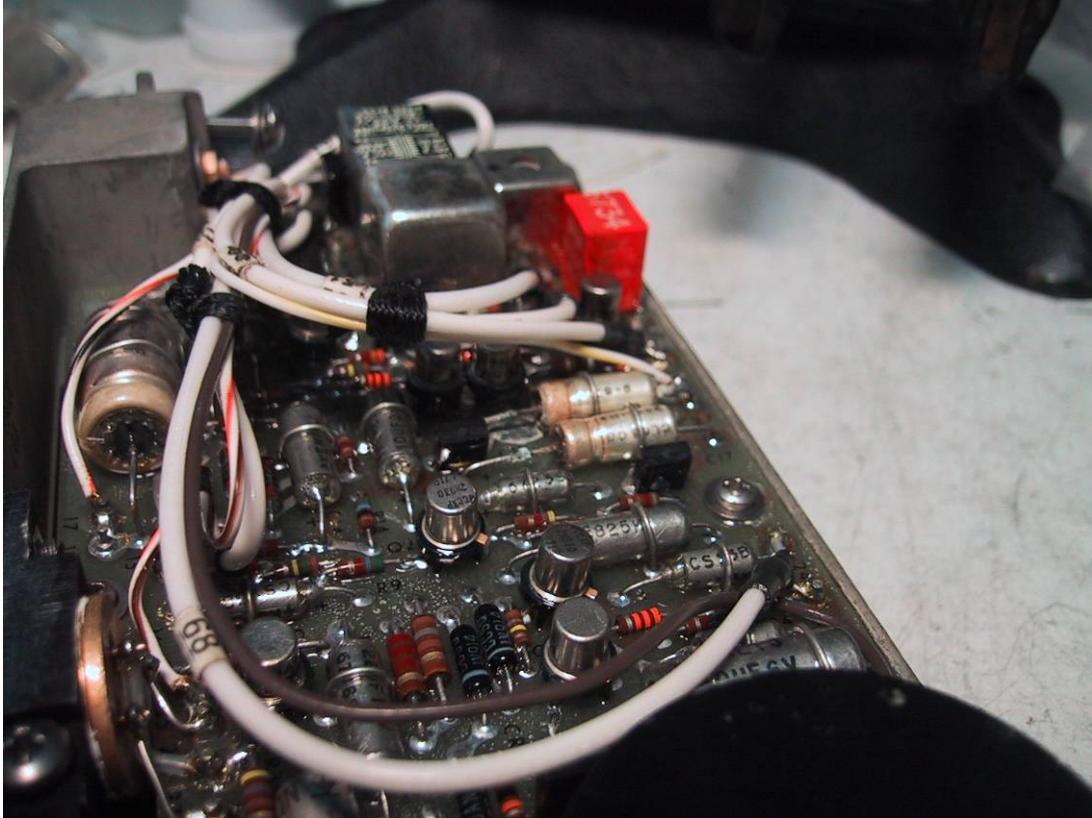
Assembly Detector /AF Amplifier A1A2A7

Severe E-cap deterioration in assemblies :
Assembly Detector /AF Amplifier A1A2A7,
Rear deck supply decoupling board A1A3A3,
Power Supply A1A3PS1

Replace all bad E-cap and suspicious item with 125degC rated long life parts.

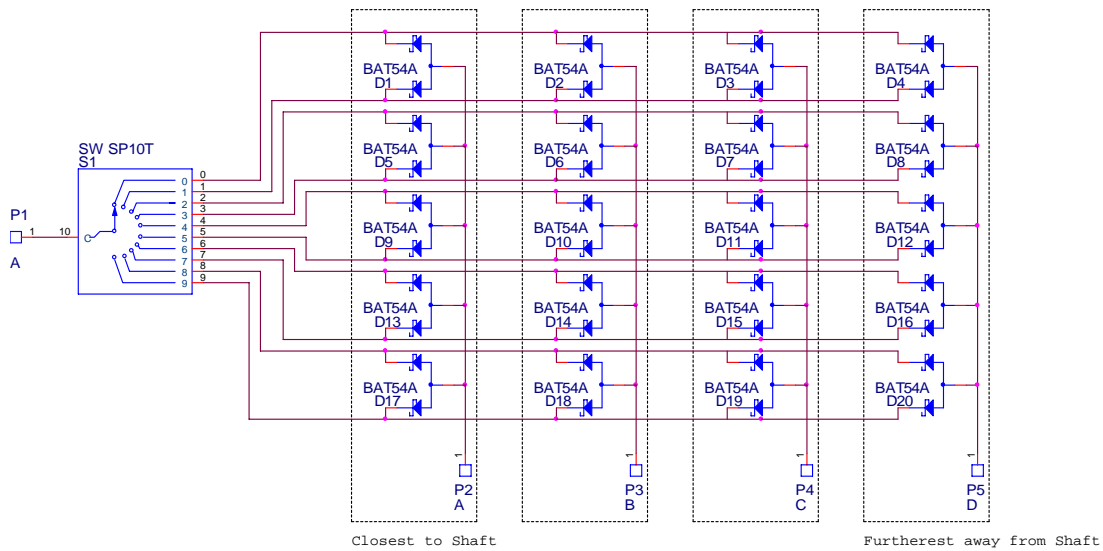
The 4 pole 10 throw switch used on the R1490 cannot be easily found from retail sources. An alternative is to use a single pole 10 throw switch combined with a diode matrix to generate the same binary code.

5 pcs of Schottky diodes are required for each assembly of A,B,C and D.

A logic level of “0” requires population of one diode at corresponding position (manual page 4-79).

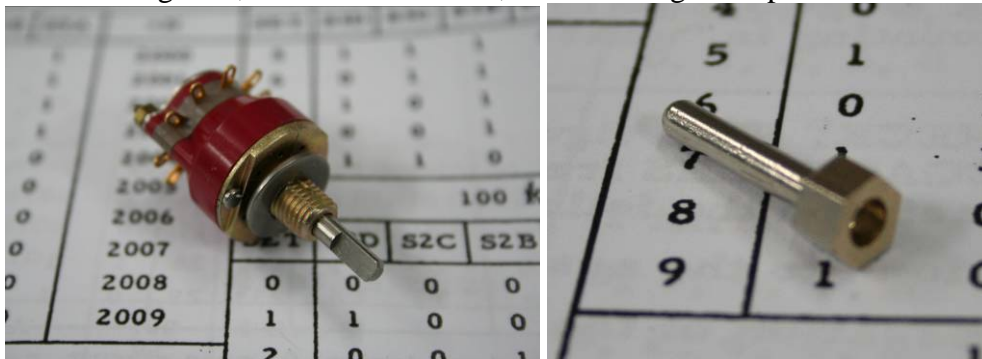
The major difference is shaft length, this causes significant difficulty on adapting the switch to the existing R-1490 mechanical design.

A shaft adaptor was made from commercially available Brass test fixture pins, one end having 2.8mm diameter which serves as mounting shaft of the original control knob. The other end is a hexagonal standoff with a 3mm internal thread. The threads were carefully removed with a 1/8" HSS drill bit, making a smooth bore to fit the stainless steel shaft of the 71A36 switch. The result is a precise tight fit that allow extension of the shaft (see photos) without adhesive application.

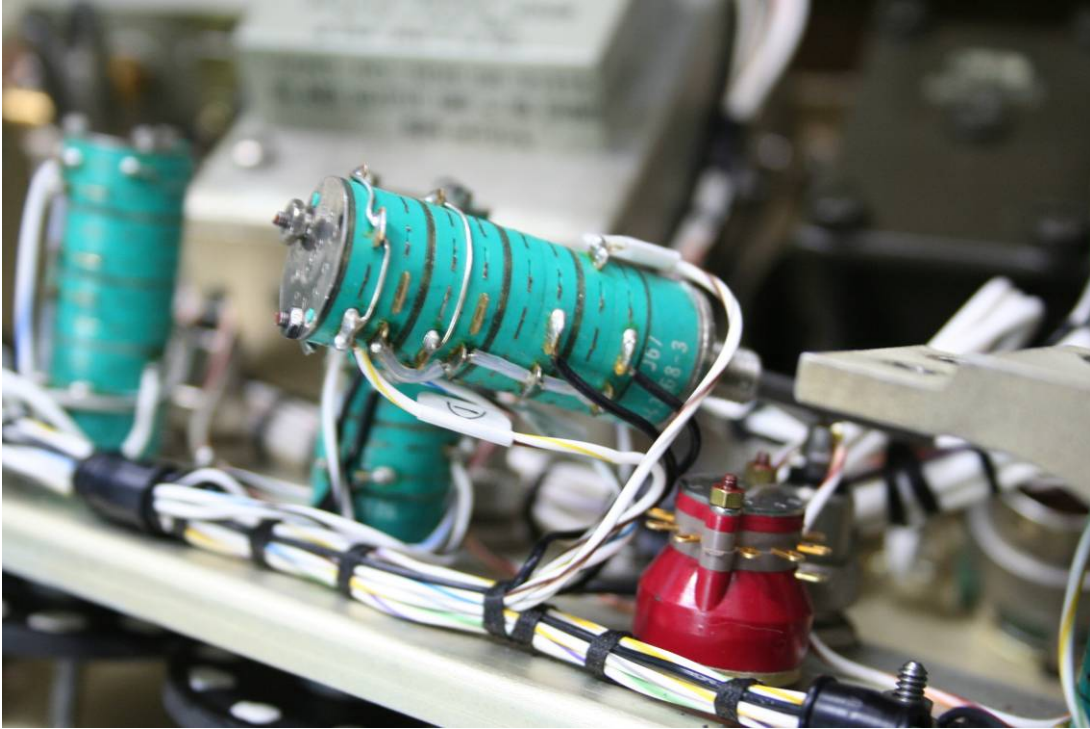
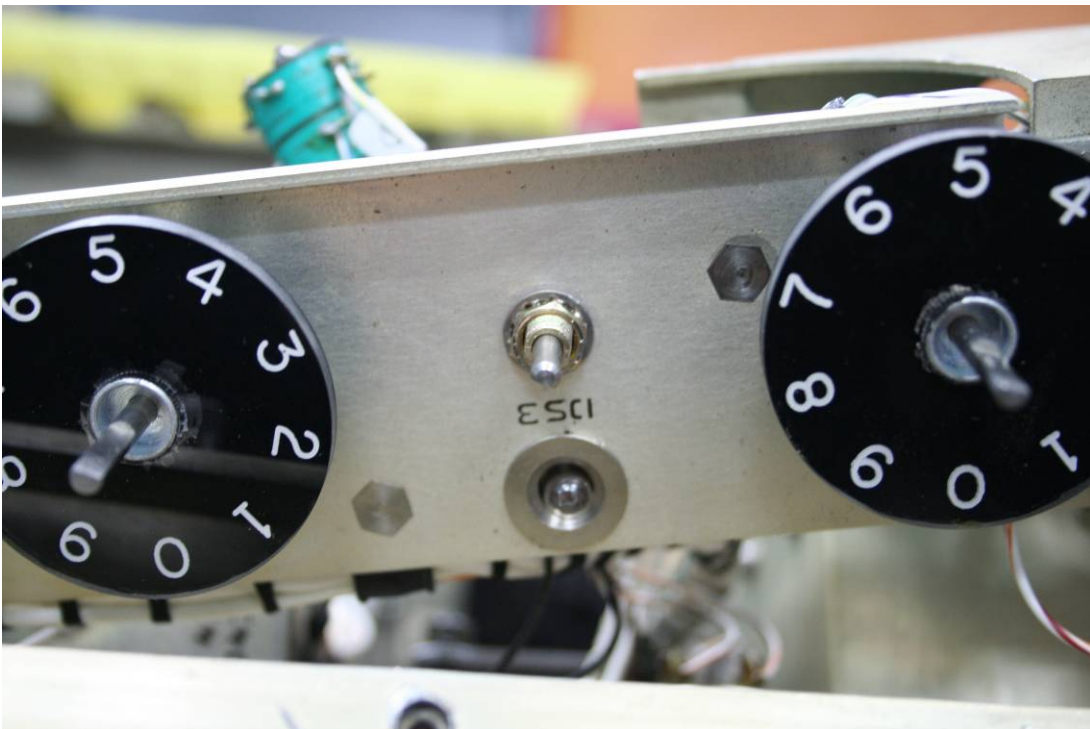
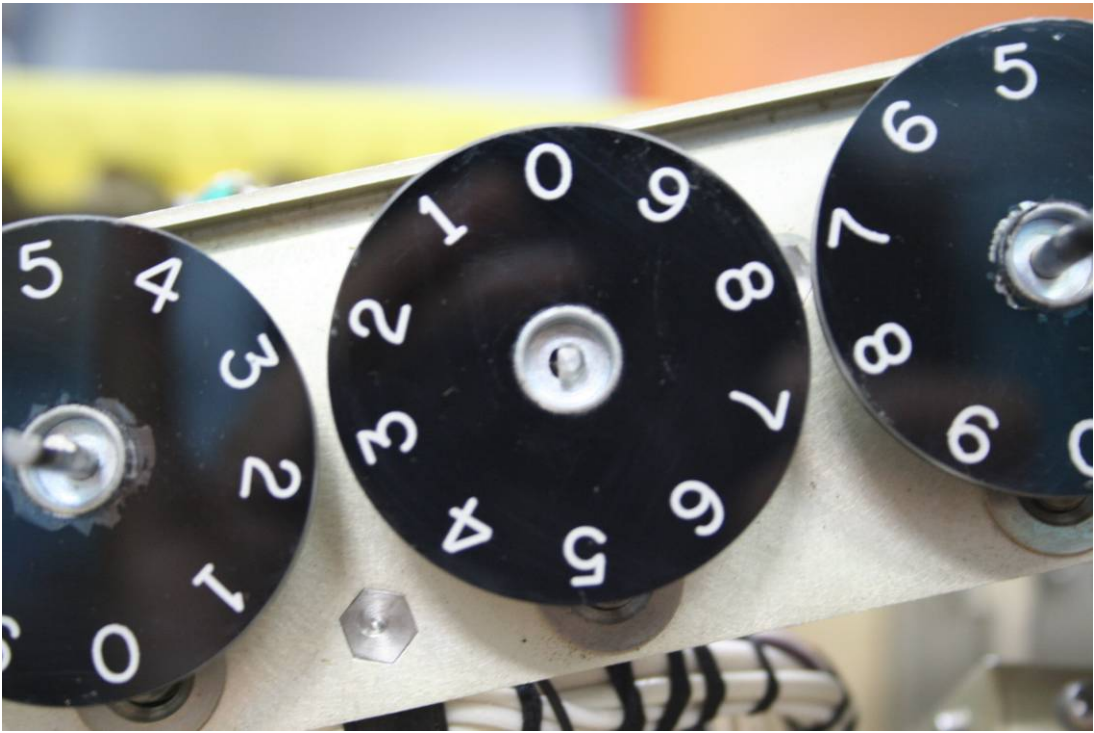
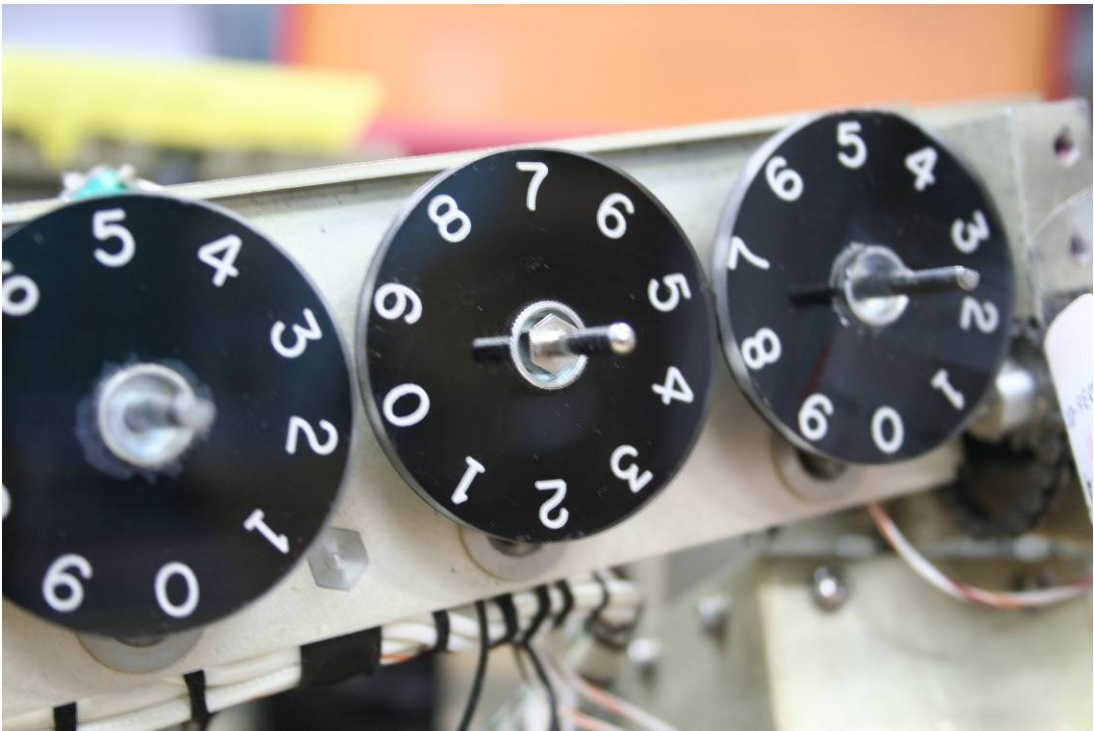
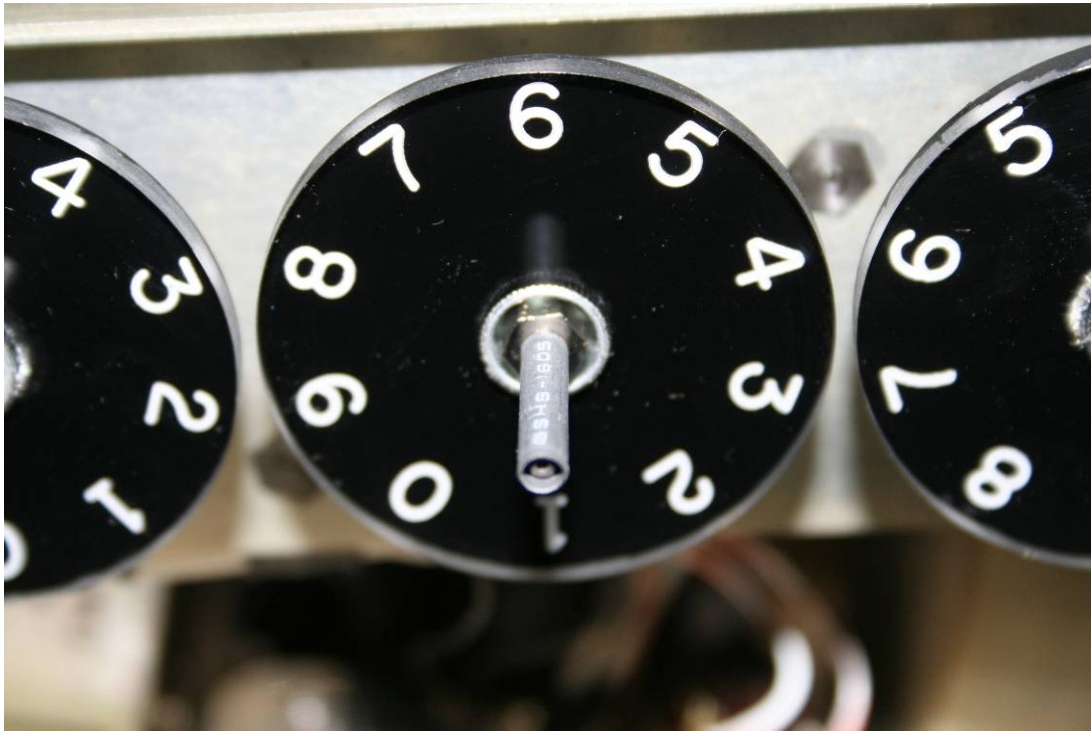
- S3 suffers bad contact. One mounting shaft of switch S3 suffers stripped thread
- Problems with 1MHz,10MHz frequency selector knob
- Adhesive applied incorrectly on encoder S1, set screw didn't seat on flat surface of shaft.
- S1 Bevel gears fastened incorrectly
- S1 stop unable to replace, broken.
- Toothed belt partly disintegrated
- S9 spindle toothed wheel mounted incorrectly, set screw didn't seat on flat surface of shaft.
- Drive wheel for A1A2A1 S1 mounted incorrectly, set screw didn't seat on flat surface of shaft.
- 115V AC input Y-capacitor, C2 burnt open, disintegrated. Check manual page 5-93,5-94.

1. De-solder and mark lead wires for S3 properly.
2. Remove digit dial from shaft
3. Remove S1 from switch assembly bracket.
4. Install digit dial such that position "0" appear on window align with position "10" on switch. Doing this display digit "1" will align with position "1" on switch.
5. Rotate shaft such that "0" align with window.
6. Tighten S3 mounting screw, inspect position of digit on window. Re-adjust mounting screw if needed.
7. Insert adaptor shaft.
8. Adaptor shaft is slightly smaller than original part, insert a 2.5mm shrinkable tube onto shaft to improve knob fitting.

9. Install switch assembly to front panel, proceed to toothed belt installation and alignment.

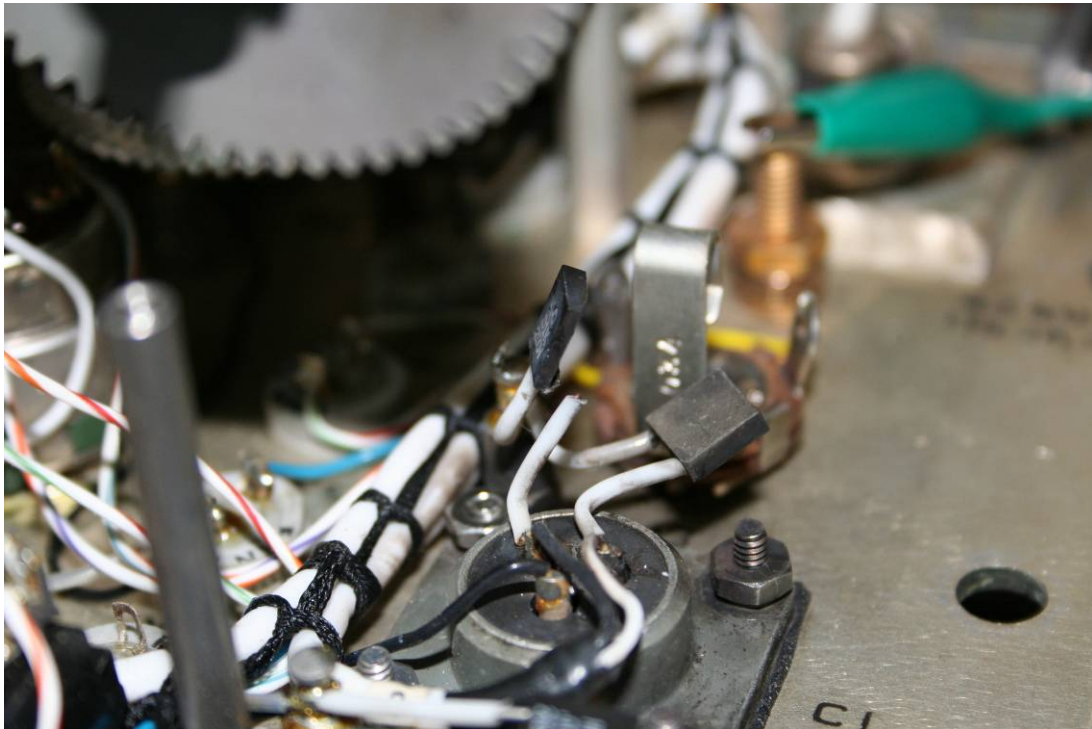
- 115V AC input Y-capacitors. manual page 5-93,5-94

200V ceramic capacitors were used, which is unsuitable for Line-Earth application by today's standard. 10n Y capacitors was not available at time of repair, 10n X2 capacitor was used instead. Both C1 and C2 were replaced for reliability reason.
