## ABOUT ADSP-21365 SILICON ANOMALIES

These anomalies represent the currently known differences between revisions of the SHARC ADSP-21365 product(s) and the functionality specified in the ADSP-21365 data sheet(s) and the Hardware Reference book(s).

## SUMMARY OF SILICON ANOMALIES

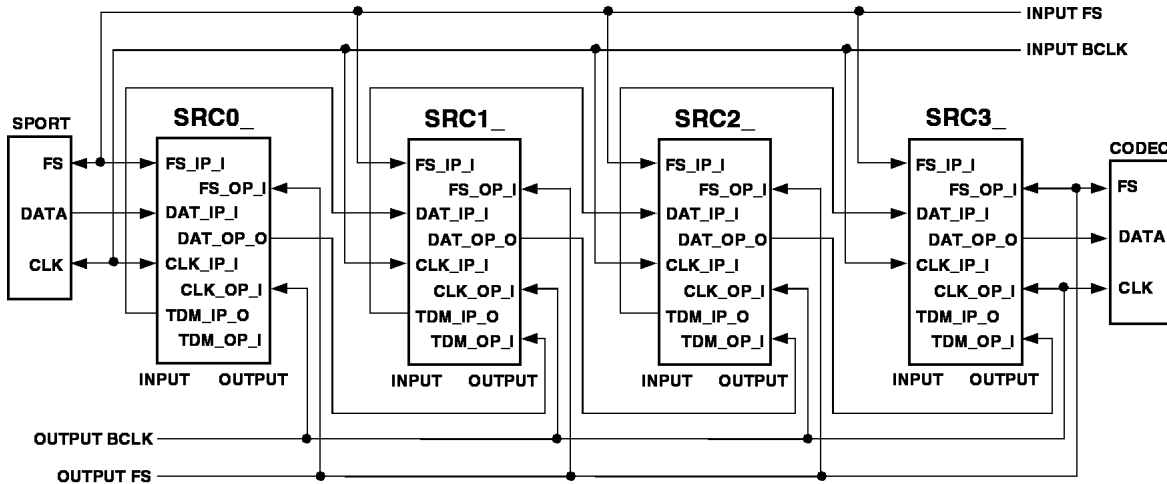
In the TDM Daisy chaining mode the ASRCs can be connected as follows to achieve TDM mode:

When the ASRCs are used in TDM Daisy chaining mode, the MSB of the input data is lost at the output of each ASRC in the chain. This anomaly is applicable for the TDM mode in both the bypass and non-bypass modes. The following example provides the expected failure pattern for the bypass mode, since in bypass mode the incoming data is not modified by the ASRC.

The workaround for this anomaly must be carried out in the software, only on the input data to the ASRCs in TDM daisy chaining mode. It can not be implemented on the output data from the ASRCs. The workaround implementation in the software adds some core MIPS to the application. For the devices like ADC/CODECs the workaround may not be implemented directly. For such systems, two serial ports of the processor should be dedicated for this purpose. One serial port should be used for receiving the data from the ADC/CODEC and the other one should be used for transmitting the modified input data to the ASRC.

When the ASRCs are used in TDM daisy chaining mode, only the 24-MSBs of the input 32-bit data is used and the 8-LSBs are not used by the ASRC. The anomaly can be workaround by shifting the 24-MSBs of the data to the 8-LSBs as follows:
