ABOUT ADSP-21366 SILICON ANOMALIES

SUMMARY OF SILICON ANOMALIES

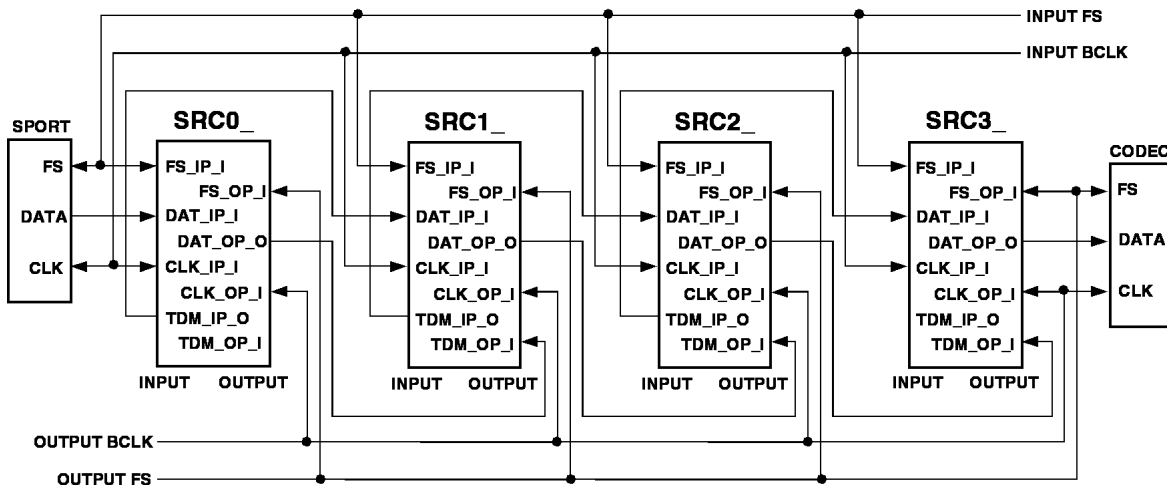
6. 07000019 - Input Shift Register Anomaly in ASRCs (Asynchronous Sample Rate Converters) impacts Daisy-Chained TDM mode:

In the TDM Daisy chaining mode the ASRCs can be connected as follows to achieve TDM mode:

When the ASRCs are used in TDM Daisy chaining mode, the MSB of the input data is lost at the output of each ASRC in the chain. This anomaly is applicable for the TDM mode in both the bypass and non-bypass modes. The following example provides the expected failure pattern for the bypass mode, since in bypass mode the incoming data is not modified by the ASRC.

For a TDM daisy chain with 8 channels in BYPASS mode, the output of the final ASRC in the chain will result in three-bit left shift for the channels 1 and 2, two bit left shift for the channels 3 and 4 and one bit left shift for the channels 5 and 6. The channels 7 and 8 will not have any data shift. At the output end, three MSBs will be lost for the channels 1 and 2, two MSBs will be lost for the channels 3 and 4 and

one MSB will be lost for the channels 5 and 6.

For a TDM daisy chain in NON-BYPASS mode, the output of the TDM Daisy chain will be corrupted completely because of the MSB bit loss in each ASRC in the chain.

The workaround for this anomaly must be carried out in the software, only on the input data to the ASRCs in TDM daisy chaining mode. It can not be implemented on the output data from the ASRCs. The workaround implementation in the software adds some core MIPS to the application. For the devices like ADC/CODECs the workaround may not be implemented directly. For such systems, two serial ports of the processor should be dedicated for this purpose. One serial port should be used for receiving the data from the ADC/CODEC and the other one should be used for transmitting the modified input data to the ASRC.

When the ASRCs are used in TDM daisy chaining mode, only the 24-MSBs of the input 32-bit data is used and the 8-LSBs are not used by the ASRC. The anomaly can be workaround by shifting the 24-MSBs of the data to the 8-LSBs as follows:

1. Right shift the input data for channels 1 and 2 by three bits. Now the 24-MSBs which has the data are placed in the bits from 28 - 5.
2. Right shift the input data for channels 3 and 4 by two bits. Now the 24-MSBs which has the data are placed in the bits from 29 - 6.
3. Right shift the input data for channels 5 and 6 by one bit. Now the 24-MSBs which has the data are placed in the bits from 30 - 7.
4. The input data for channels 7 and 8 need not be modified.
