ABOUT ADSP-21367 SILICON ANOMALIES

These anomalies represent the currently known differences between revisions of the SHARC ADSP-21367 product(s) and the functionality specified in the ADSP-21367 data sheet(s) and the Hardware Reference book(s).

NR003115G

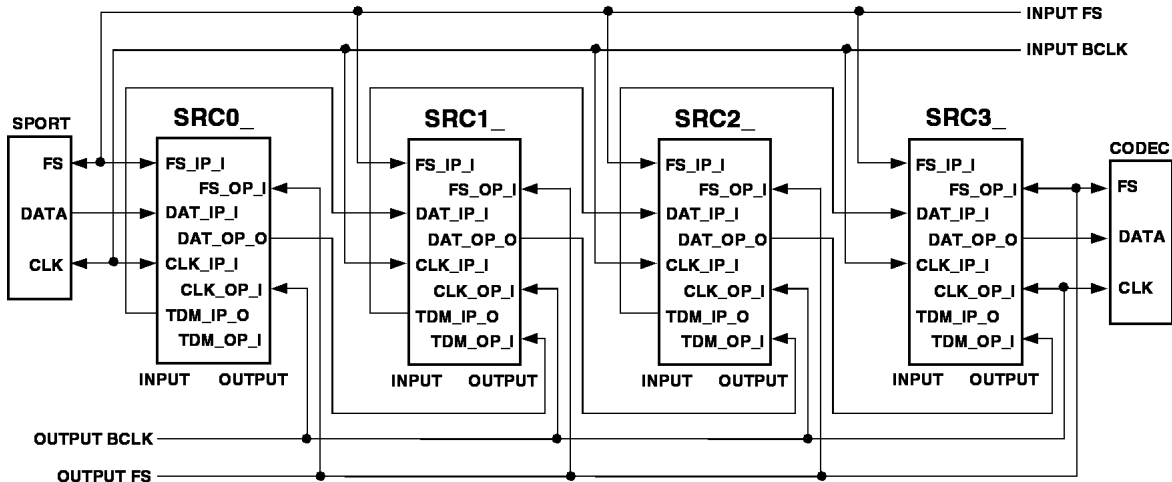
10. 08000020 - Input Shift Register Anomaly in ASRCs (Asynchronous Sample Rate Converters) impacts Daisy-Chained TDM mode:

When the ASRCs are used in TDM Daisy chain mode, the MSB of the input data is lost at the output of each ASRC in the chain. This anomaly is applicable for the TDM mode in both the bypass and non-bypass modes. The following example provides the expected failure pattern for the bypass mode, since in bypass mode the incoming data is not modified by the ASRC.

For a TDM daisy chain with 8 channels in BYPASS mode, the output of the final ASRC in the chain will result in three-bit left shift for the channels 1 and 2, two bit left shift for the channels 3 and 4 and one bit left shift for the channels 5 and 6. The channels 7 and 8 will not

have any data shift. At the output end, three MSBs will be lost for the channels 1 and 2, two MSBs will be lost for the channels 3 and 4 and one MSB will be lost for the channels 5 and 6.

For a TDM daisy chain in NON-BYPASS mode, the output of the TDM Daisy chain will be corrupted completely because of the MSB bit loss in each ASRC in the chain.

The workaround for this anomaly must be carried out in software only on the device providing input data to the ASRCs in TDM daisy chain mode. It can not be implemented on the output data from the ASRCs. The workaround implementation in software adds some core MIPS to the application. For devices like ADCs/CODECs, the workaround may not be implemented directly. For such systems, two serial ports of the SHARC should be dedicated for this purpose. One serial port should be used for receiving the data from the ADC/CODEC and the other one should be used for transmitting the modified input data to the ASRC.

When the ASRCs are used in TDM daisy chain mode, only the 24-MSBs of the input 32-bit data is used and the 8-LSBs are not used by the ASRC. The anomaly can be worked around by shifting the 24-MSBs of the data to the 8-LSBs as follows:

1. Right shift the input data for channels 1 and 2 by three bits. Now the 24-MSBs which has the data are placed in the bits from 28 - 5.
2. Right shift the input data for channels 3 and 4 by two bits. Now the 24-MSBs which has the data are placed in the bits from 29 - 6.
3. Right shift the input data for channels 5 and 6 by one bit. Now the 24-MSBs which has the data are placed in the bits from 30 - 7.
4. The input data for channels 7 and 8 need not be modified.

When the modified input data is provided to the TDM daisy chain, one MSB of the modified data will be lost at each ASRC in the chain due to the anomaly. Since the 24-MSBs which has the data is shifted to the LSBs of the input, the actual MSB is not lost at each ASRC in the chain. Because of the anomaly the data will be shifted left by the ASRC and received correctly at the output end.
