MIPS R4000PC/SC Errata, Processor Revision 2.2 and 3.0

May 10, 1994

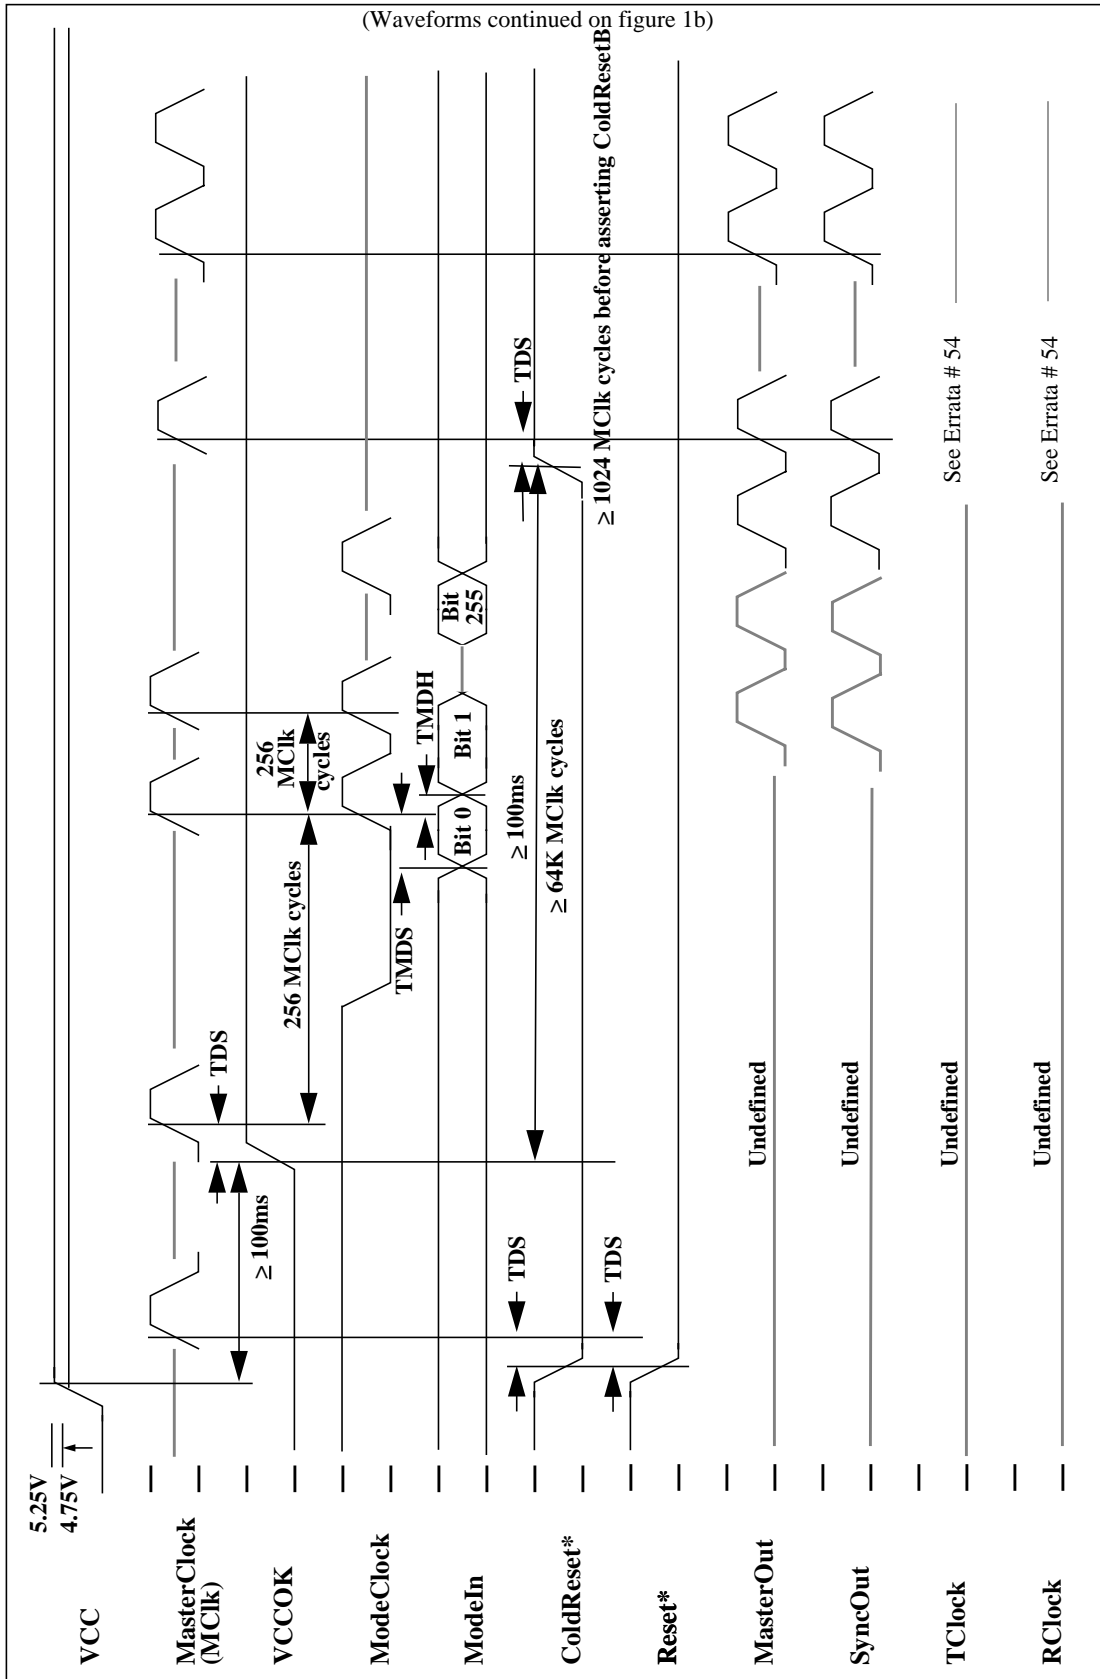
Figure 1a: Power-on Reset or Cold Reset - Workaround for Bug# 54

- 54.** R4000PC, R4000SC: During the power up sequence, the period of TClk and RClk may not be as expected for at least 1024 MasterClock cycles following the de-assertion of ColdResetB. The above bug is true for all system interface divisors. Furthermore, if the system interface divisor other than 2 (i.e. 3,4,6 & 8) is used, TClk and RClk's rising edge may not align to the rising edge of the MasterClock, as specified.

This may not be a problem for systems using only TClk for the external logic. However, certain systems like -

this bug may cause problems.

Thus, for system with interface divisor set to two, the only violation will be that the TClk and RClk's period might not be valid within 64 MasterClock after the ColdResetB is de-asserted.
