MIPS R4400PC/SC Errata, Processor Revision 1.0

February 9, 1994

MIPS Technologies Inc.
2011 N Shoreline Blvd
PO Box 7311
Mountain View, CA 94039-7311

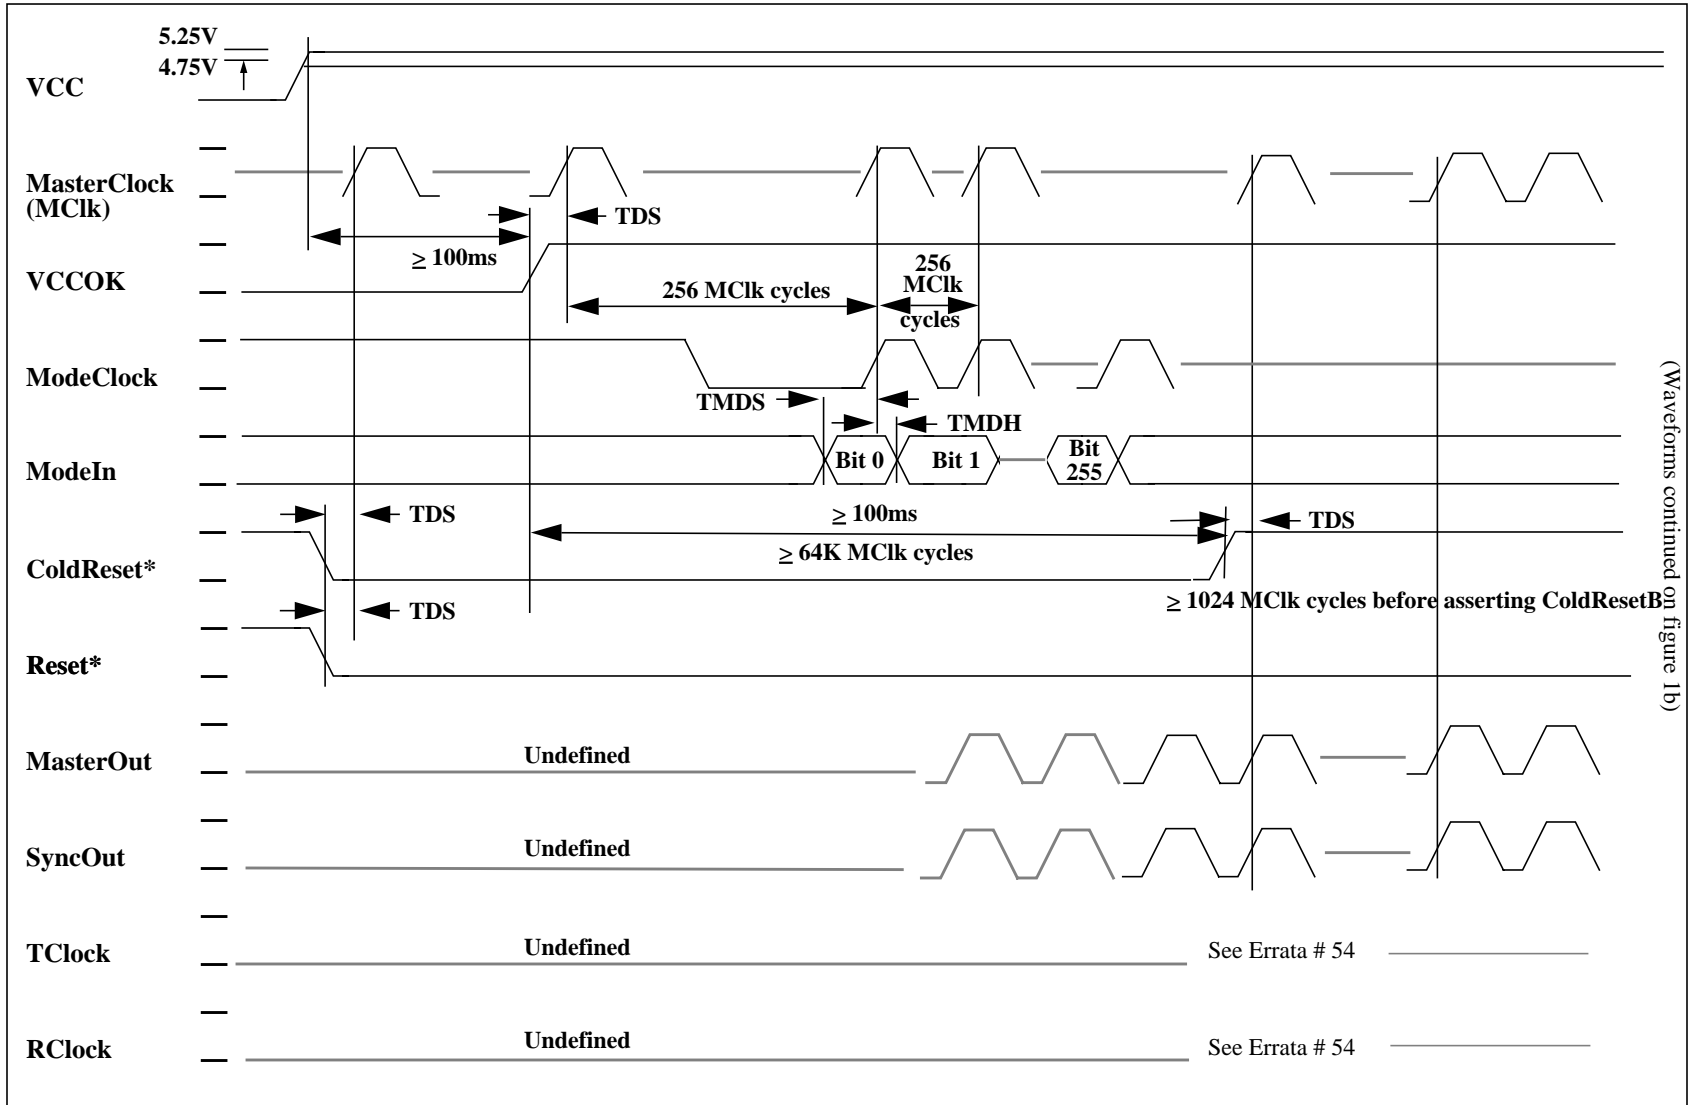
Figure 1a: Power-on Reset or Cold Reset - Workaround for Bug# 22

22. R4400PC, R4400SC: During the power up sequence, the period of TClk and RClk may not be as expected for at least 1024 MasterClock cycles following the de-assertion of ColdResetB. The above bug is true for all system interface divisors. Furthermore, if the system interface divisor other than 2 (i.e. 3,4,6 & 8) is used, TClk and RClk's rising edge may not align to the rising edge of the MasterClock, as specified.

Thus, for system with interface divisor set to two, the only violation will be that the TClk and RClk's period might not be valid within 64 MasterClock after the ColdResetB is de-asserted.

Workaround: Assert a second ColdResetB after at least 1024 MasterClock cycles from the de-assertion of the first ColdResetB. ResetB should remain asserted until at least 64 MasterClock cycles following the de-assertion of the second ColdResetB. TClk and RClk will then be valid 64 MasterClock cycles after the de-assertion of the second ColdResetB and their edge alignment with respect to MasterClock will be as specified. Figure 1a & 1b show the waveforms in more detail. Note that the waveforms in Figure 1b are continuation of the those in figure 1a.
