# **MIPS R4400PC/SC Errata, Processor Revision 2.0 & 3.0**

January 24, 1995

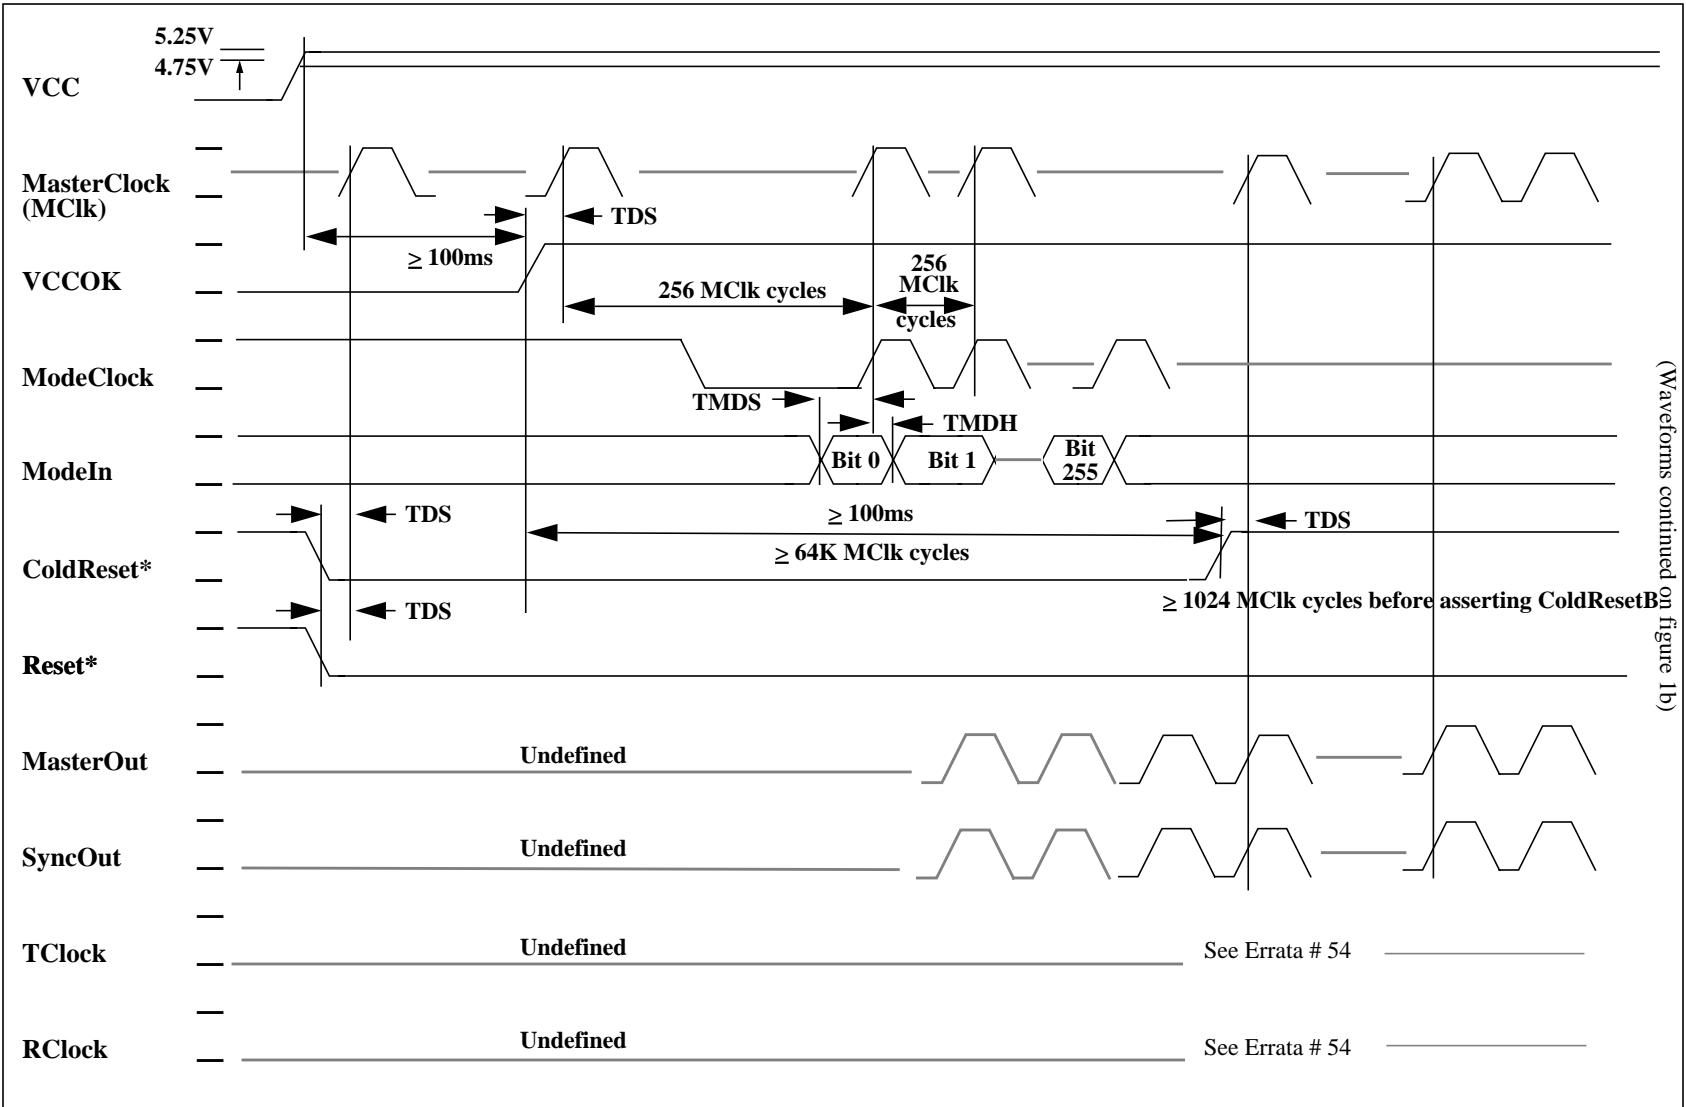
Figure 1a: Power-on Reset or Cold Reset - Workaround for Bug# 16

15. R4400PC, R4400SC: During the power up sequence, the period of TClk and RClk may not be as expected for at least 1024 MasterClock cycles following the de-assertion of ColdResetB. The above bug is true for all system interface divisors. Furthermore, if the system interface divisor other than 2 (i.e. 3,4,6 & 8) is used, TClk and RClk's rising edge may not align to the rising edge of the MasterClock, as specified.

**Workaround:** Assert a second ColdResetB after at least 1024 MasterClock cycles from the de-assertion of the first ColdResetB. ResetB should remain asserted until at least 64 MasterClock cycles following the de-assertion of the second ColdResetB. TClk and RClk will then be valid 64 MasterClock cycles after the de-assertion of the second ColdResetB and their edge alignment with respect to MasterClock will be as specified. Figure 1a & 1b show the waveforms in more detail. Note that the waveforms in Figure 1b are continuation of the those in figure 1a.
