Power MOSFET in High-Side Operating Modes, Possible Failure Modes, and Failure Signatures

By Kandarp Pandya

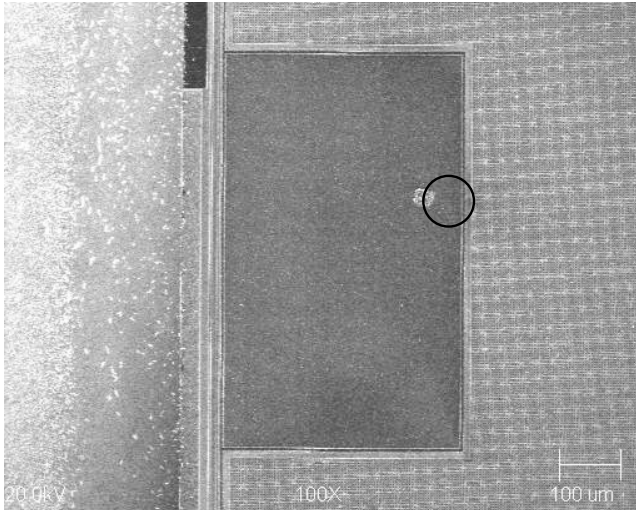
During turn-on and turn-off, switching power losses are likely to dissipate from a very small area of the active die. The resulting failure signature is high-power burn-out, with a random amount of damage located in the active area of the die. Invariably such failure is labeled as **EOS**.

A failure example of a DPAK power MOSFET is shown in the figures 3, 4, and 5.

Fig. 3 - EOS dDamage Location

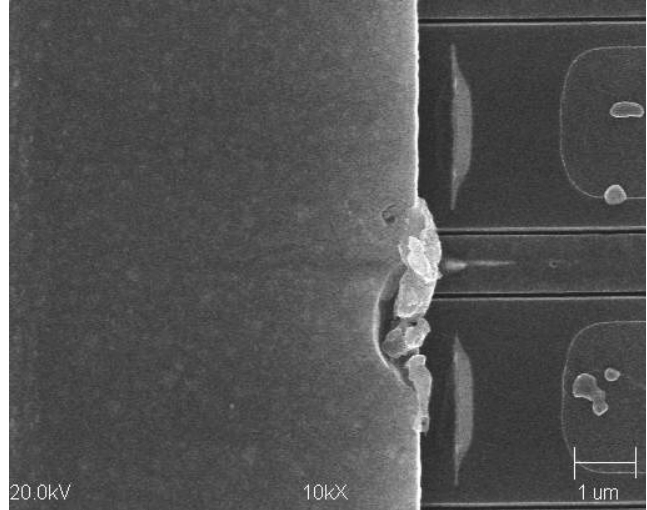
Fig. 5 - Damage on Gate Poly

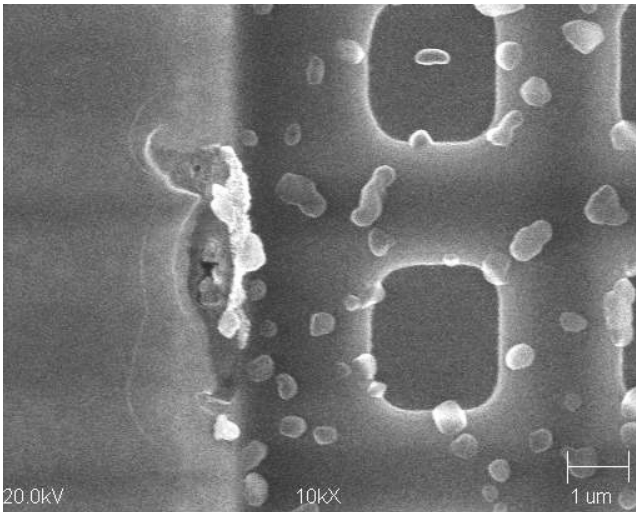
Fig. 4 - Damage on BPSG

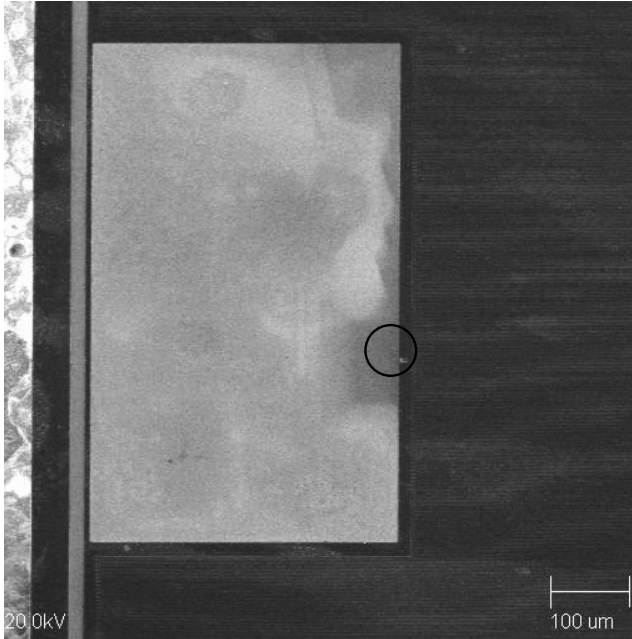
A second possible scenario arising from a virtually floating gate condition caused by the high impedance of an ASIC driver and/or high gate resistor is increased susceptibility of the gate-source area for damage from ESD or a similar event. In addition to a typical ESD event, high-energy, high-voltage transients of short duration can be generated from energy re-circulation and/or energy interruption from inductive components. With reference to figure 6, these include the low-side load (L1, R1), other parallel connected load (L2, R4), and series feed-in/harness impedance (L3, R5).

Failure signatures are usually located near the gate termination and in the gate-source area. An example of a DPAK power MOSFET failure is shown in figures 7, 8 and 9.

Fig. 7 - ESD Damage near the Gate-Source

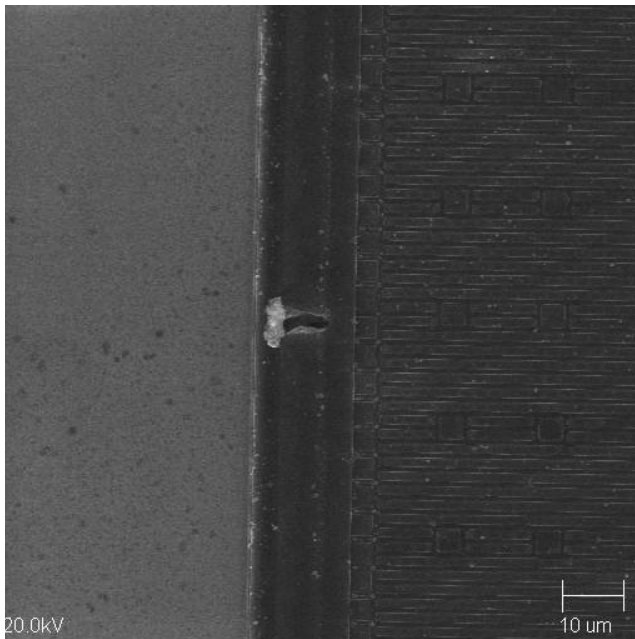
Fig. 8 - ESD on the Gate Termination

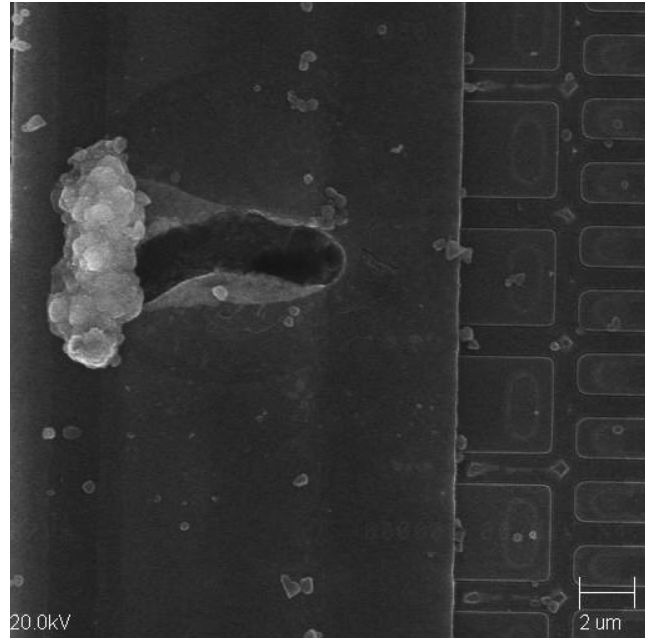
Fig. 9 - Close-up of ESD Damage

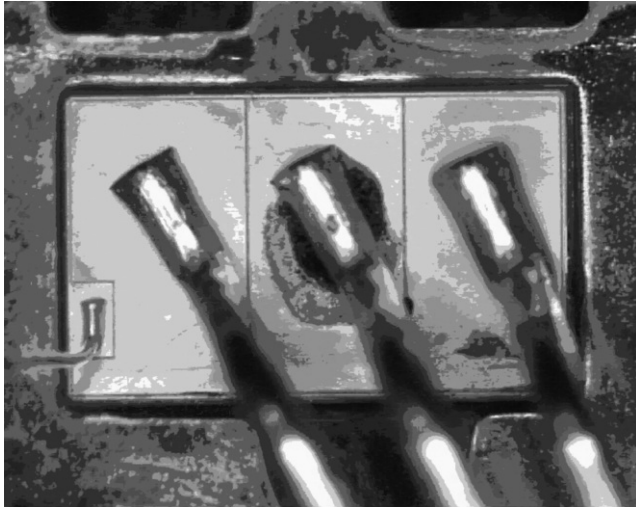
D²PAK example: figures 10 to 12 are failure signatures for a D²PAK power MOSFET.

Fig. 10 - High Power EOS (after Decapsulation)

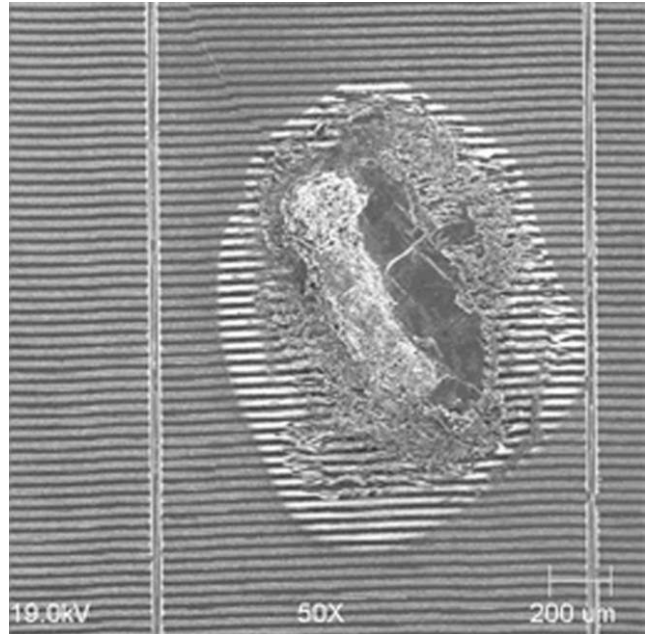
Fig. 12 - EOS Damage at 50 x Magnification

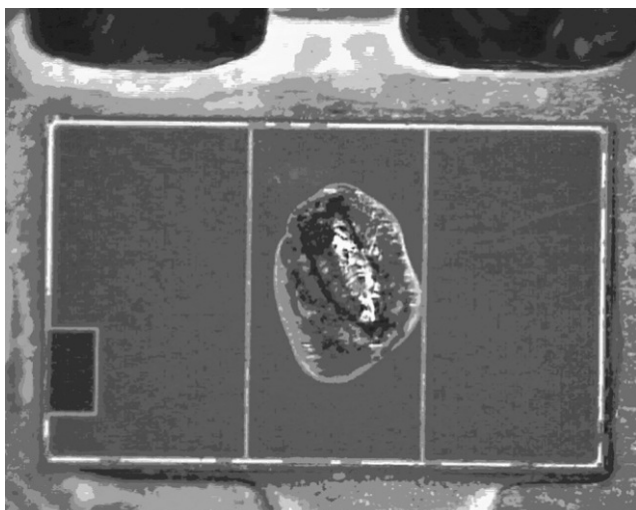
Fig. 11 - EOS Signature after Removing Top Metal Layer

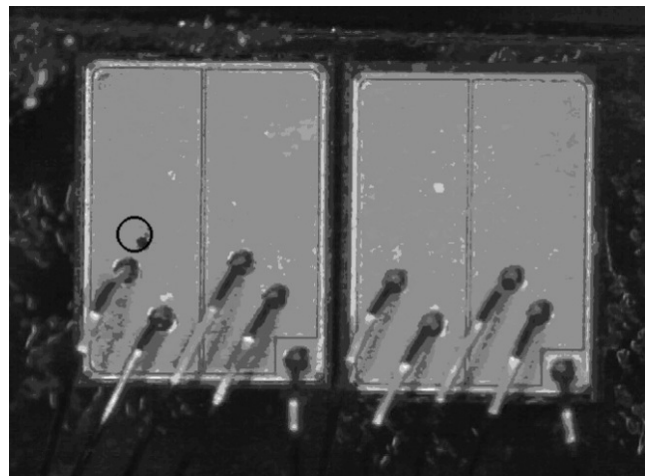
SO-8 dual example: figures 13 to 15 are another example of a dual SO-8 power MOSFET failure identified as EOS

Fig. 13 - Failure near Bond Wire

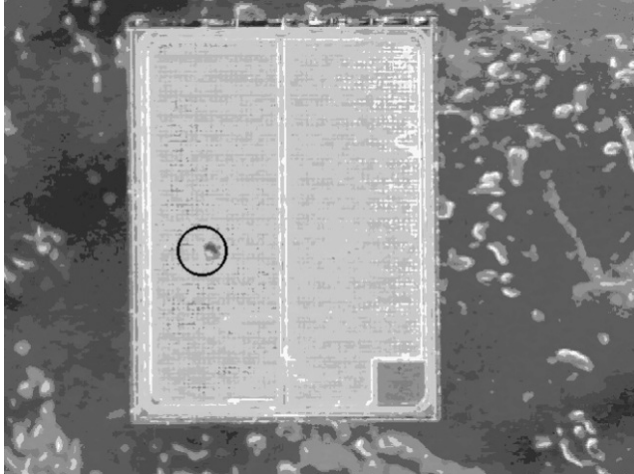
Fig. 14 - EOS in Active Region

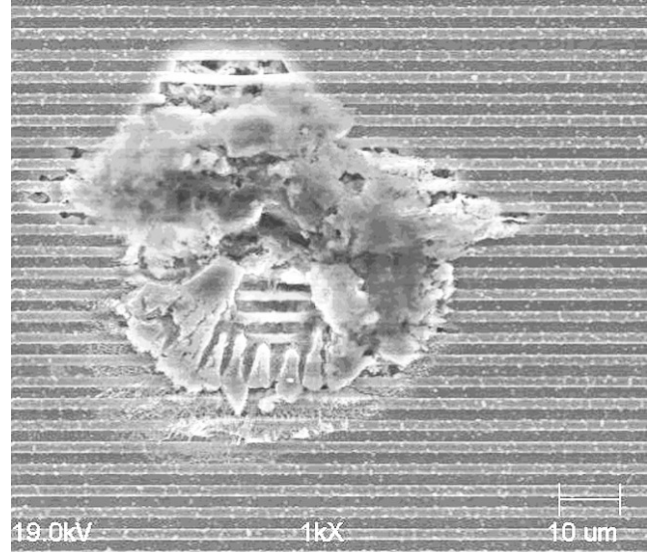
Fig. 15 - Close-up of EOS Damage
