PIC16C73B Rev. A Silicon Errata Sheet

The PIC16C73B (Rev. A) parts you have received conform functionally to the Device Data Sheet (DS30605A), except for the anomalies described below.

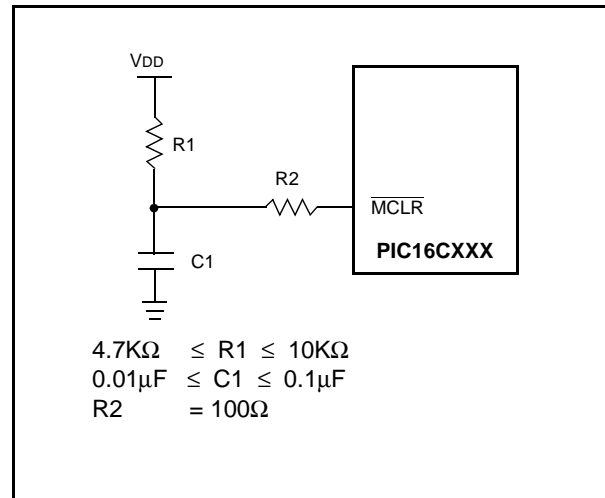
FIGURE 1: $\overline{\text{MCLR}}$ EXTERNAL CIRCUIT

The minimum specification for the $\overline{\text{MCLR}}$ must be met in order to RESET the PIC16CXXX. If a $\overline{\text{MCLR}}$ pulse occurs that is less than the minimum specification (parameter #30), improper device operation can occur.

If the minimum specification cannot be met, then an external circuit must be used to insure that any pulse width less than the specification will be filtered before it reaches the $\overline{\text{MCLR}}$ pin.

A possible circuit is shown in Figure 1. Proper design validation needs to be done to ensure desired operation over the applications operating conditions

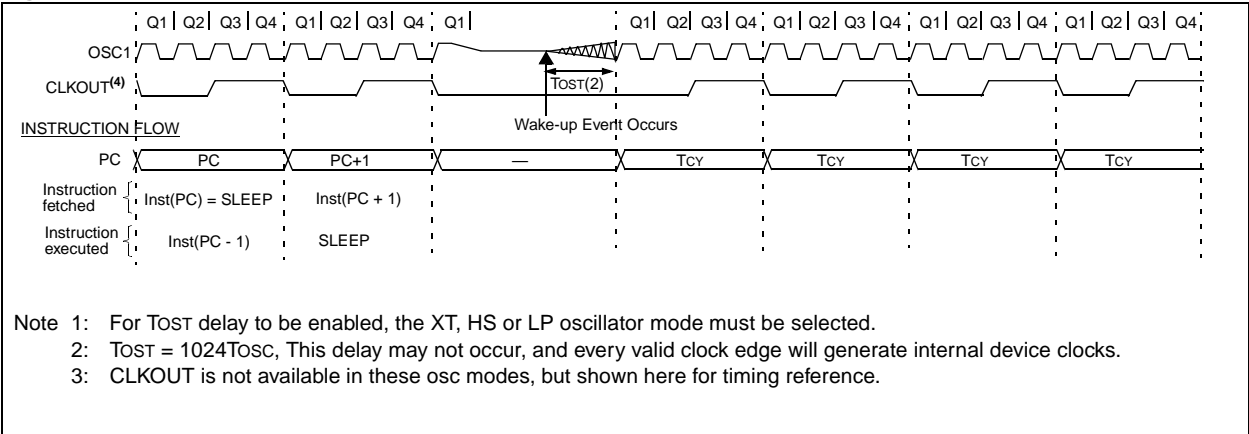
Figure 2: Wake-up from Sleep

The Oscillator Start-up Timer (TOST) delay may not occur when the device wakes-up from sleep.

Figure 2 shows the start-up of the crystal after the event that causes the device to wake up from sleep mode (as specified in device data sheet). The start-up time (TOST) may not occur.

After the SLEEP instruction, do a software delay of 256 Tcy (same as 1024 TOSC). At the Reset and Interrupt vector addresses, test to see if the device woke from sleep (the $\overline{\text{TO}}$ and $\overline{\text{PD}}$ bits), and if the device did wake from sleep, ensure that the total cycle delay is 256 Tcy.

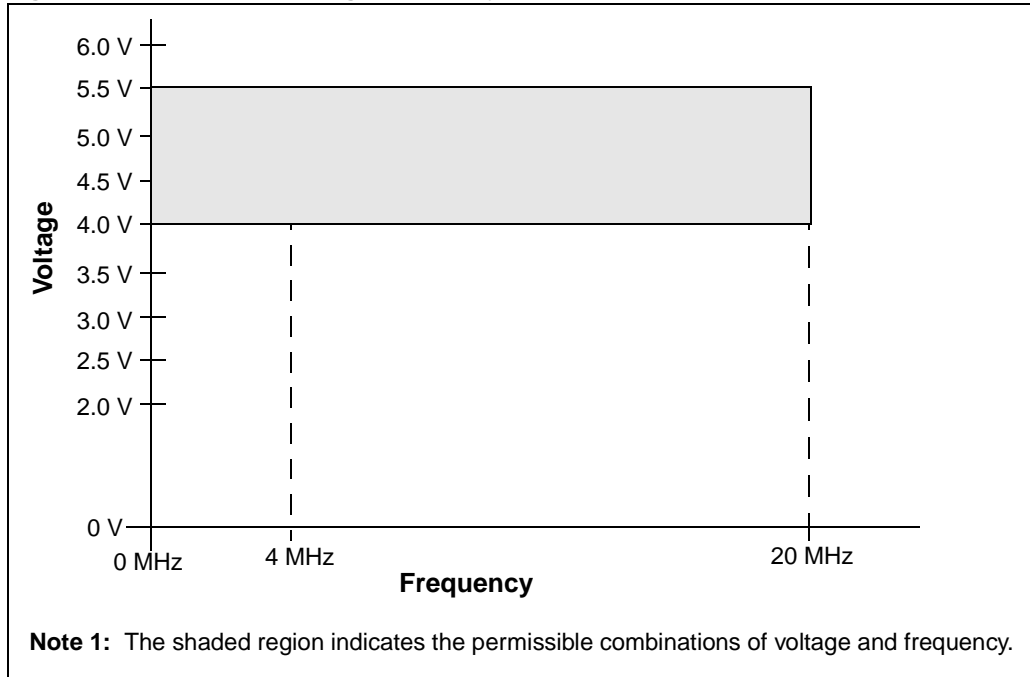
Figure 3: PIC16CXXX Voltage-Frequency Graph

Figure 3 shows the voltage vs. frequency operation for the PIC16CXXX devices. Devices marked with a "-04" operate up to 4 MHz, while devices marked with a "-20" operate up to 20 MHz. The entire shaded region is the valid operating region.

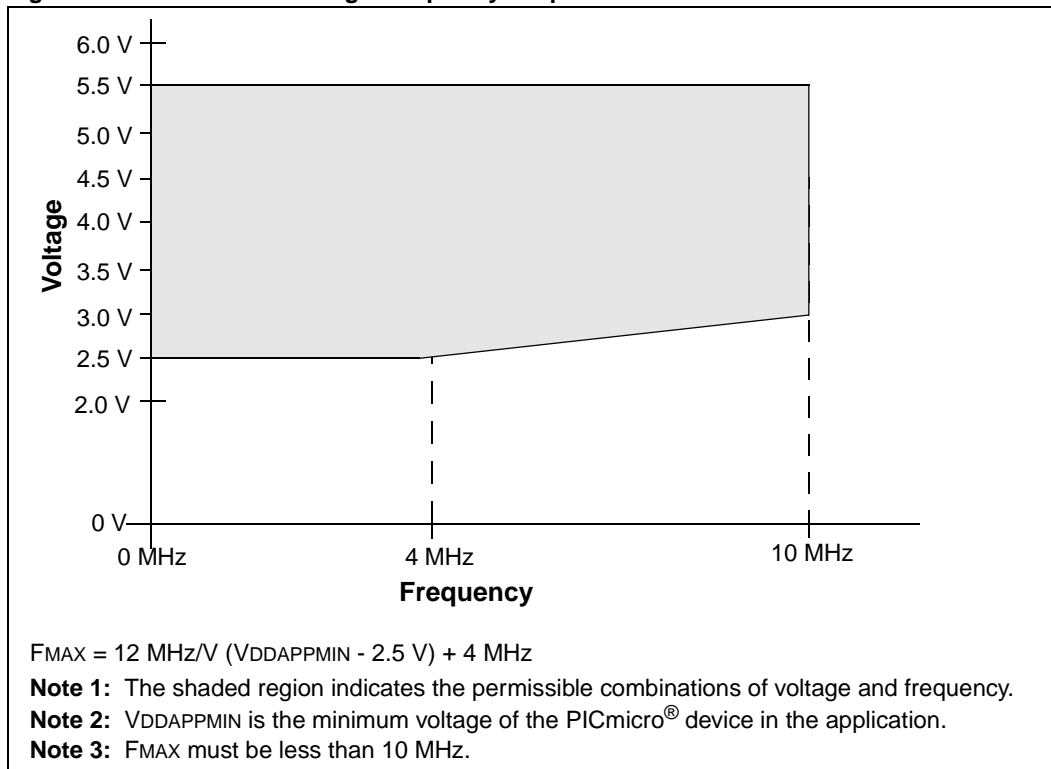
Figure 4: PIC16LCXXX Voltage-Frequency Graph

Figure 4 shows the voltage vs. frequency operation for the PIC16LCXXX devices. The devices marked with a "-04" operate up to 4 MHz at the minimum supplied voltage. The devices also operate at a higher frequency (10 MHz) and at a higher voltage (3V). The entire shaded region is the valid operating region.
