PIC16C72A Rev. A Silicon Errata Sheet

The PIC16C72A (Rev. A) parts you have received conform functionally to the Device Data Sheet (DS35008A), except for the anomalies described below.

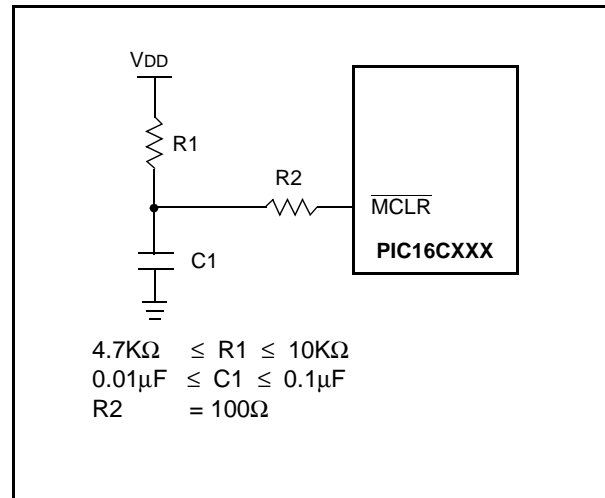
FIGURE 1: $\overline{\text{MCLR}}$ EXTERNAL CIRCUIT

The minimum specification for the $\overline{\text{MCLR}}$ must be met in order to RESET the PIC16CXXX. If a $\overline{\text{MCLR}}$ pulse occurs that is less than the minimum specification (parameter #30), improper device operation can occur.

If the minimum specification cannot be met, then an external circuit must be used to insure that any pulse width less than the specification will be filtered before it reaches the $\overline{\text{MCLR}}$ pin.

A possible circuit is shown in Figure 1. Proper design validation needs to be done to ensure desired operation over the applications operating conditions

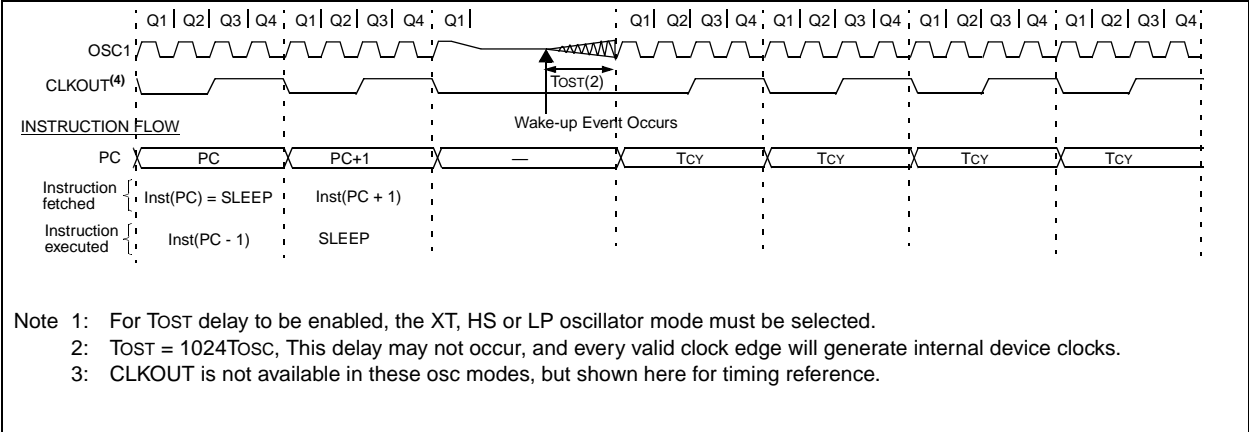
Figure 1: Wake-up from Sleep

The Oscillator Start-up Timer (TOST) delay may not occur when the device wakes-up from sleep.

Figure 1 shows the start-up of the crystal after the event that causes the device to wake up from sleep mode (as specified in device data sheet). The start-up time (TOST) may not occur.

After the SLEEP instruction, do a software delay of 256 Tcy (same as 1024 TOSC). At the Reset and Interrupt vector addresses, test to see if the device woke from sleep (the $\overline{\text{TO}}$ and $\overline{\text{PD}}$ bits), and if the device did wake from sleep, ensure that the total cycle delay is 256 Tcy.
