PIC16C62B Rev. A Silicon Errata Sheet

The PIC16C62B (Rev. A) parts you have received conform functionally to the Device Data Sheet (DS35008A), except for the anomalies described below.

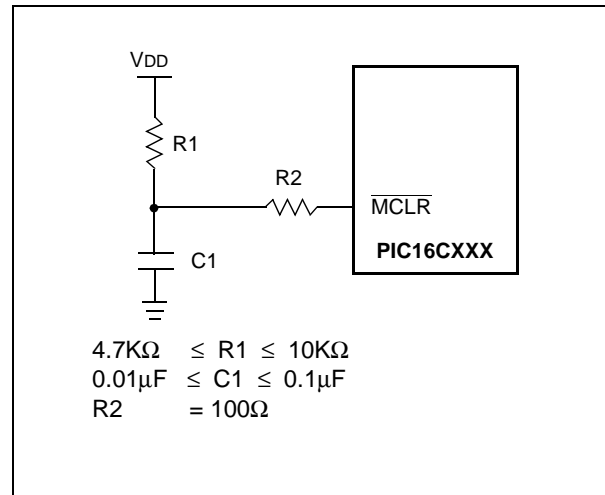
FIGURE 1: $\overline{\text{MCLR}}$ EXTERNAL CIRCUIT

The minimum specification for the $\overline{\text{MCLR}}$ must be met in order to RESET the PIC16CXXX. If a $\overline{\text{MCLR}}$ pulse occurs that is less than the minimum specification (parameter #30), improper device operation can occur.

If the minimum specification cannot be met, then an external circuit must be used to insure that any pulse width less than the specification will be filtered before it reaches the $\overline{\text{MCLR}}$ pin.

A possible circuit is shown in Figure 1. Proper design validation needs to be done to ensure desired operation over the applications operating conditions
