PIC16C923 Rev. A Silicon Errata Sheet

The PIC16C923 (Rev. A) parts you have received conform functionally to the Device Data Sheet (DS30444D), except for the anomalies described below.

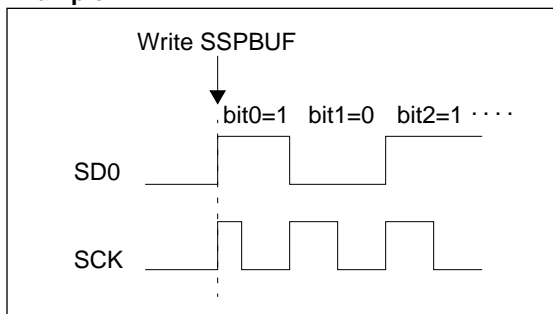
Example:

5. Module: SSP (SPI Mode)

When the SPI is using Timer2/2 as the clock source, a shorter-than-expected SCK pulse may occur on the first bit of the transmitted/received data.

Work Around

To avoid producing the short pulse, turn off Timer2 and clear the TMR2 register, load the SSPBUF with the data to transmit, and then turn Timer2 back on.

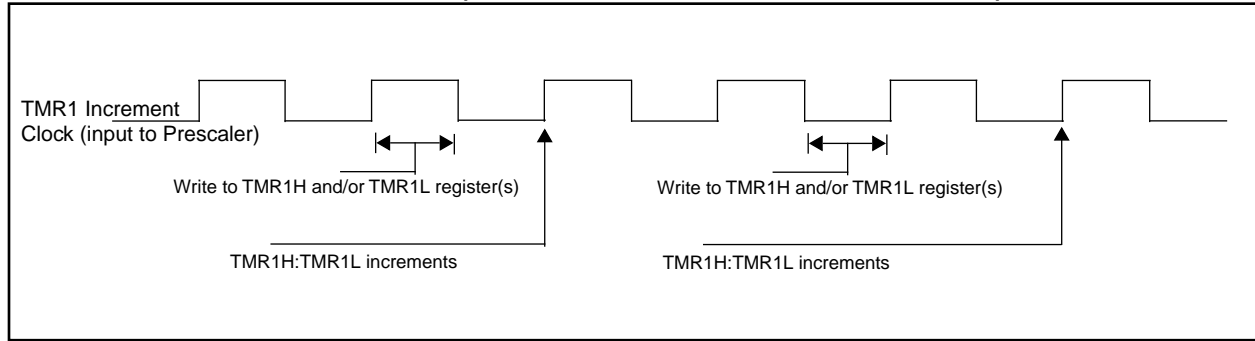
FIGURE 1: WRITES TO TIMER1 (EXTERNAL CLOCK / OSCILLATOR MODE)

- a) The operation of Timer1 needs some clarification when the timer registers are written when the TMR1ON bit is set.

The internal clock signal that is the input to the TMR1 prescaler affects the incrementing of Timer1 (TMR1H:TMR1L registers and the Timer1 prescaler). When the Timer1 registers are NOT written, the Timer1 will increment on the rising edge of the TMR1 increment clock.

When the TMR1H and/or TMR1L registers are written while this clock is high, TMR1 will increment on the next rising edge of this clock.

When the TMR1H and/or TMR1L registers are written while this clock is low, TMR1 will not increment on the next rising edge of this clock, but must first have a falling clock and the the rising clock for TMR1 to increment.

Figure 1 shows the two cases of writes to the TMR1H and/or TMR1L registers. Due to the V_{IH} and V_{IL} thresholds on the oscillator/clock pins, external Timer1 oscillator components, and external clock frequency, the Timer1 increment clock may not be of a 50% duty cycle.

The TMR1 increment clock is out of phase of the T1OSO/T1CKI pin by a small propagation delay.
