## PIC16CR62 Rev. A Silicon Errata Sheet

The PIC16CR62 (Rev. A) parts you have received conform functionally to the Device Data Sheet (DS30234D), except for the anomalies described below.

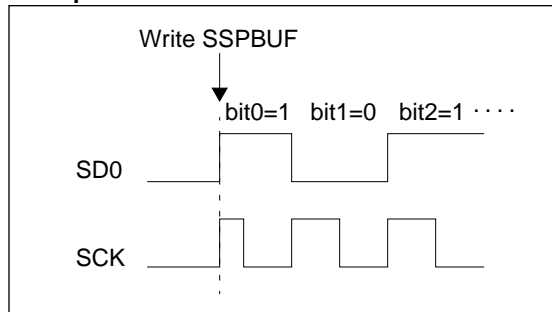
### Example:

## 4. Module: SSP (SPI Mode)

When the SPI is using Timer2/2 as the clock source, a shorter-than-expected SCK pulse may occur on the first bit of the transmitted/received data.

To avoid producing the short pulse, turn off Timer2 and clear the TMR2 register, load the SSPBUF with the data to transmit, and then turn Timer2 back on.

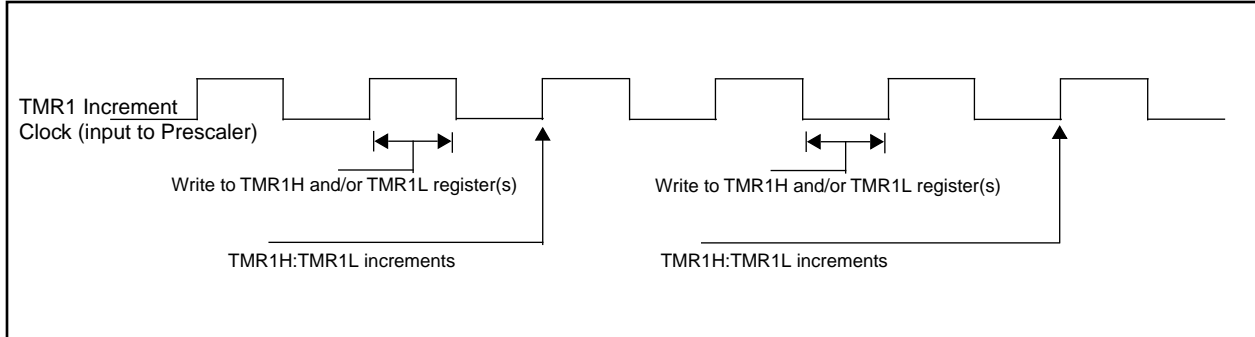
**FIGURE 1: WRITES TO TIMER1 (EXTERNAL CLOCK / OSCILLATOR MODE)**

- a) The operation of Timer1 needs some clarification when the timer registers are written when the TMR1ON bit is set.

The internal clock signal that is the input to the TMR1 prescaler affects the incrementing of Timer1 (TMR1H:TMR1L registers and the Timer1 prescaler). When the Timer1 registers are NOT written, the Timer1 will increment on the rising edge of the TMR1 increment clock.

When the TMR1H and/or TMR1L registers are written while this clock is high, TMR1 will increment on the next rising edge of this clock.

When the TMR1H and/or TMR1L registers are written while this clock is low, TMR1 will not increment on the next rising edge of this clock, but must first have a falling clock and then the rising clock for TMR1 to increment.

Figure 1 shows the two cases of writes to the TMR1H and/or TMR1L registers. Due to the  $V_{IH}$  and  $V_{IL}$  thresholds on the oscillator/clock pins, external

Timer1 oscillator components, and external clock frequency, the Timer1 increment clock may not be of a 50% duty cycle.

The TMR1 increment clock is out of phase of the T1OSO/T1CKI pin by a small propagation delay.
