PIC16CR64 Rev. A Silicon Errata Sheet

The PIC16CR64 (Rev. A) parts you have received conform functionally to the Device Data Sheet (DS30234D), except for the anomalies described below.

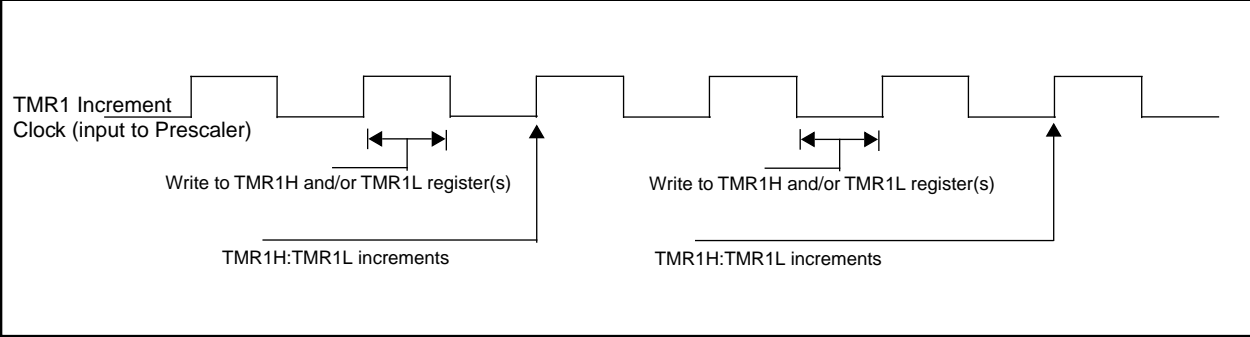
FIGURE 1: WRITES TO TIMER1 (EXTERNAL CLOCK / OSCILLATOR MODE)

- a) The operation of Timer1 needs some clarification when the timer registers are written when the TMR1ON bit is set.

The internal clock signal that is the input to the TMR1 prescaler affects the incrementing of Timer1 (TMR1H:TMR1L registers and the Timer1 prescaler). When the Timer1 registers are NOT written, the Timer1 will increment on the rising edge of the TMR1 increment clock.

When the TMR1H and/or TMR1L registers are written while this clock is high, TMR1 will increment on the next rising edge of this clock.

When the TMR1H and/or TMR1L registers are written while this clock is low, TMR1 will not increment on the next rising edge of this clock, but must first have a falling clock and then the rising clock for TMR1 to increment.

Figure 1 shows the two cases of writes to the TMR1H and/or TMR1L registers. Due to the V_{IH} and V_{IL} thresholds on the oscillator/clock pins, external Timer1 oscillator components, and external clock frequency, the Timer1 increment clock may not be of a 50% duty cycle.

The TMR1 increment clock is out of phase of the T1OSO/T1CKI pin by a small propagation delay.
