SB-101 AVC Slow Recovery After Transmit

The Problem and Solution

{ by WA2HIP }

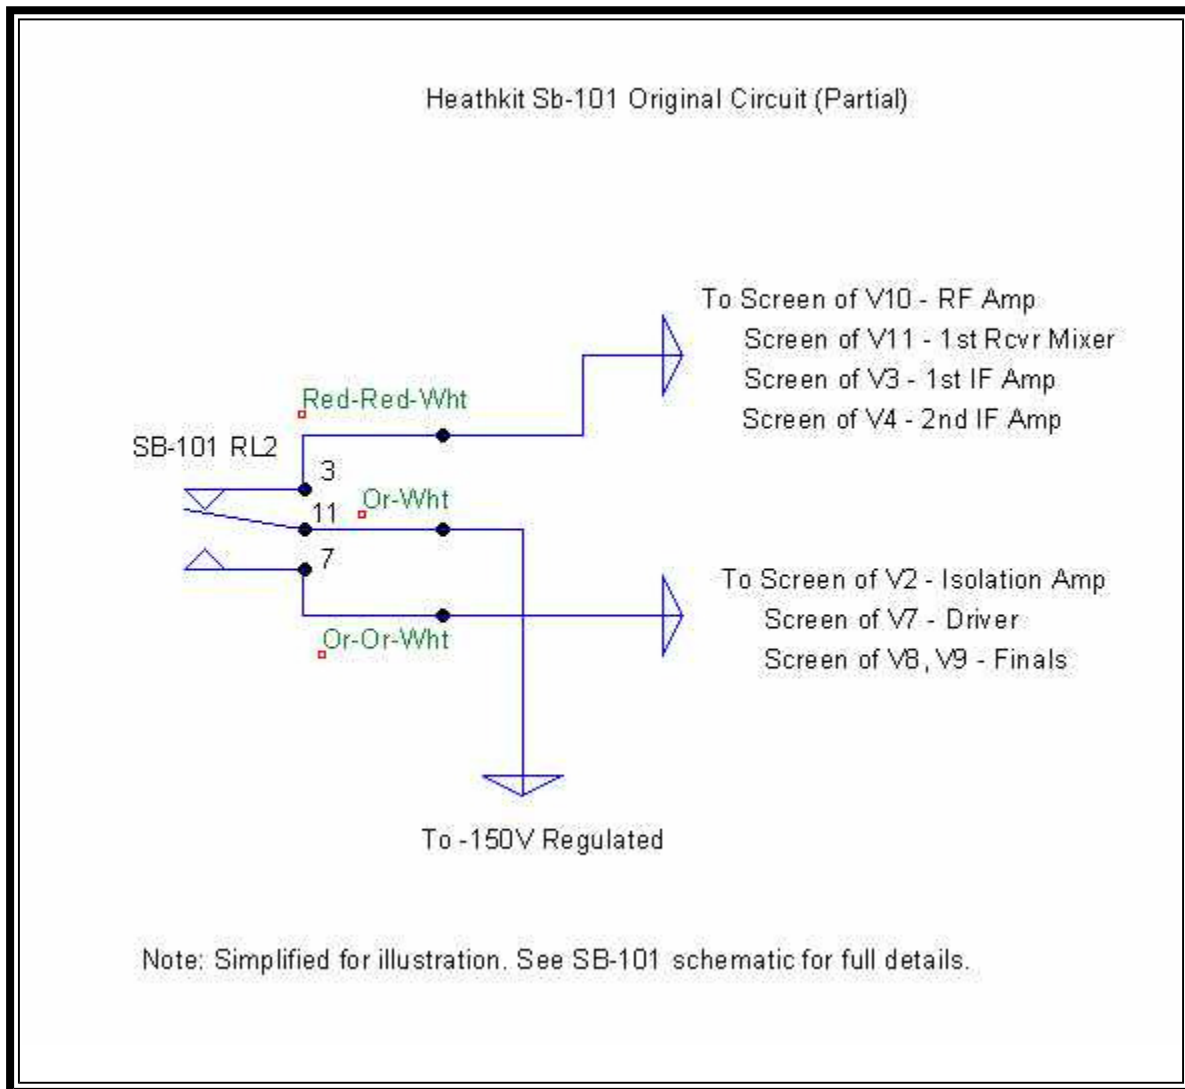
Below are diagrams of the original circuit (simplified) and the upgrade & fixes.

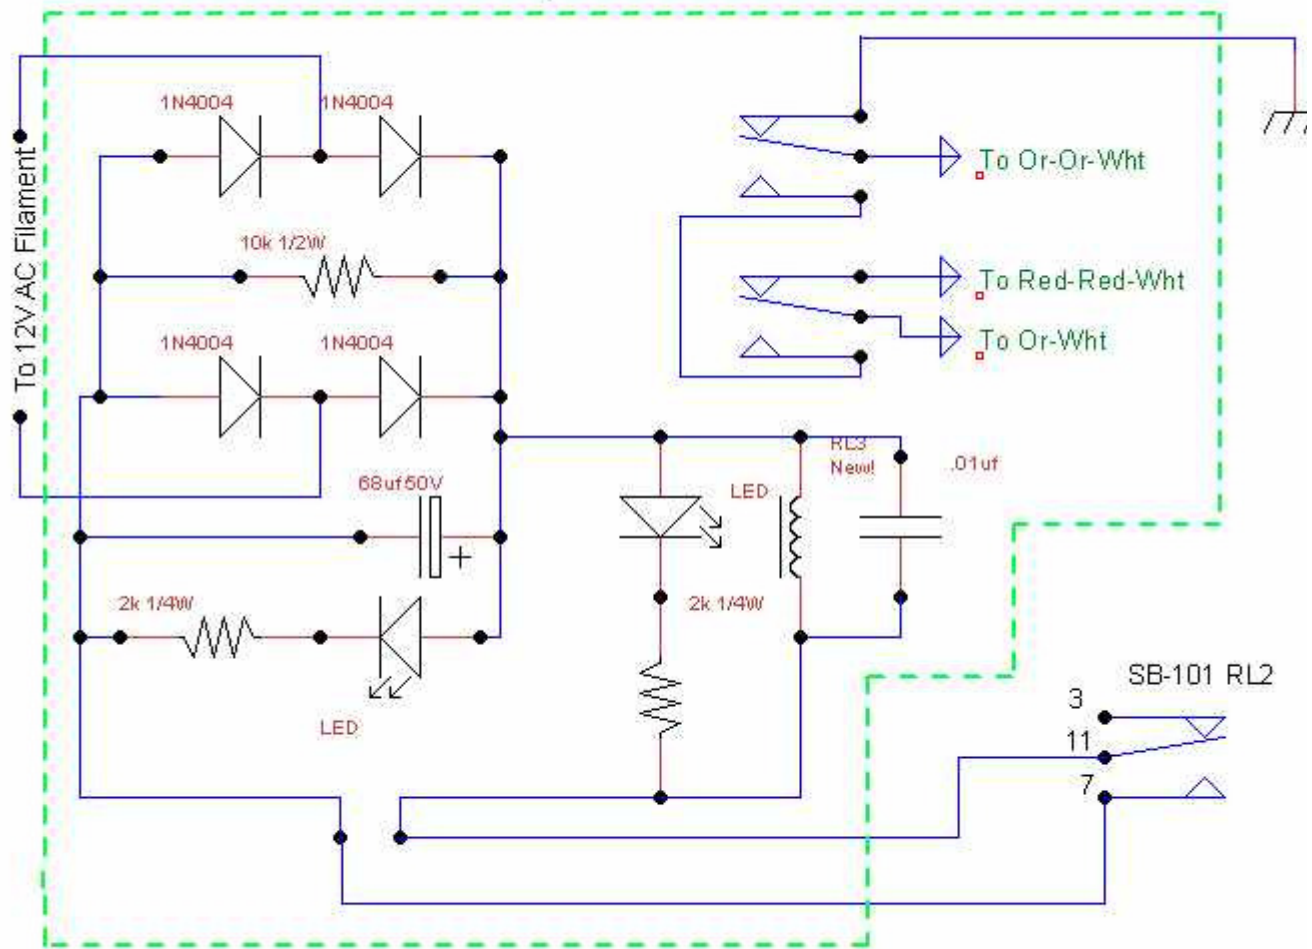
Heathkit Sb-101 Revision for AVC Hang Problem
by WA2HIP

Note that the LED's are just "fluff" an may be eliminated.

The solution is rather simple now. Add a relay to ground the screens of the 6146's during receive. Note that I did CAREFULLY wire in a switch to manually simulate this grounding action and the problem was eliminated.

I installed a new DPDT 12 volt relay in the rig on and moved the connections from lugs 3, 7, & 11 to

this new relay. I used the NO (normally open) contacts (lugs 7 & 11) of the existing relay to energize the new relay.
