Technical Service Bulletin No. 23

Created by: Lab.gruppen AB Service Department

Reference no: Measure for broken NTC in DC/DC on SP200PCF

PLM20000Q

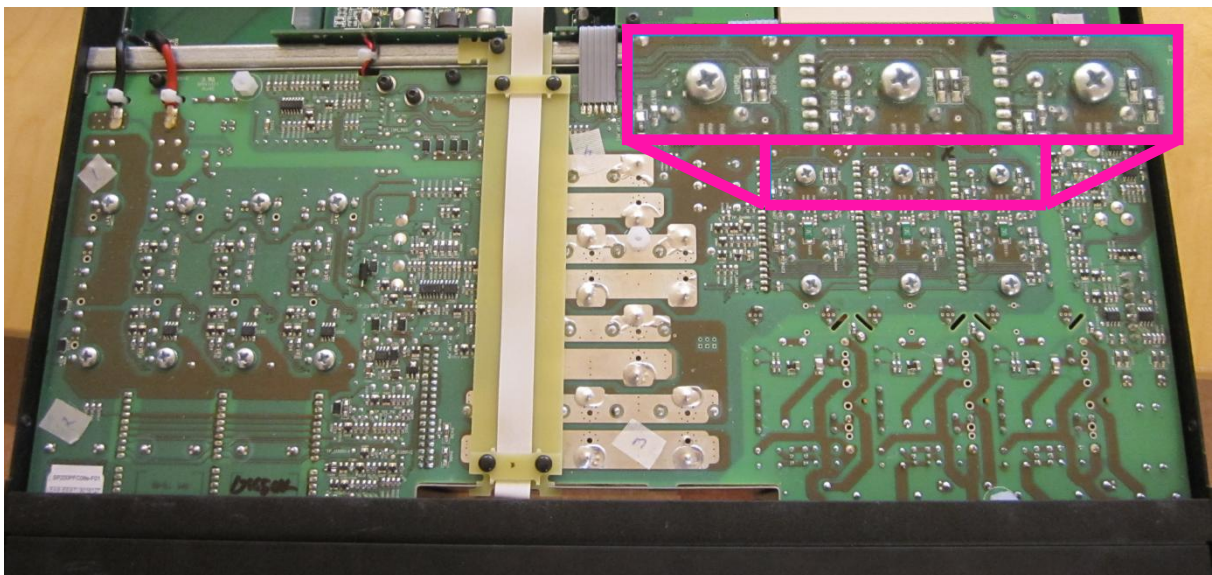
5.	At room temperature, Ohm measure; NTC601, NTC702, NTC802	~18kOhm to ~20kOhm	
----	--	-----------------------	--

6.	If any of NTC601, NTC702, NTC802 does not pass ~18-20kOhm at room temperature, this NTC needs to be exchanged.		
----	---	--	--

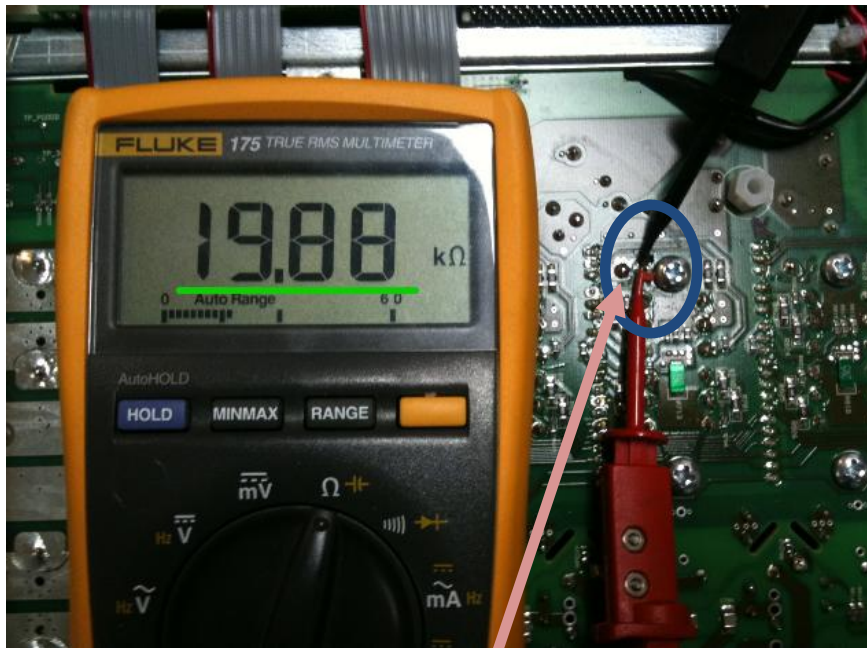
Overview SP200 of which region of the board.
