si 881219-14 e

Ref.: EM 2003 TV

Fault: 50 Hz hum when the EM 2003 TV receives an RF-carrier without modulation.

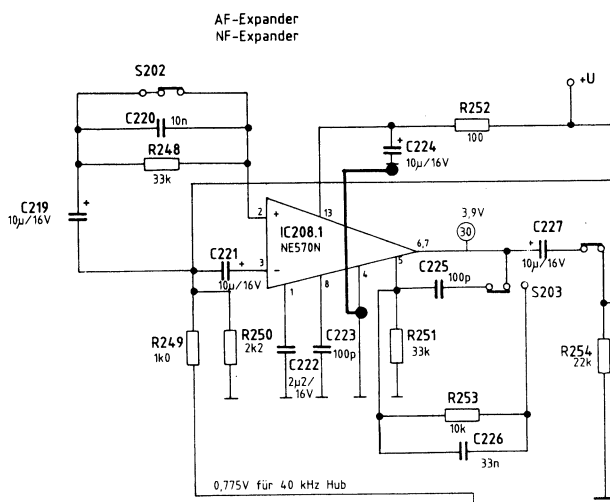
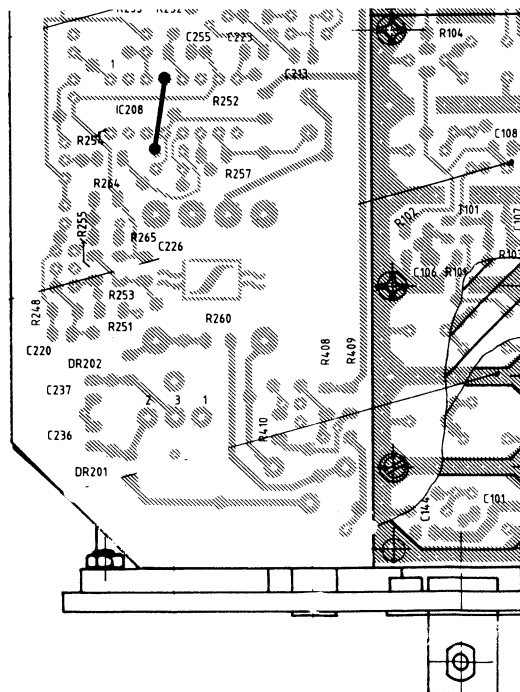
Cause: Insufficient ground connection at HiDyn-IC

Remedy: Connect ground connection of IC 208.1 to ground connection of IC 224. This will reduce the hum by 6 dB.

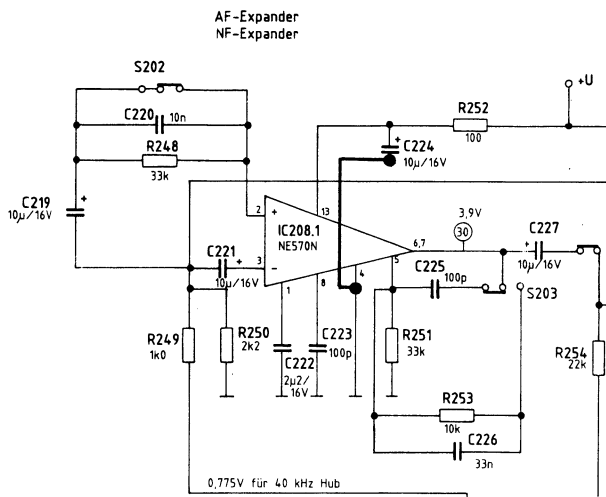
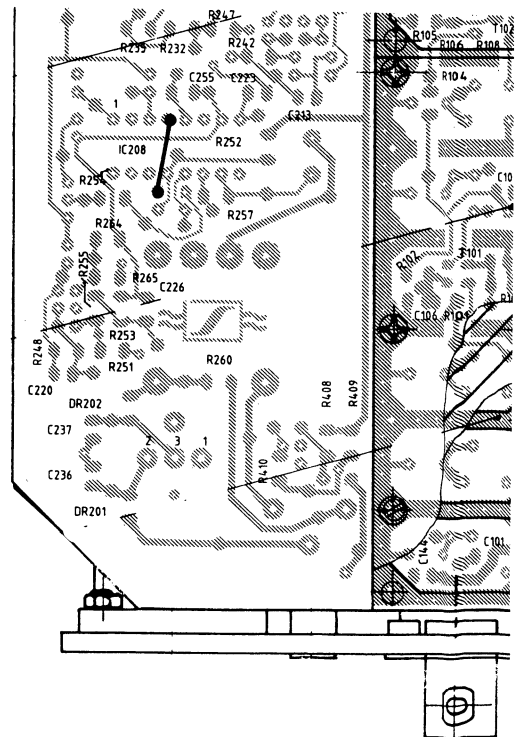
- Betr.:** EM 2003 TV
- Fehler:** 50 Hz-Brummen bei Empfang eines unmodulierten HF-Trägers
- Ursache:** Unzureichende Masseverbindung am HiDyn-IC
- Abhilfe:** Massebrücke zwischen C 224 und Pin 4 / IC 208.1 auf Lötseite einbauen. Dadurch wird eine Verringerung des Brummens um 6 dB erreicht.
