# Service Technical Information

MODEL NO. CSD-A310 / TD31 / TD32 / TD33 / TD41 / TD42 CA-DW237 / DW247 / DW257 / DW537
SUBJECT Frictional noise is produced when the CD lid is closed

REF.No. :G - A0 - 041 - E0

DATE :31. AUG. 2000

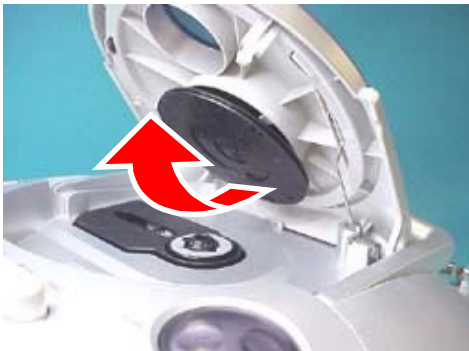
Fig-1

Please take the following countermeasure when there is a complaint that "frictional noise is produced when the lid CD is closed".

1. Remove the chuck part from the CD lid.  
(Remove from the rear side as shown in Fig-1.)
2. Release the hooks at three locations, and then remove the HLDR CHUCK.  
(See Fig-2 and 3)
3. Mount the new HLDR CHUCK ASSY (replacement part).  
Make sure that the hooks at all three locations are engaged.
4. Mount the chuck part to the CD lid.
