# Service Technical Information

MODEL NO. XP-R210/SP910/SP911/V713/V714/V715J/V716C/V510/V511 V512/V513/V514/V516C/V410/V411/V412/V416C/SR311
SUBJECT Change of the PICK UP Mechanism

REF.No. :G - A0 - 059 - E0

DATE :06. SEP. 2000

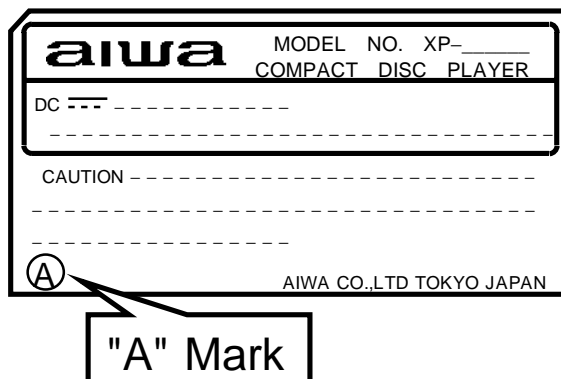
Example:

Identifying new PICK UP Mechanism :

- A new type of PICK UP Mechanism will be mounted on a product carrying an "(A)" indication on the SPEC LABEL.

- Check the SPEC LABEL for the suitable Service Manual.
- No change has been made in the CD TEST MODE.
