1. Planning Information

This Service Bulletin applies to all Avidyne FlightMax 800 units with the following hardware part number:

Part Number	Rev.
D98-00001-58-G	03

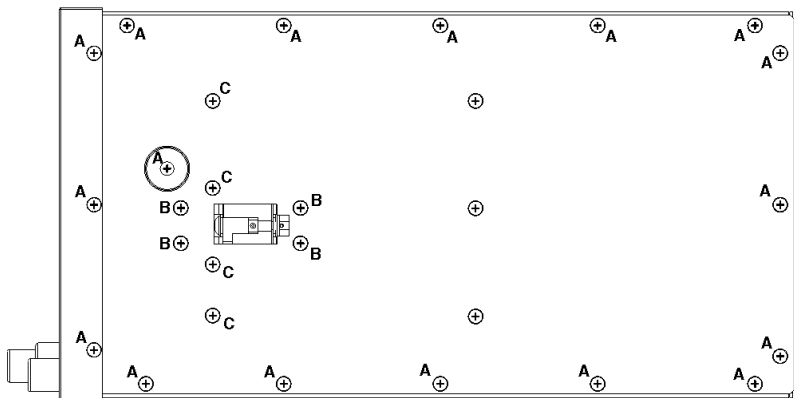
It was discovered that on some installations, the latch mechanism was not keeping tension on the unit, allowing it to freely slide out of position. A revised latch mechanism fixes the problem.

3. Remove the ribbon cable from the memory device.
4. Remove the 4 screws marked "B" which secures the latch mechanism to the lid.
5. The 4 screws marked "C" may need to be removed to allow the completion of step 6.

6. Position the new latch mechanism in place, and re-secure with 4 screws in the locations marked "B." Torque should be 5.0 – 5.5 in lb. Check that the head of the socket-head screw (part of the latch mechanism assembly) faces the front of the unit (towards the display).
