Service Bulletin #: SB16

Title: Sensor Interface Unit (SIU) CHT Recalibration

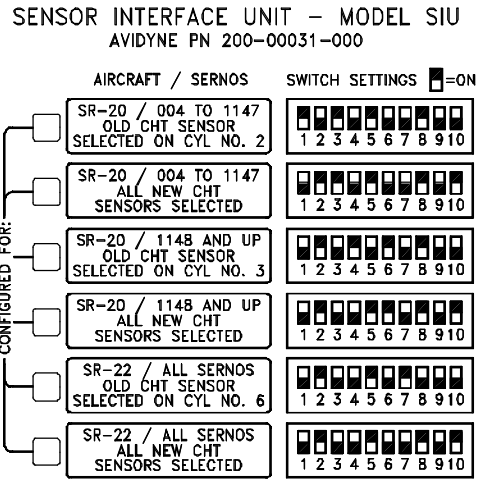
No Mod Applied

Note that there are no Mod Status blocks appearing below the "Avidyne PN" line.

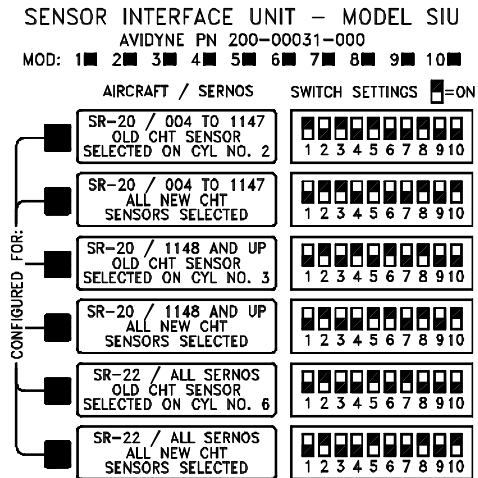
Numbered Mods Applied

Note the "Mod. Blocks" appearing below the "Avidyne PN" line. All modifications are indicated by a mark in the corresponding "Mod. Block."
