SERVICE NOTES

B&W MODEL 5100 TRANSMITTER

MODEL 5100 - SERVICE NOTES  
SUB-HARMONIC RADIATION

### MODIFICATION TO REDUCE BACKWAVE

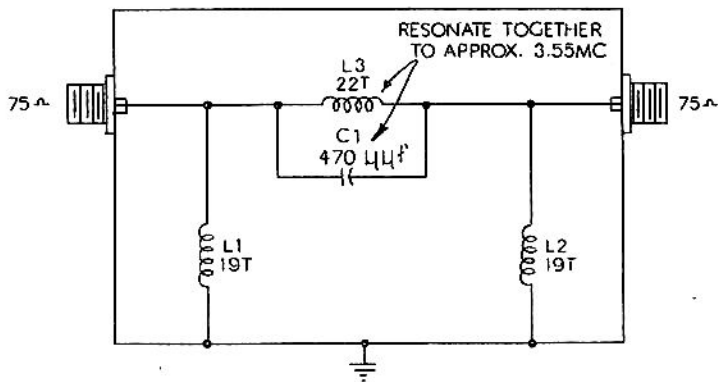
# FILTER NETWORK

Experience with the B&W Model 5100 Transmitter, based on reports from owners of these equipments using the popular "Windom" Multiband antenna, indicates that a few are experiencing 80 meter sub-harmonic radiation when operating on the 40 meter band.

(80 METER REJECTION FOR 40 METER OPERATION)

An adequate means of correcting the 40 meter sub-harmonic in troublesome cases, is the use of a High Pass Filter connected in series with the output of the transmitter.

A circuit diagram of an easily constructed and effective High Pass Filter is attached. It is understood that this filter must be removed from the feed line circuit when operating on 80 meters, but it may be left in the circuit when operating on any of the other bands. Its use will provide at least 25 D.B. attenuation of the 40 meter sub-harmonic.

- 1 ALL COILS ARE MODIFIED #3011 MININDUCTORS
- 2 CAPACITOR IS 2500V, TRANSMITTING TYPE
- 3 FOR BEST RESULTS, ASSEMBLY SHOULD BE SHIELDED
- 4 MAY BE LEFT IN TRANSMISSION LINE FOR ALL BANDS EXCEPT 80 METERS

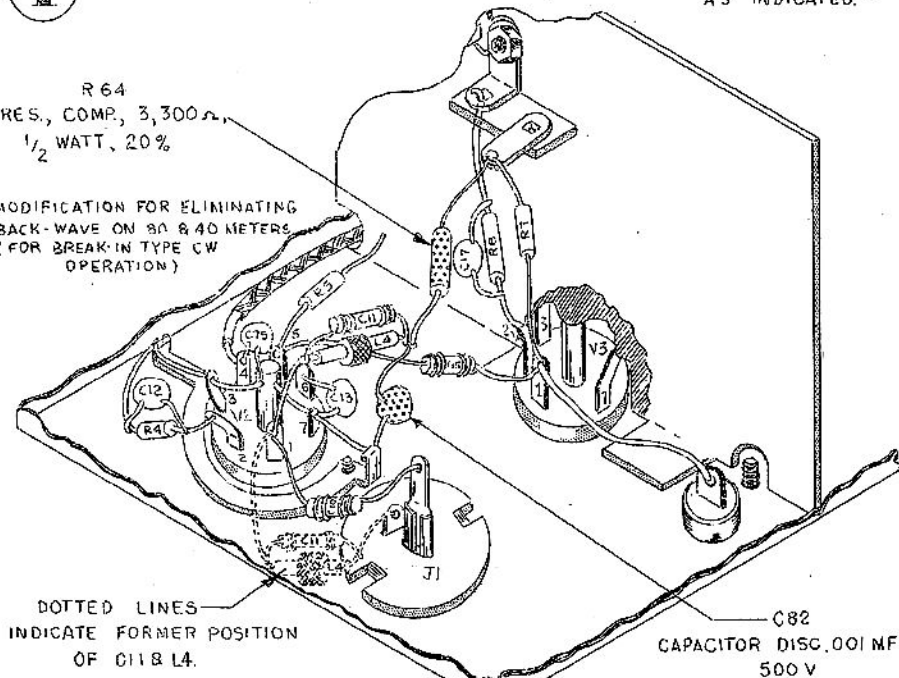
PARTIAL WIRING DIAGRAM  
BUFFER-XTAL OSC.

Under conditions of spot frequency operation on phone or break-in type C.W. where separate antennas are used for Receiving and Transmitting, back-wave from the VFO will be noticed. The degree of this interference is a matter dependent on the sensitivity of the Receiver and proximity of the Receiving and Transmitting Antennas with respect to each other as well as the strength of the received signal. This interference is evident on the 40 and 80 meter bands only.

MODIFICATION FOR ELIMINATING  
BACK-WAVE ON 80 & 40 METERS  
(FOR BREAK-IN TYPE CW  
OPERATION)

1. Remove the "Buffer-Xtal Osc." Unit from the Transmitter.
2. Remove bottom shield from the unit by removing the six screws on the sides.
3. Referring to the accompanying drawing, disconnect the parallel combination of L4 and C11 from the ground lug of J1, and connect and solder to junction of R64 and C82 as shown.
4. Connect and solder other end of C82 to ground lug as shown.
5. Connect and solder R64 and R7 as shown.

R64 & C82 TO BE ADDED  
CHANGE POSITION OF C11 & L4  
AS INDICATED.

R64  
RES., COMP, 3,300  $\Omega$ ,  
 $\frac{1}{2}$  WATT, 20%

DOTTED LINES  
INDICATE FORMER POSITION  
OF C11 & L4.

C82  
CAPACITOR DISC. 001 MF  
500 V

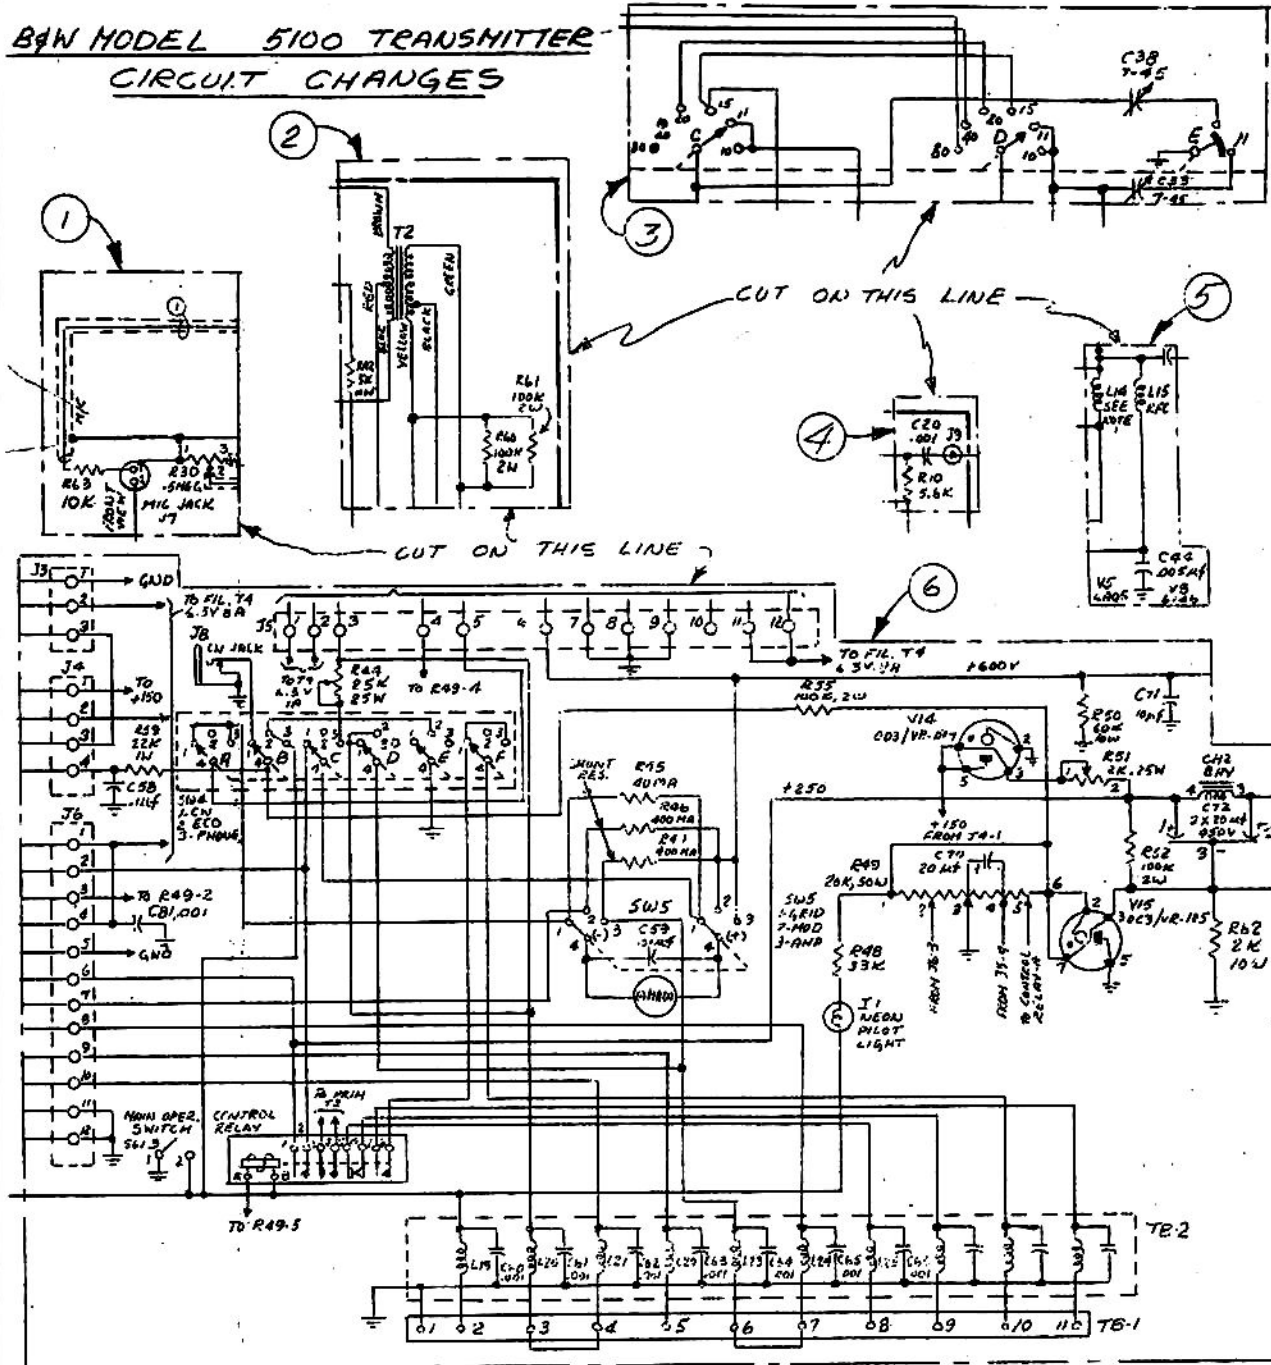
# B&W MODEL 5100 TRANSMITTER CIRCUIT CHANGES

SCHEMATIC ERRORS - See corrected circuits attached to these Service Notes.

NOTE:  
THESE CORRECTED CIRCUITS HAVE BEEN DRAWN TO SCALE, CUT OUT AS SHOWN AND PASTE ON INSTRUCTION MANUAL SCHEMATIC IN PROPER PLACES AS INDICATED BY CIRCLED NUMBERS (1)(2)(3)(4)(5)(6).

- PLACE MENT
- ① - MODULATOR (CIRCUIT OUTSIDE OF HEAVY LINE)
  - ② - MODULATOR (UPPER RIGHT HAND CORNER)
  - ③ - MULTIPLIER - FINAL AMP. (TOP CORNER OF SW)
  - ④ - BUFFER - XTAL OSCILLATOR (UPPER RIGHT)
  - ⑤ - MULTIPLIER - FINAL AMP. (LOWER RIGHT, ABOVE PH)
  - ⑥ - POWER SUPPLY
