Diagnosis of Vibration Problems in Holland

Case Studies from the Groenpol Vibration Consultancy

Matt o'Sullivan
Mechanical Engineer
Brüel and Kjær, Denmark

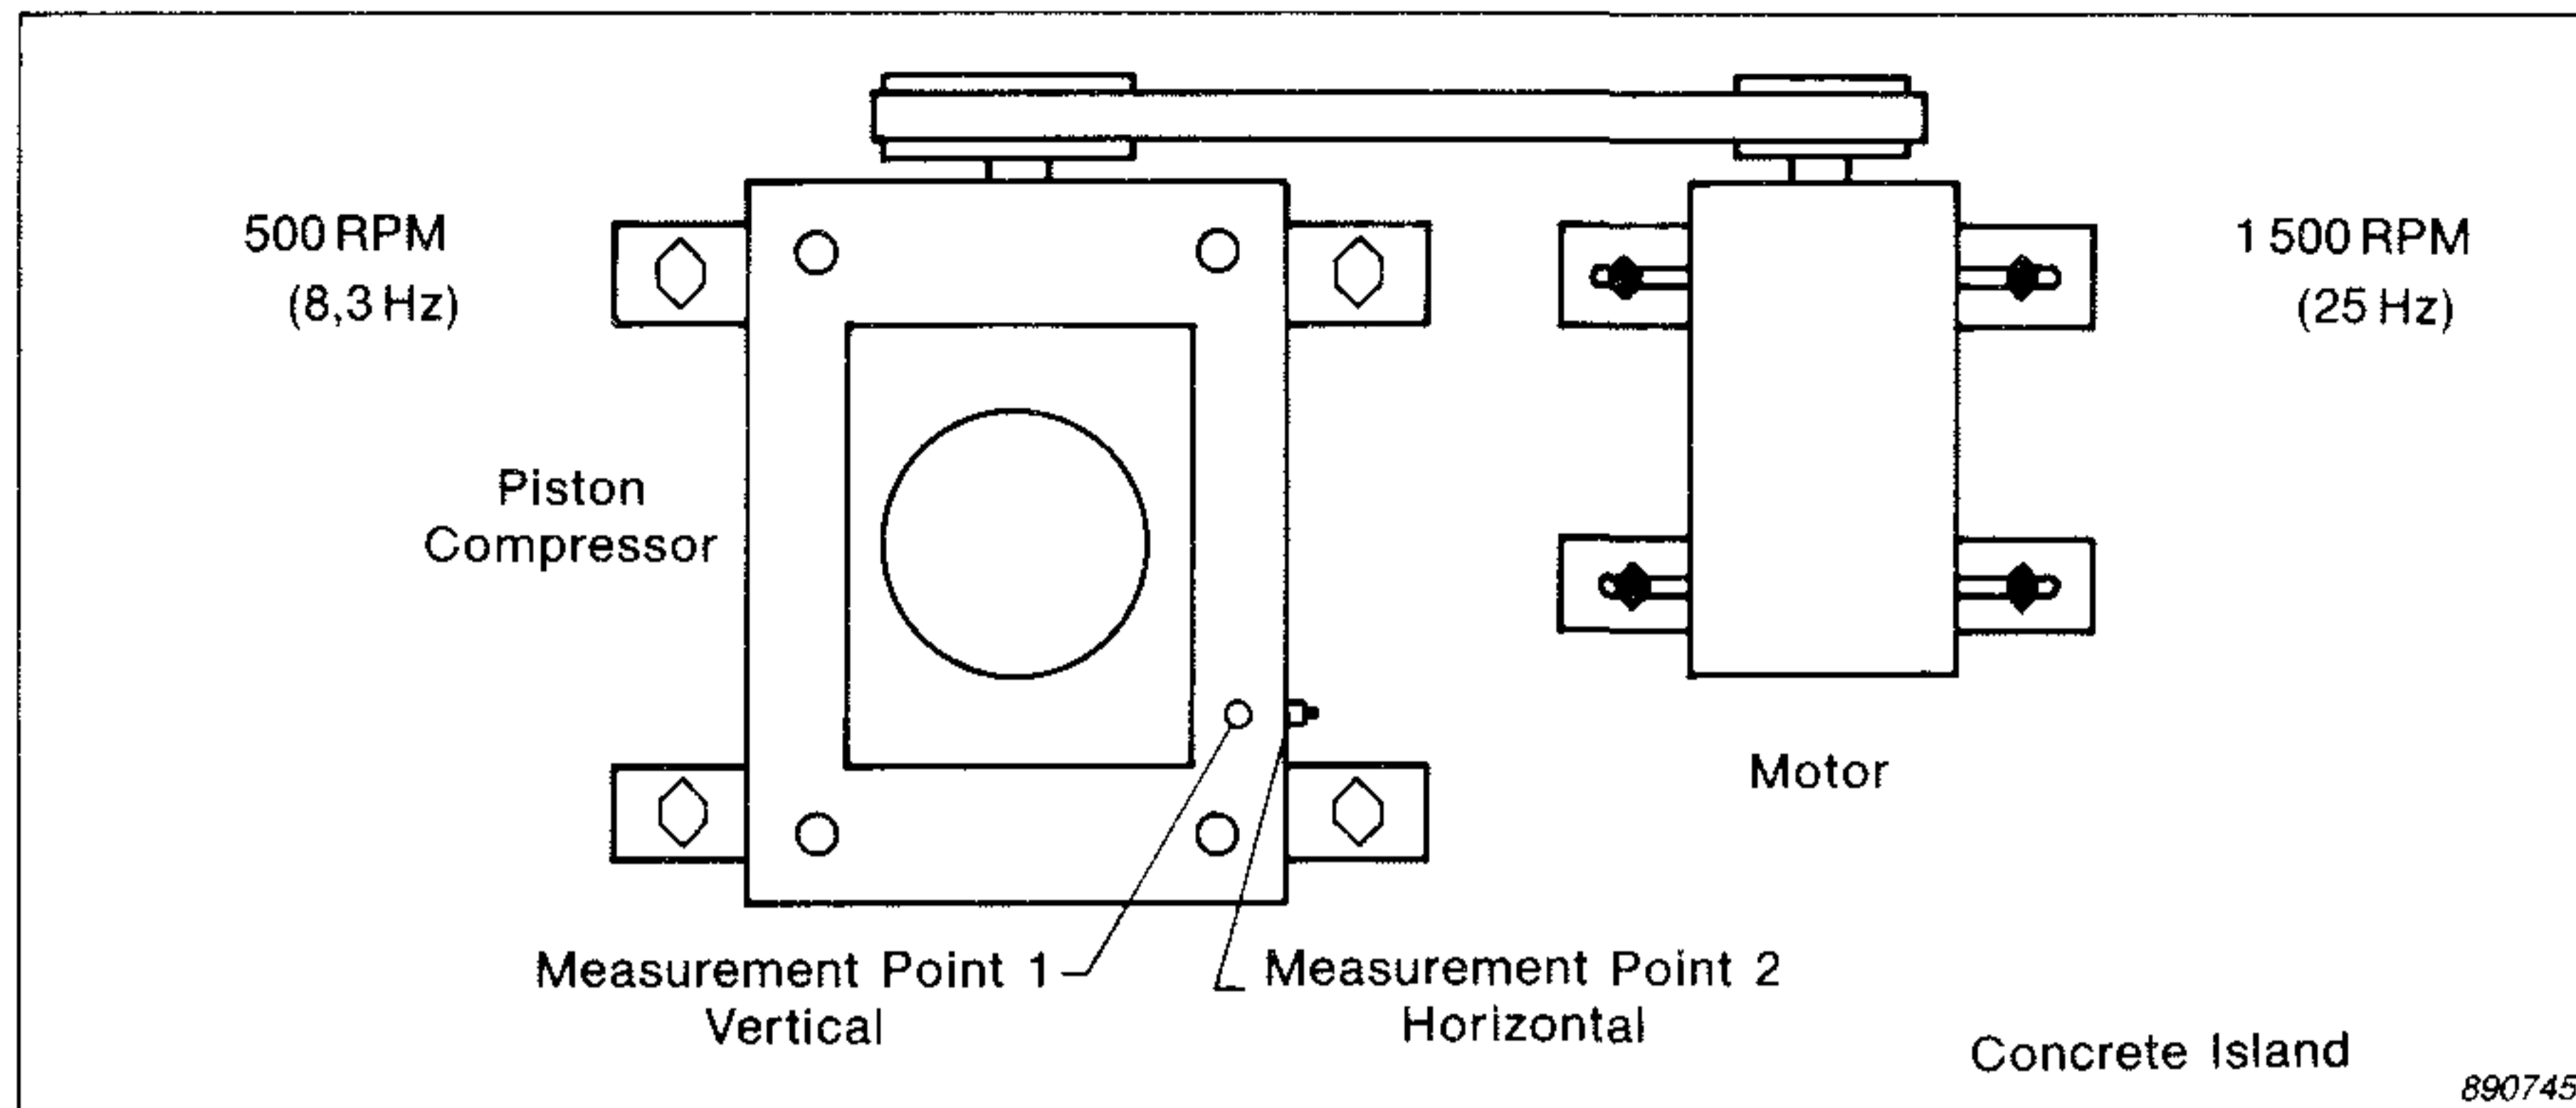
They measured the overall vibration levels, on all three compressors, at the points shown in Fig.1. For one machine the vertical ($12,8\text{mms}^{-1}$) was much higher than the horizontal ($4,4\text{mms}^{-1}$). This result suggested a foundation problem.

Fig. 1. A top view of the motor and compressor on the concrete island. The locations of the vertical and horizontal measurement points are indicated

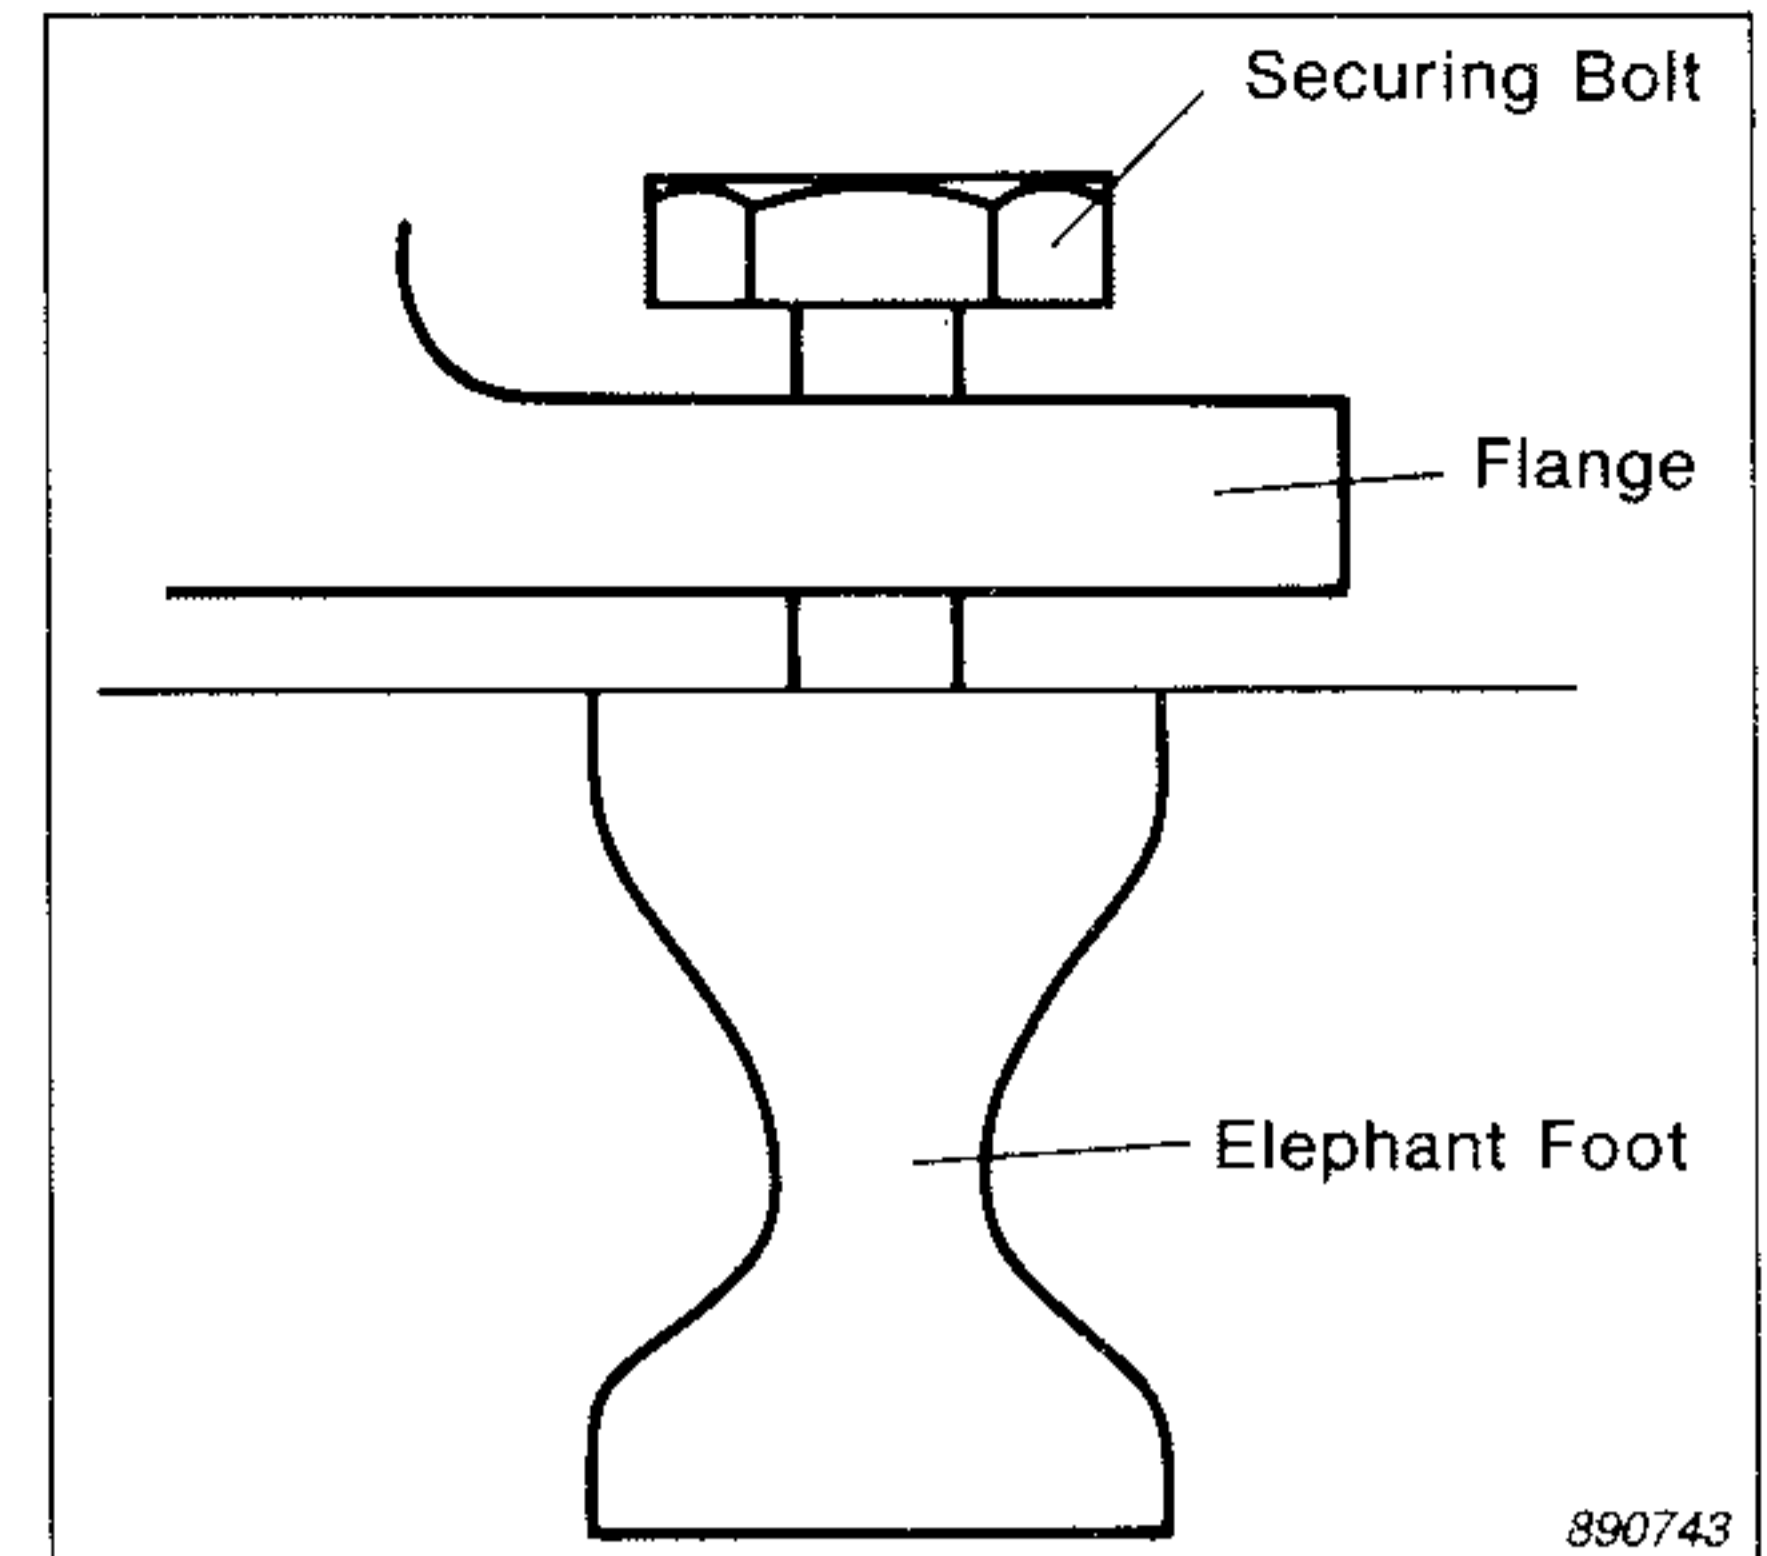
Fig. 2. A loose bolt, in its elephant foot, at the base of the non-driven end of the compressor. The casing is excited at the shaft rotation speed, causing a harmonic family of the shaft speed in the spectrum

They found two loose, worn bolts on the elephant feet at the non-driven end of the compressor, see Fig. 2. The company decided to wait until the next scheduled stop before replacing the bolts. After that, the machines would be ready for systematic monitoring.

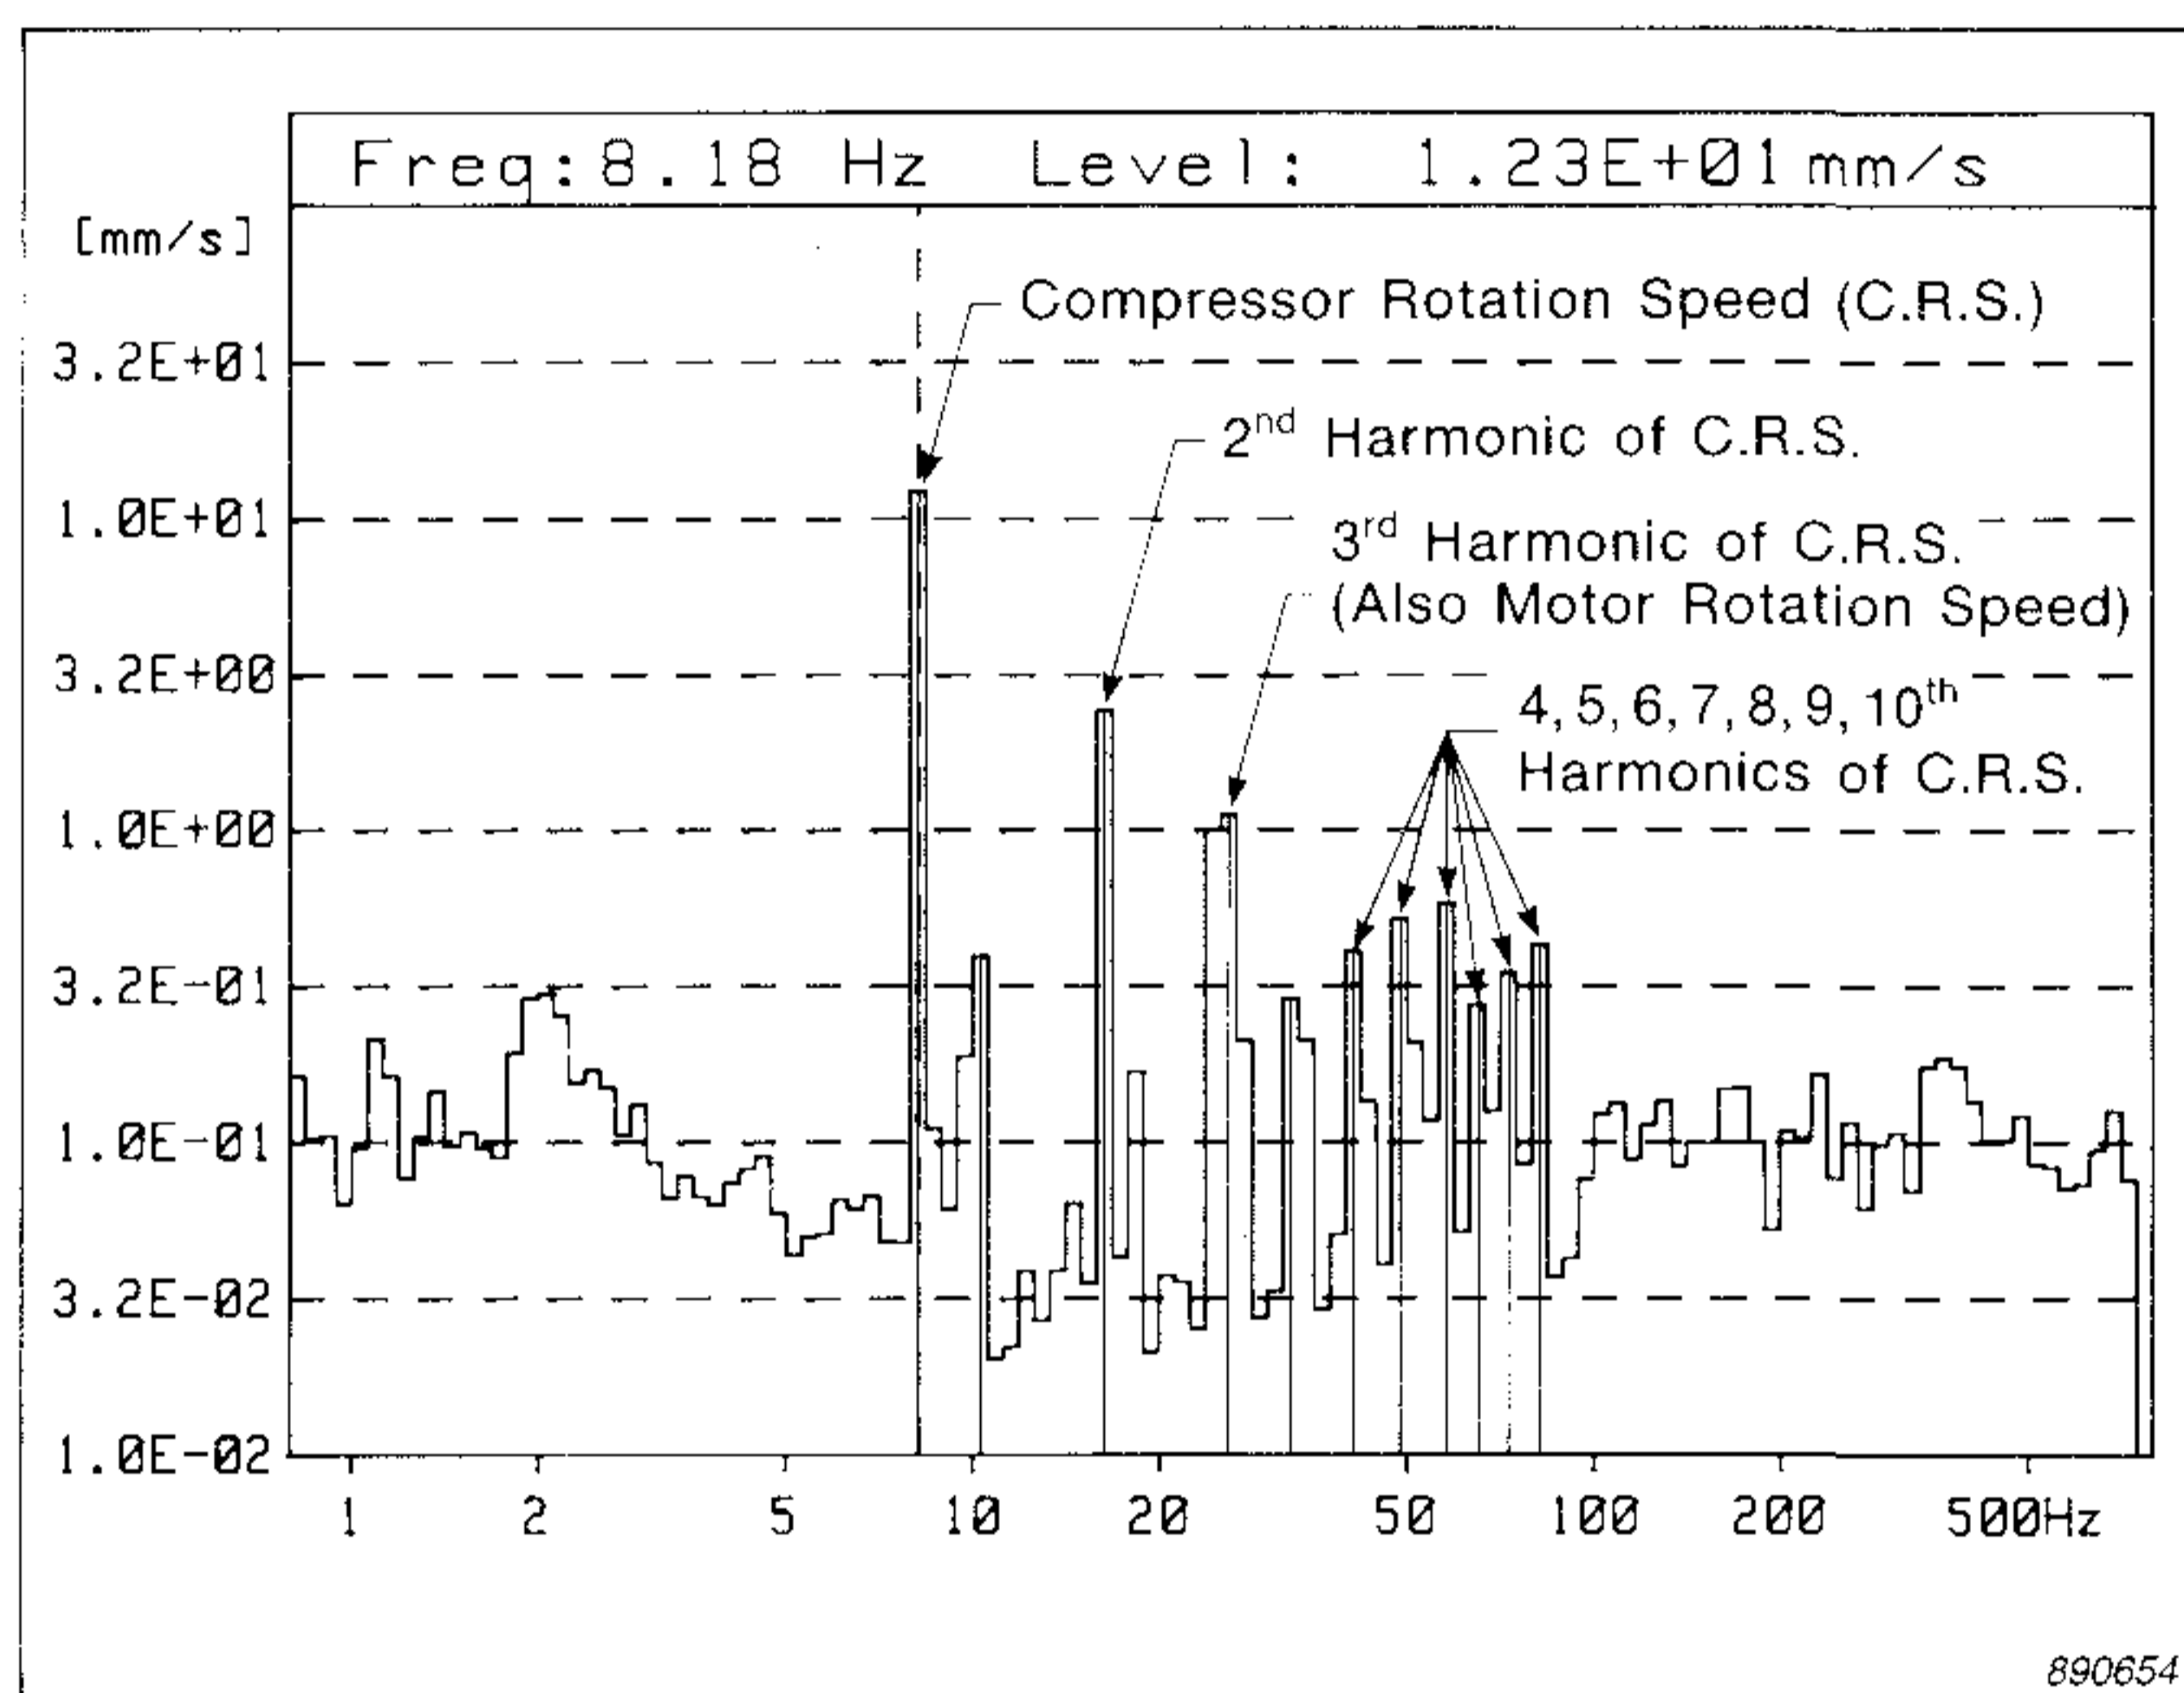
Fig. 3. A vertical measurement (500 Hz, CPB spectrum) from the compressor casing. The prominent harmonic family of the compressor rotation speed indicates looseness

The spectrum from the vertical measurement point is shown in Fig. 3. It contains a harmonic family of the rotation speed. They compared the vertical and horizontal spectra as shown in Fig. 4. The harmonic family in the vertical spectrum exceeds that in the horizontal spectrum, a result which indicates that the excessive vertical vibration is caused by mechanical looseness. Groenpol decided to check the bolts securing the compressor to its foundation.

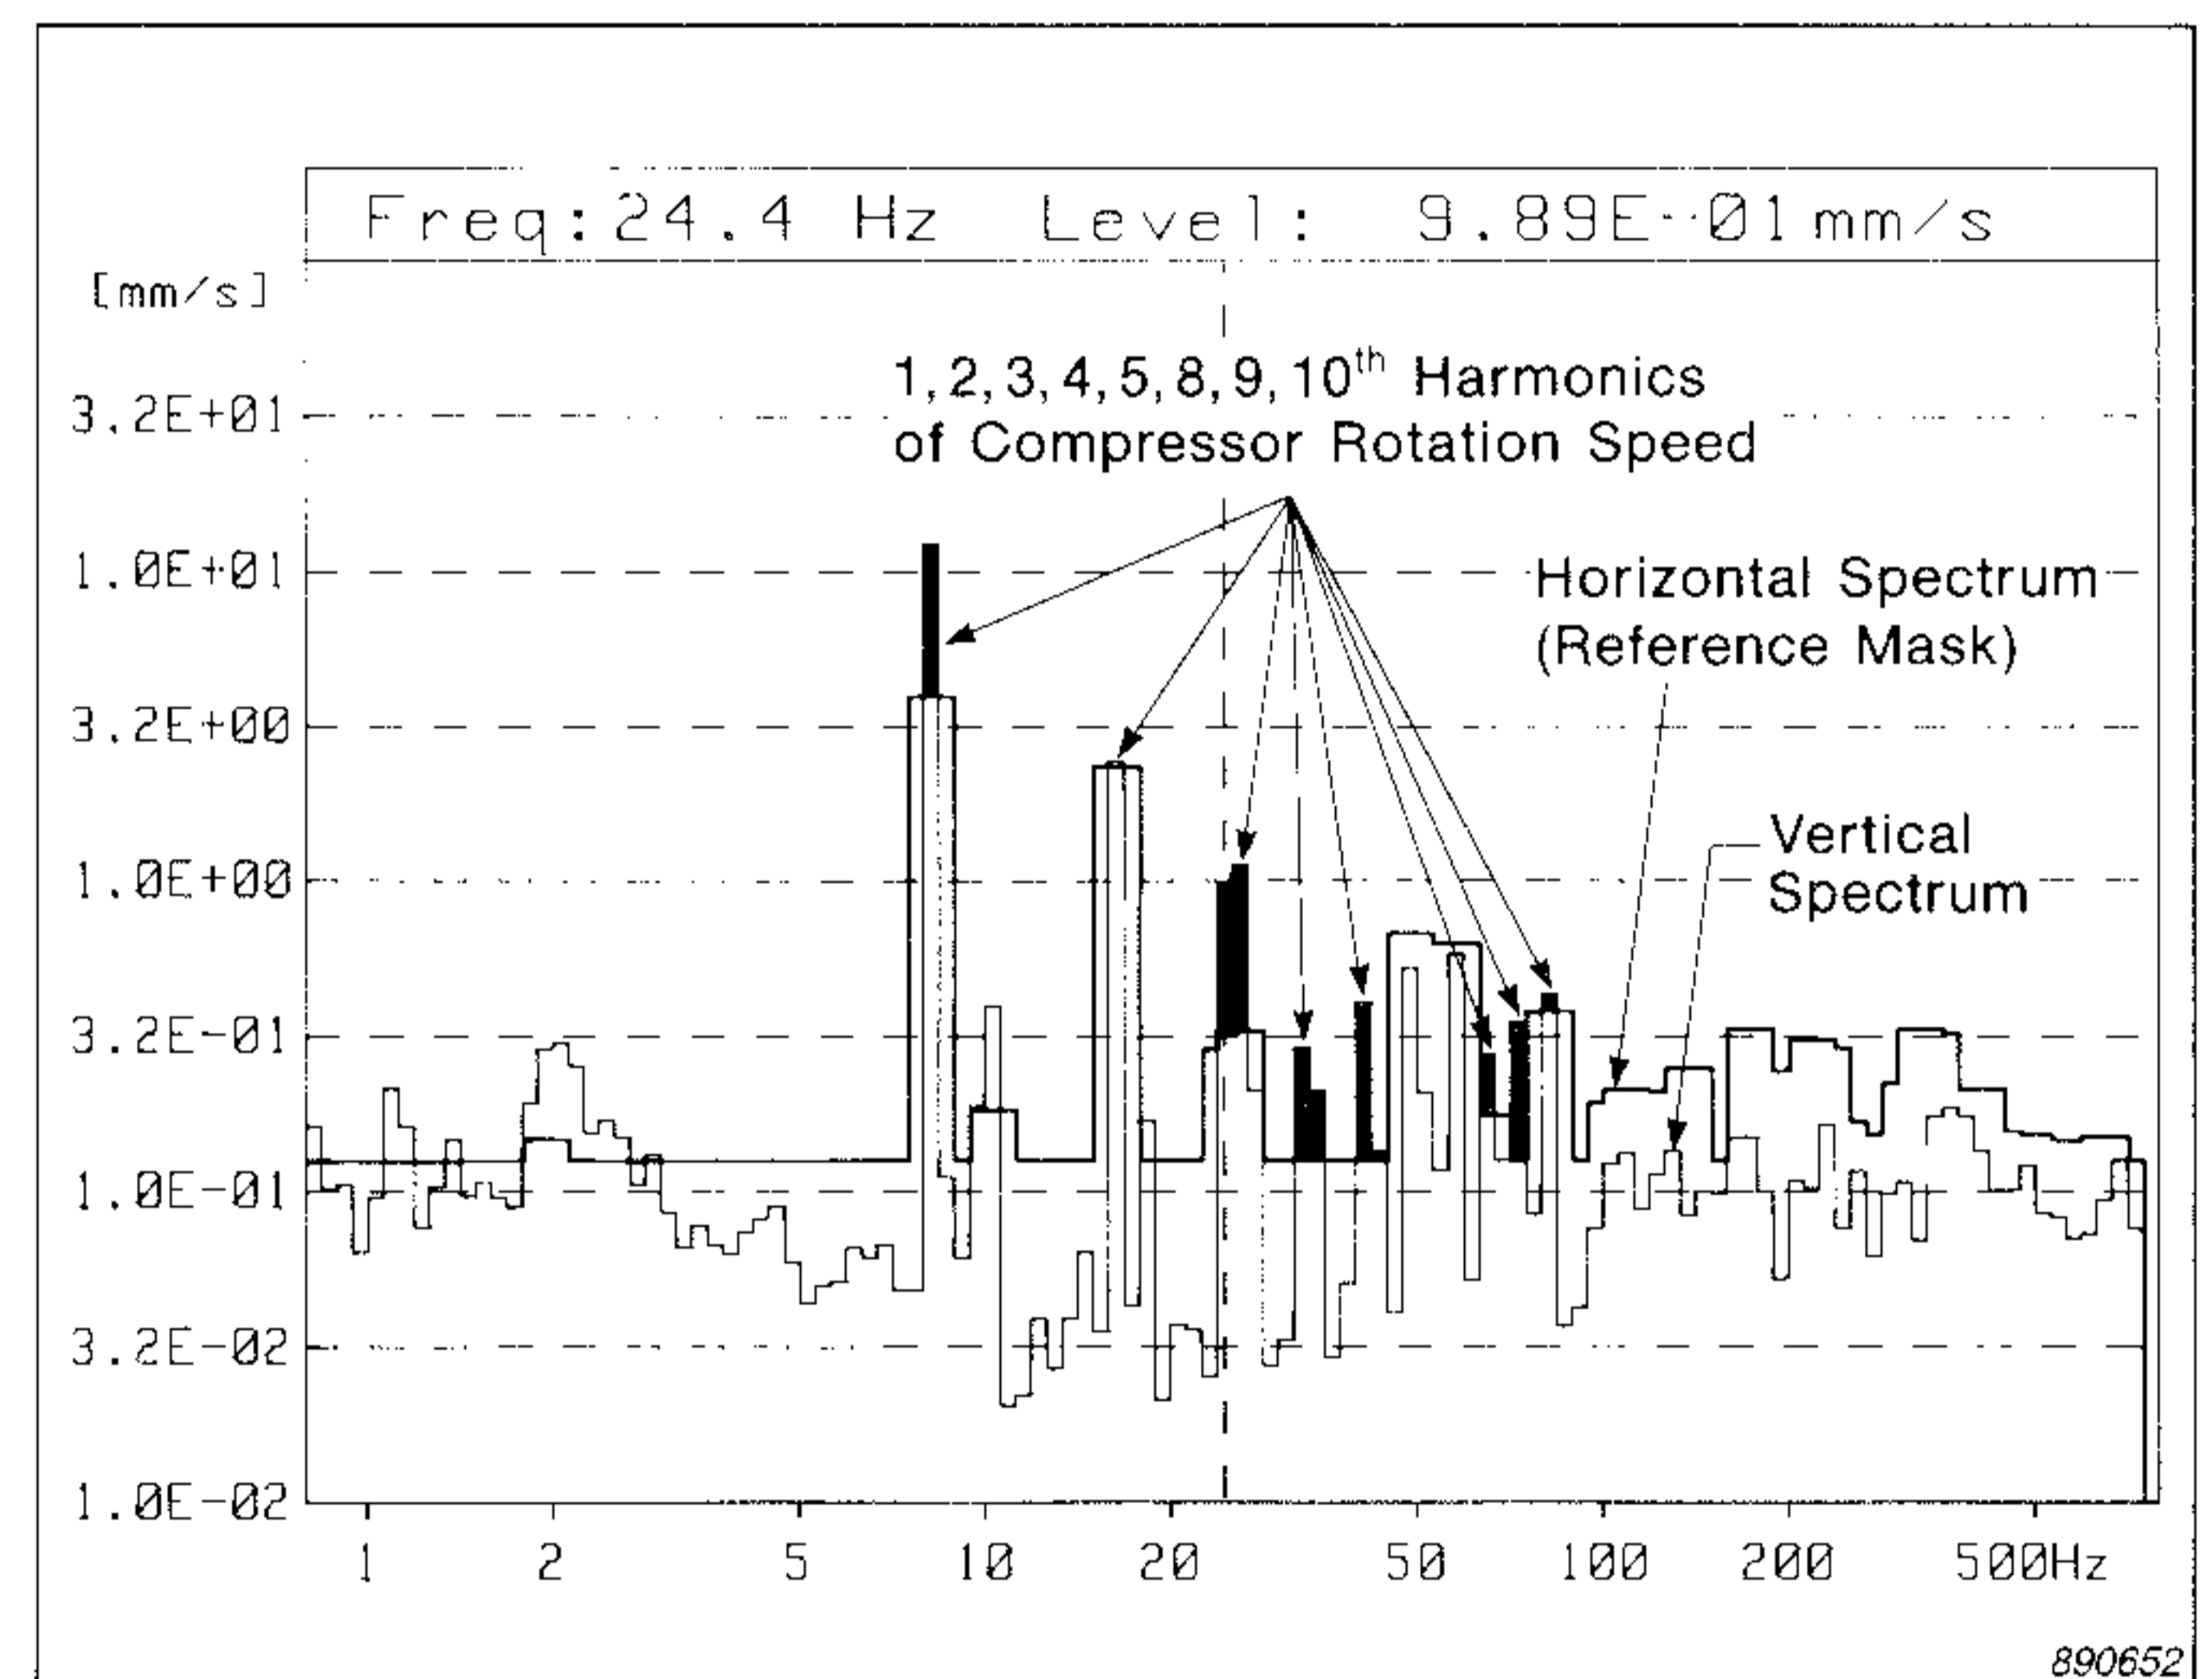
Fig. 4. A comparison of vertical and horizontal measurements (500 Hz, CPB spectra) from the compressor casing. The horizontal measurement is the reference. Note that the vertical exceeds the horizontal at harmonics of the compressor rotation speed

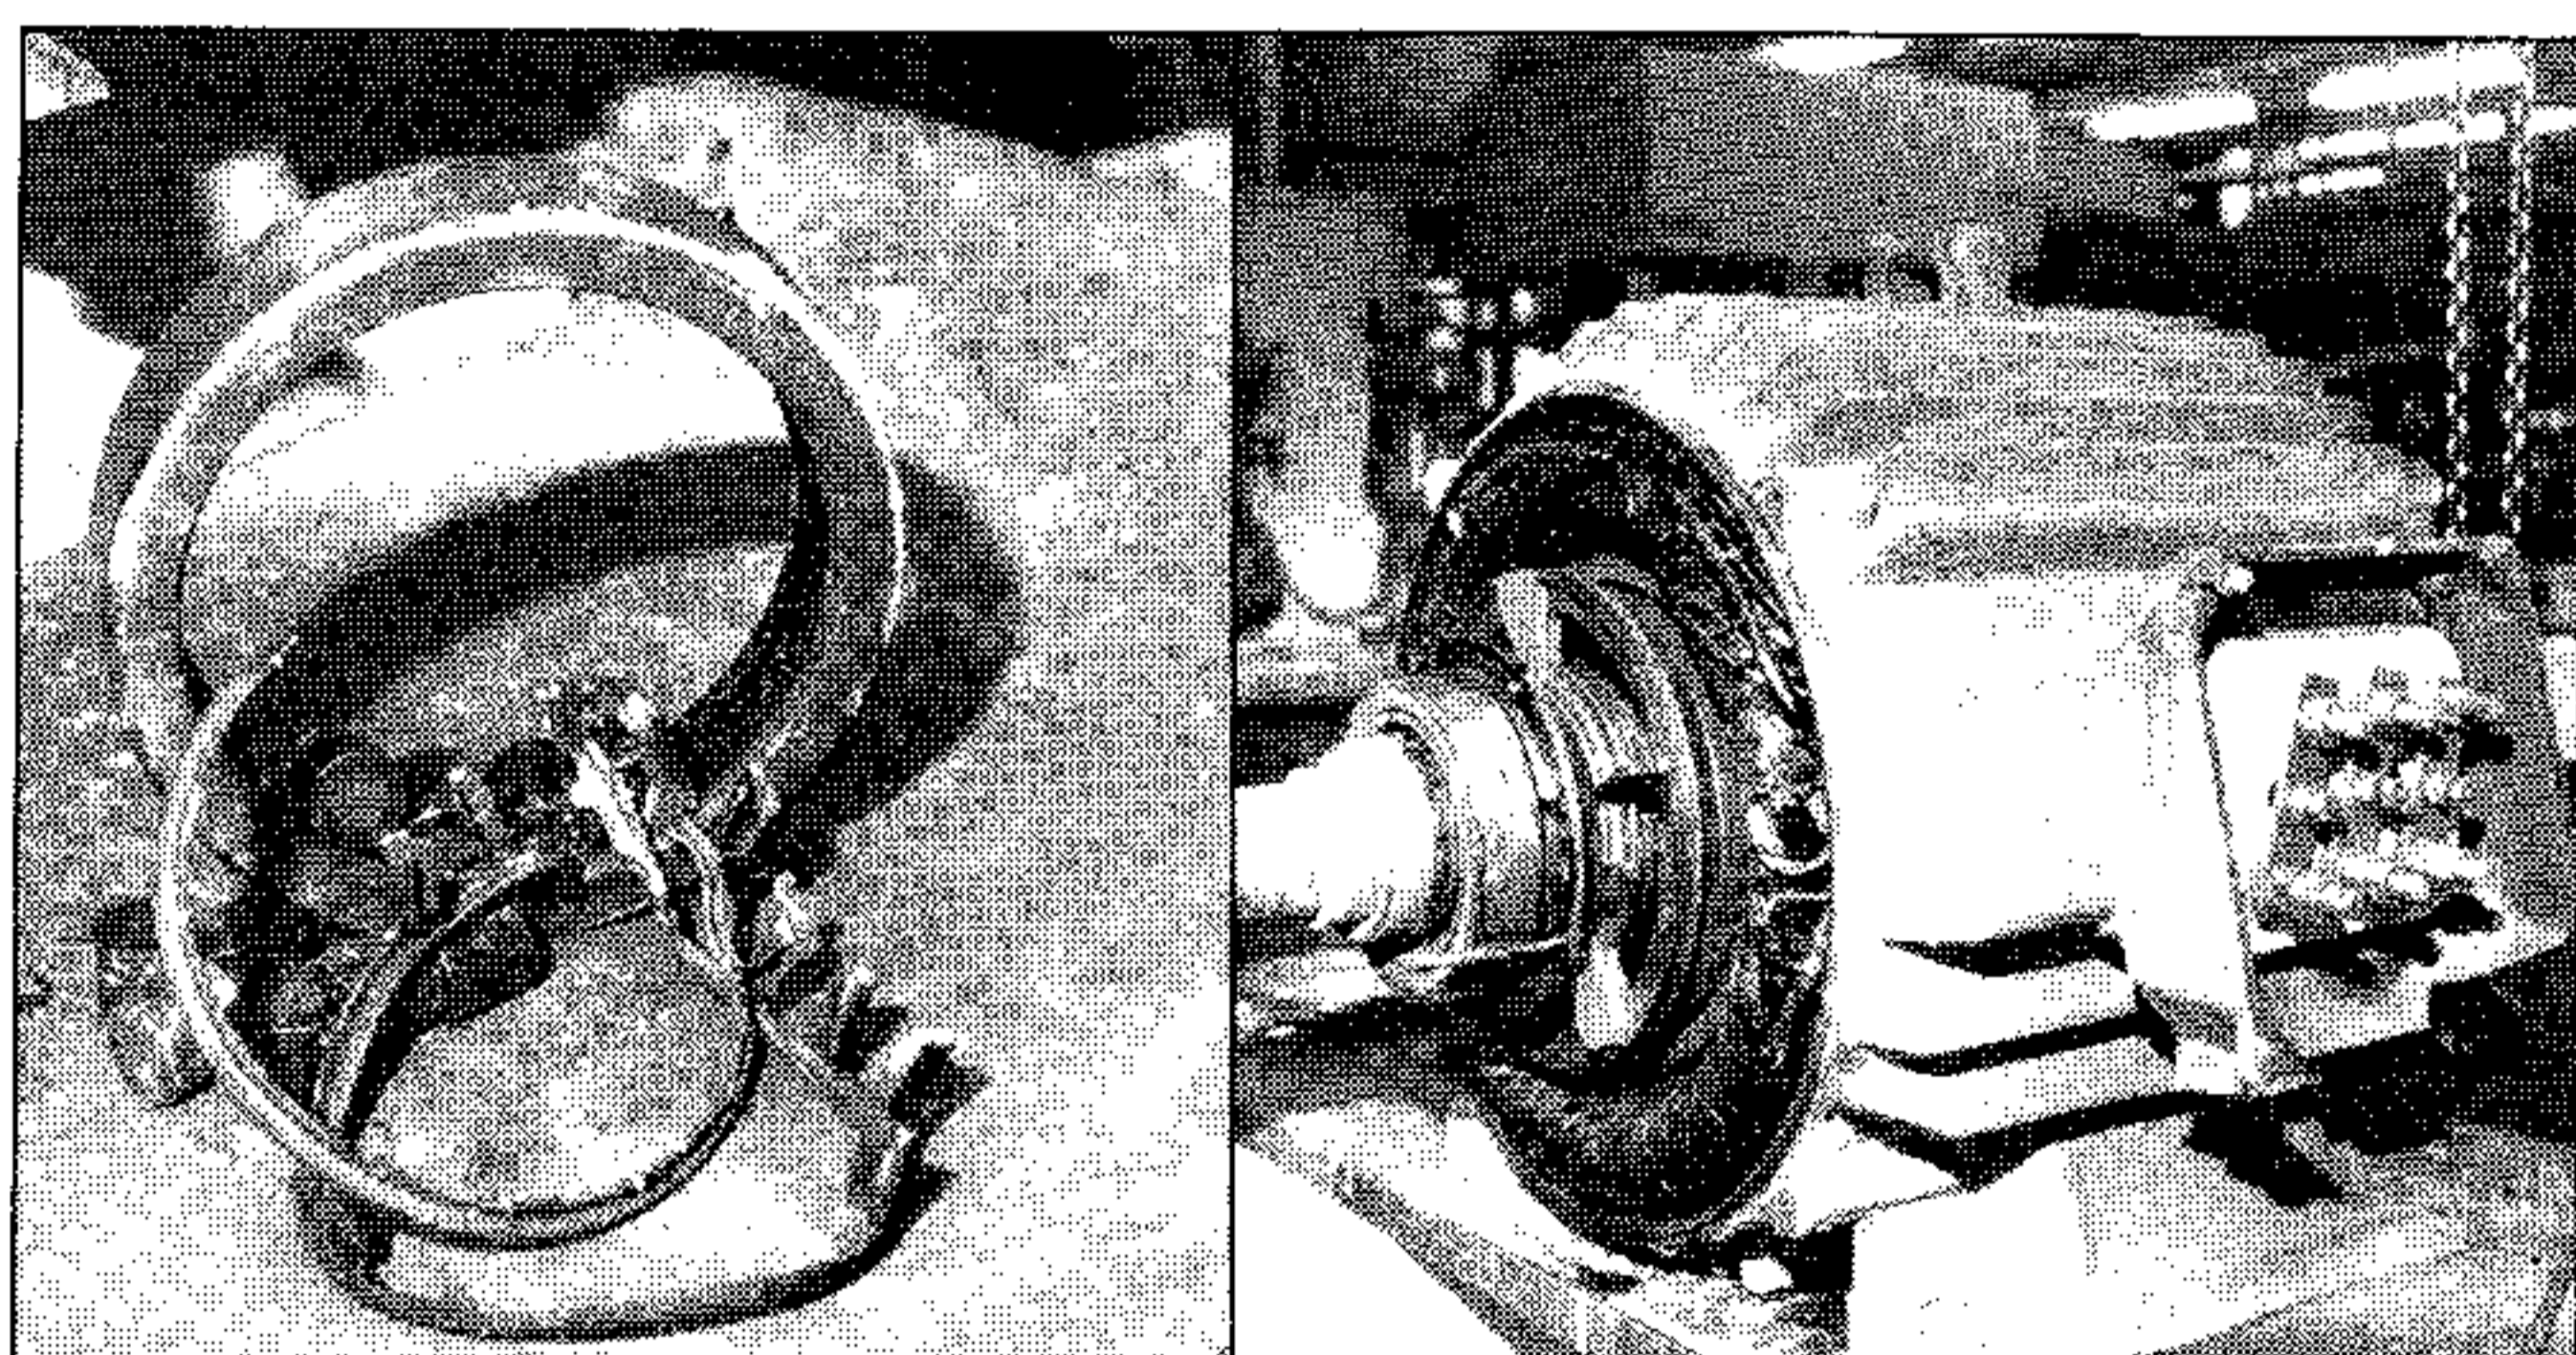
Fig. 5. Groenpol have a workshop where they service and repair various types of machines. Here is a damaged roller bearing from a dismantled electric motor

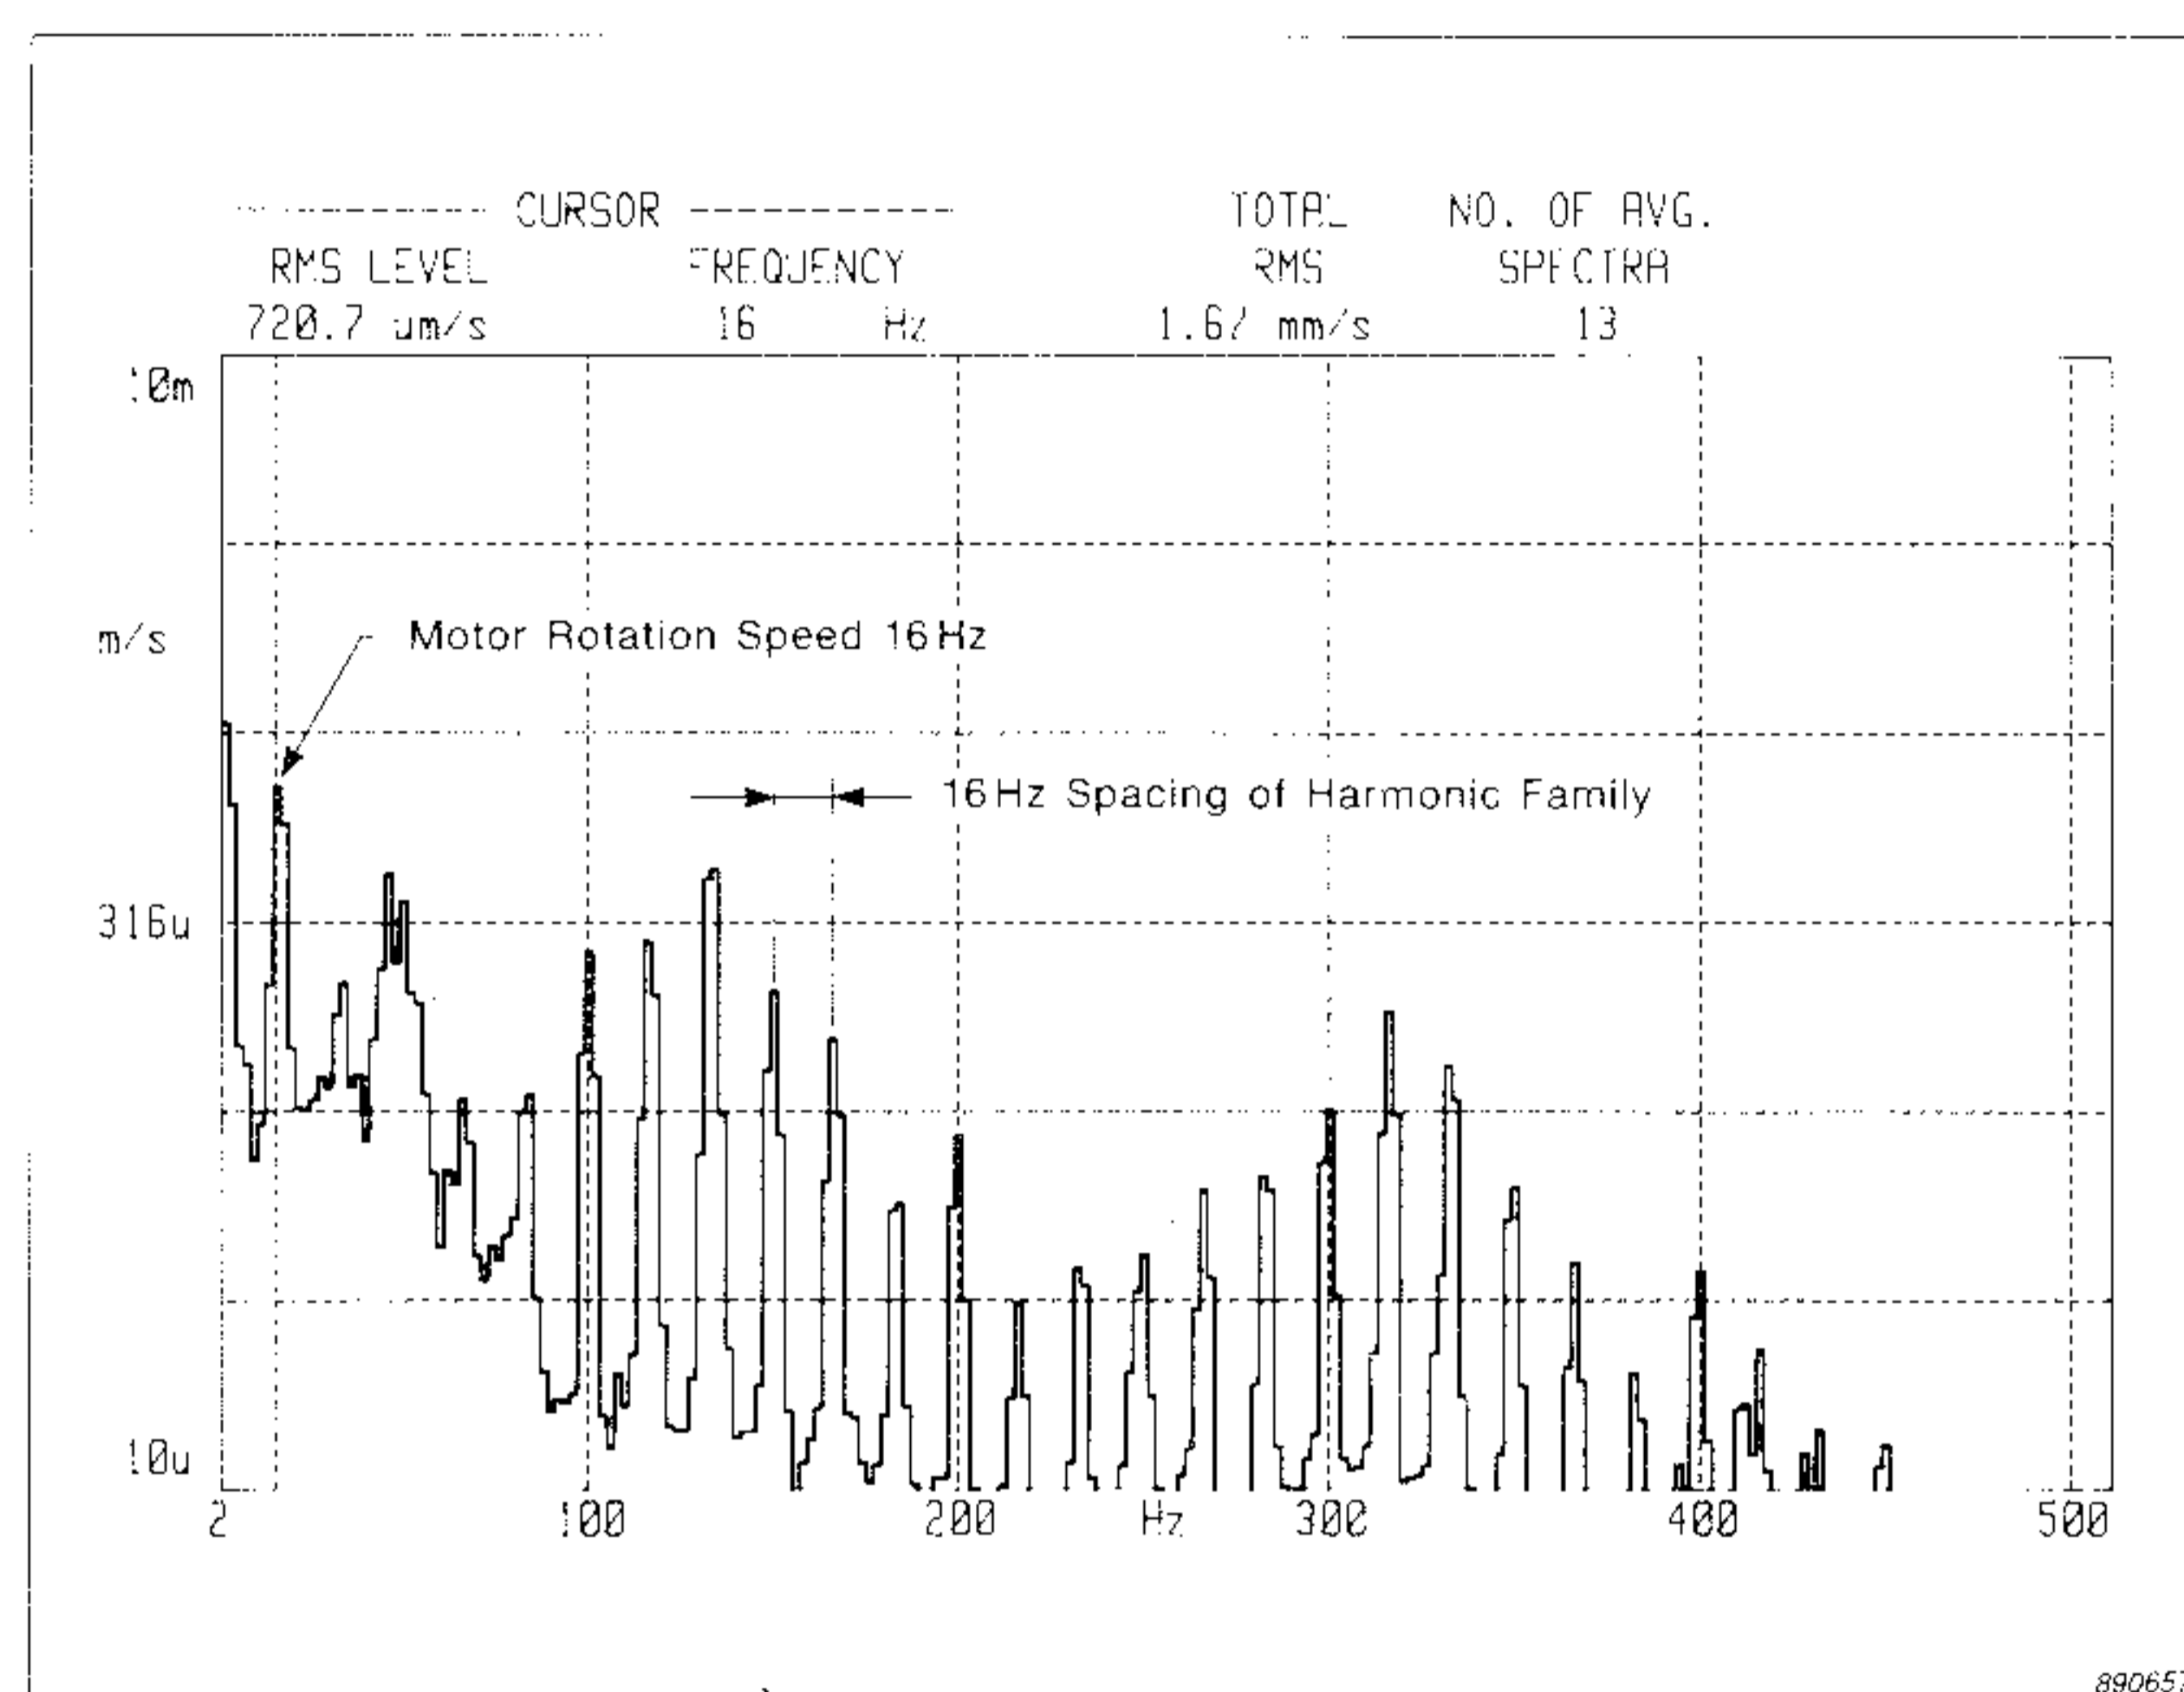
The lift motor had a vibration level of $1,67\text{ mms}^{-1}$ in the horizontal direction, so it failed to satisfy VDI 2056. The Type 2515 Vibration Analyzer was used to help diagnose the problem. A linear-baseband spectrum revealed a large family of harmonics of the rotation speed, see Fig.6. This is the classic symptom of mechanical looseness and in the case of an electrical machine, it usually indicates worn rotor

Fig. 6. The spectrum from the lift motor, measured at the drive side, horizontal direction. The harmonic family of the rotation speed is the classic symptom of a loose rotor

bearings. Groenpol secured the rotor and, as expected, the motor passed the subsequent vibration test.
