Diagnosis of Vibration Problems in Holland

Case Studies from the Groenpol Vibration Consultancy

Matt o'Sullivan
Mechanical Engineer
Brüel and Kjær, Denmark

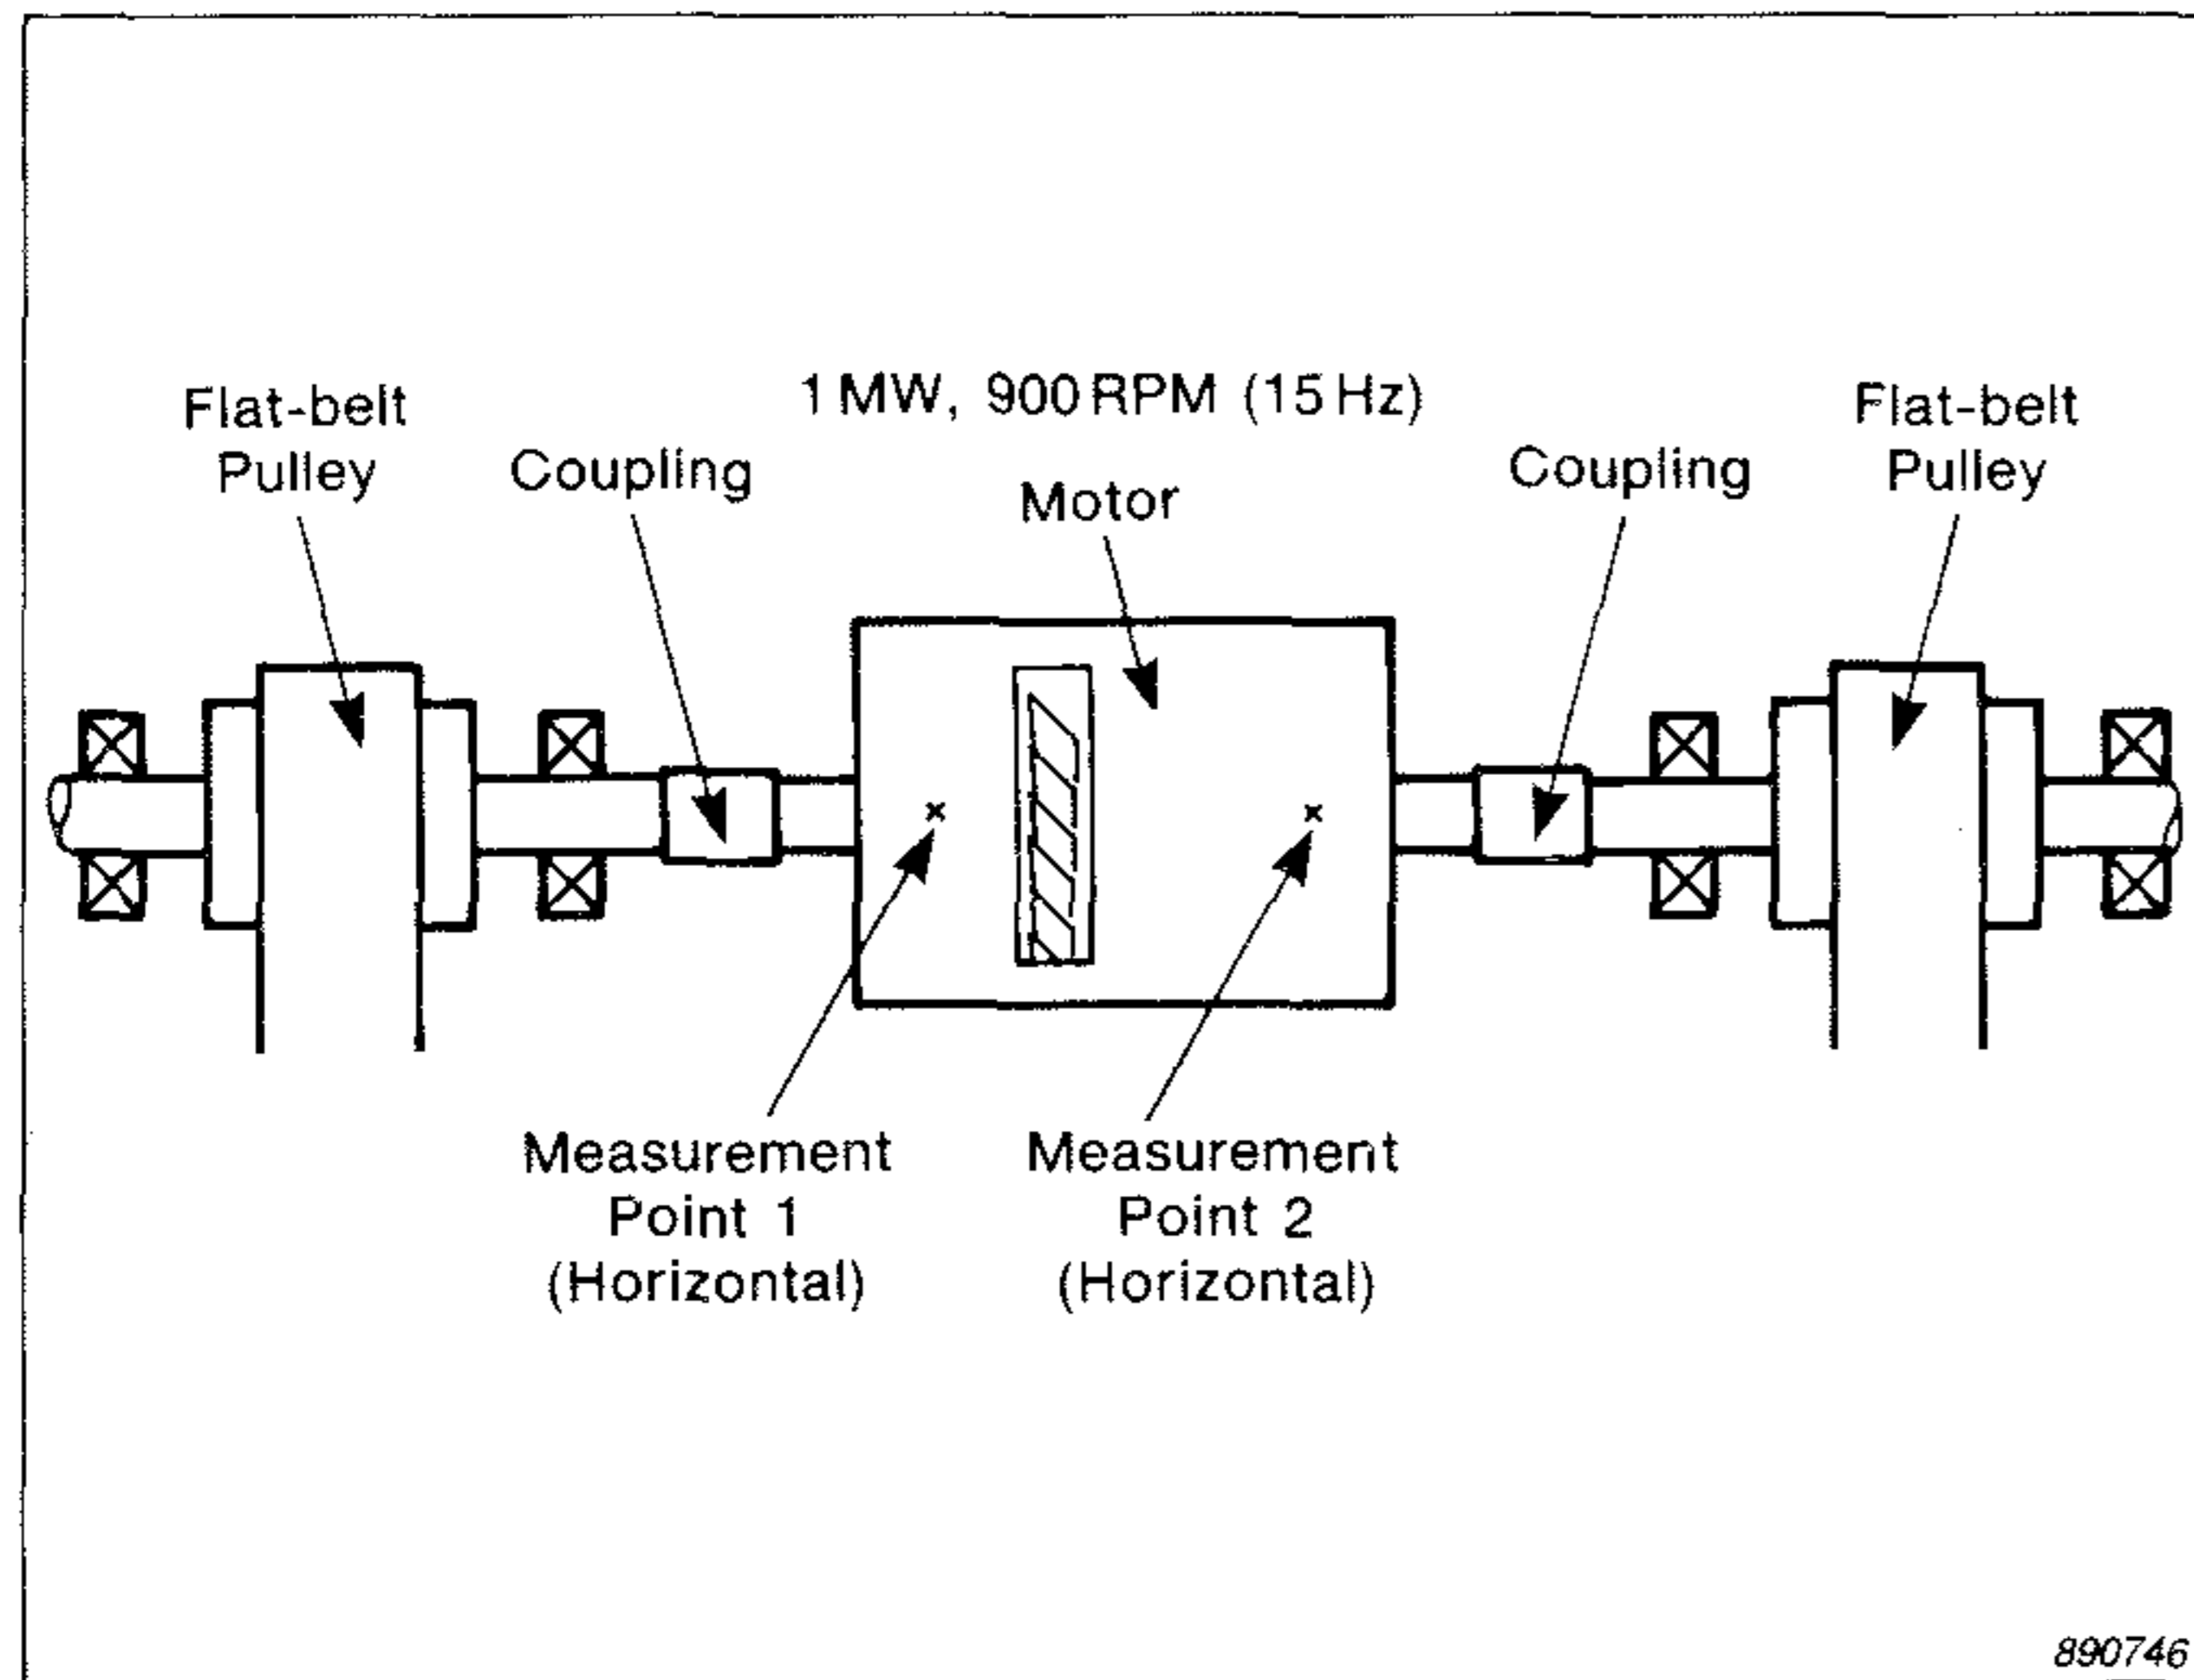
The motor concerned is a 1MW, 900 RPM (15Hz) unit, located high up in an awkward position. It drives flat-belt pulleys at both ends, see Fig.7. When the maintenance staff noticed that the vibration level was relatively high compared to vibration severity criteria VDI 2056, they called Groenpol and asked them to do the repairs in-situ.

To diagnose the fault, Groenpol measured with the vibration analyzer at the two horizontal measurement points shown in Fig.7. At measurement point 1 they noticed a high vi-

Fig. 7. The 1 MW motor drives two flat-belt pulleys as shown. Since it is very large and located high up in an awkward place, the maintenance staff wanted the repairs done in-situ

Groenpol balanced the two pulleys in-situ. Next they uncoupled the pulleys from the motor and balanced the mo-

tor in-situ. Finally they examined the coupling and they found it was stiff and worn due to lack of grease. After it was cleaned and greased, and the shafts re-coupled, the machine operated normally. An overall RMS measurement confirmed that the vibration level was now acceptable.

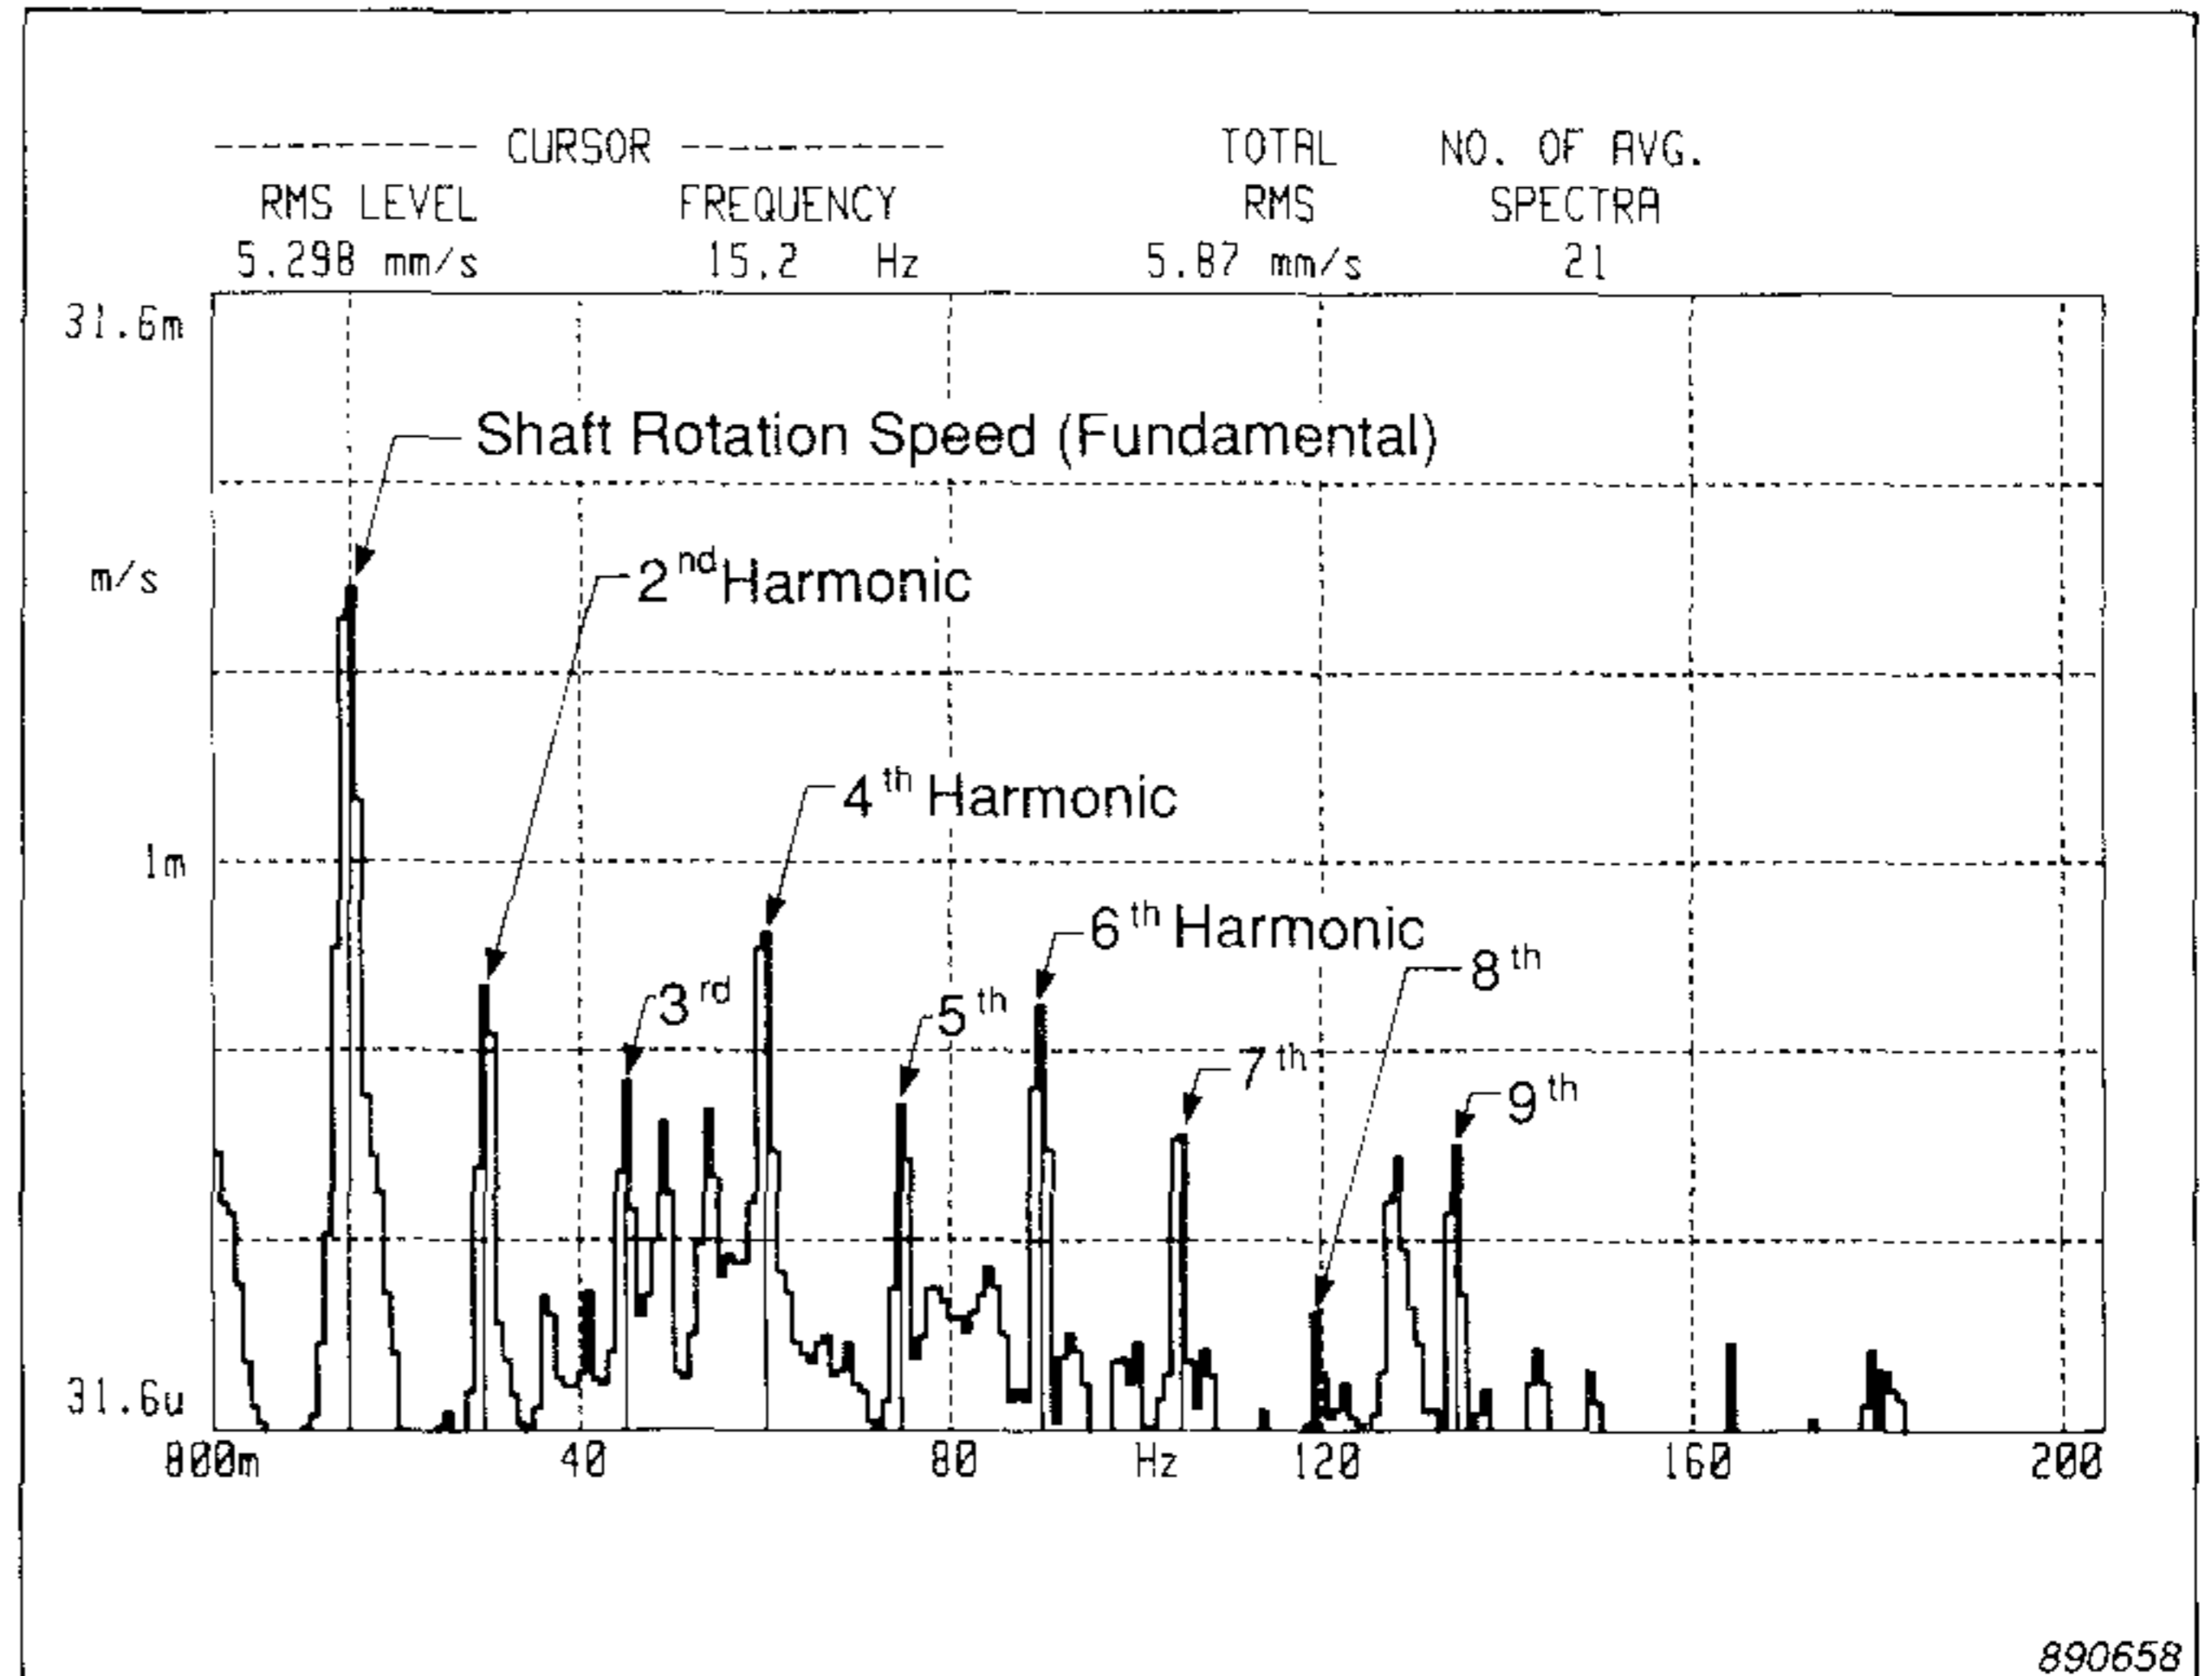
bration level at the motor rotation speed. The spectrum from measurement point 2 is shown in Fig.8. It shows that most of the vibration occurs at the rotation speed; from this Groenpol concluded that the main problem was unbalance.

The 2nd, 4th and 6th harmonics of rotation speed are prominent but their level is much lower; from this Groenpol suspected a misalignment problem at the coupling near measurement point 2.

Fig. 8. A horizontal, linear-baseband spectrum from measurement point 2. The high level at the motor speed indicates that the main problem is unbalance. The prominent $2 \times$ rotation speed harmonic family suggests a misalignment or coupling problem

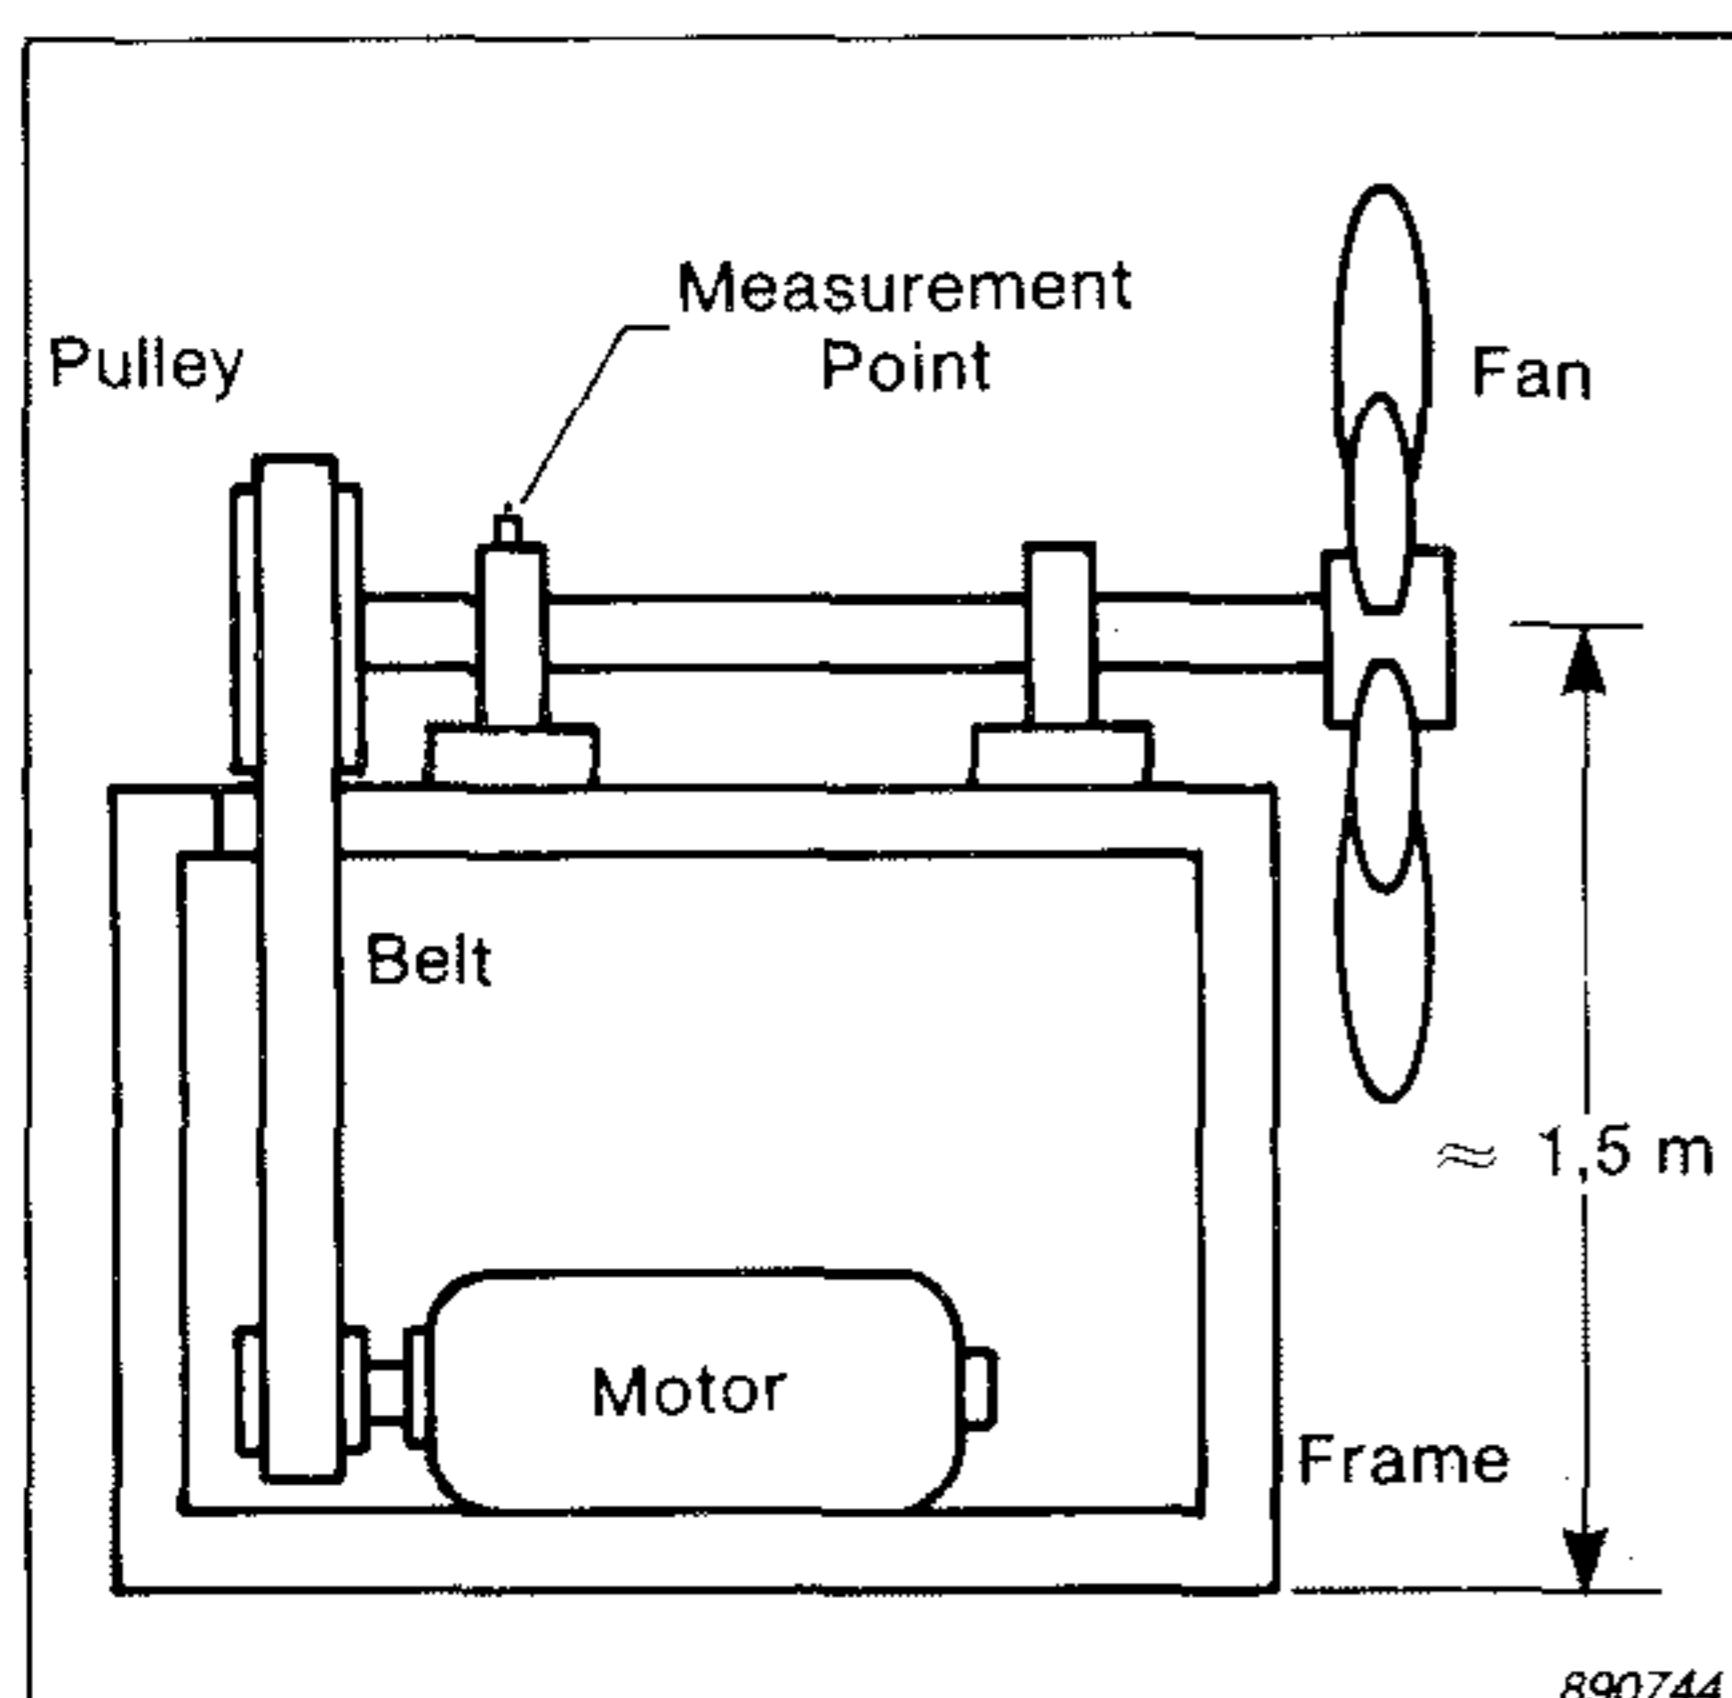
The company in this case manufactures Tarmacadam for road surfacing. The faulty fan is used to extract dust from the manufacturing area. It was located about 1.5 m from ground level, on top of a steel frame which stood unbolted to the floor, see Fig. 9.

Fig. 9. The motor drives the fan through a belt drive as shown. The frame sits loose on the floor

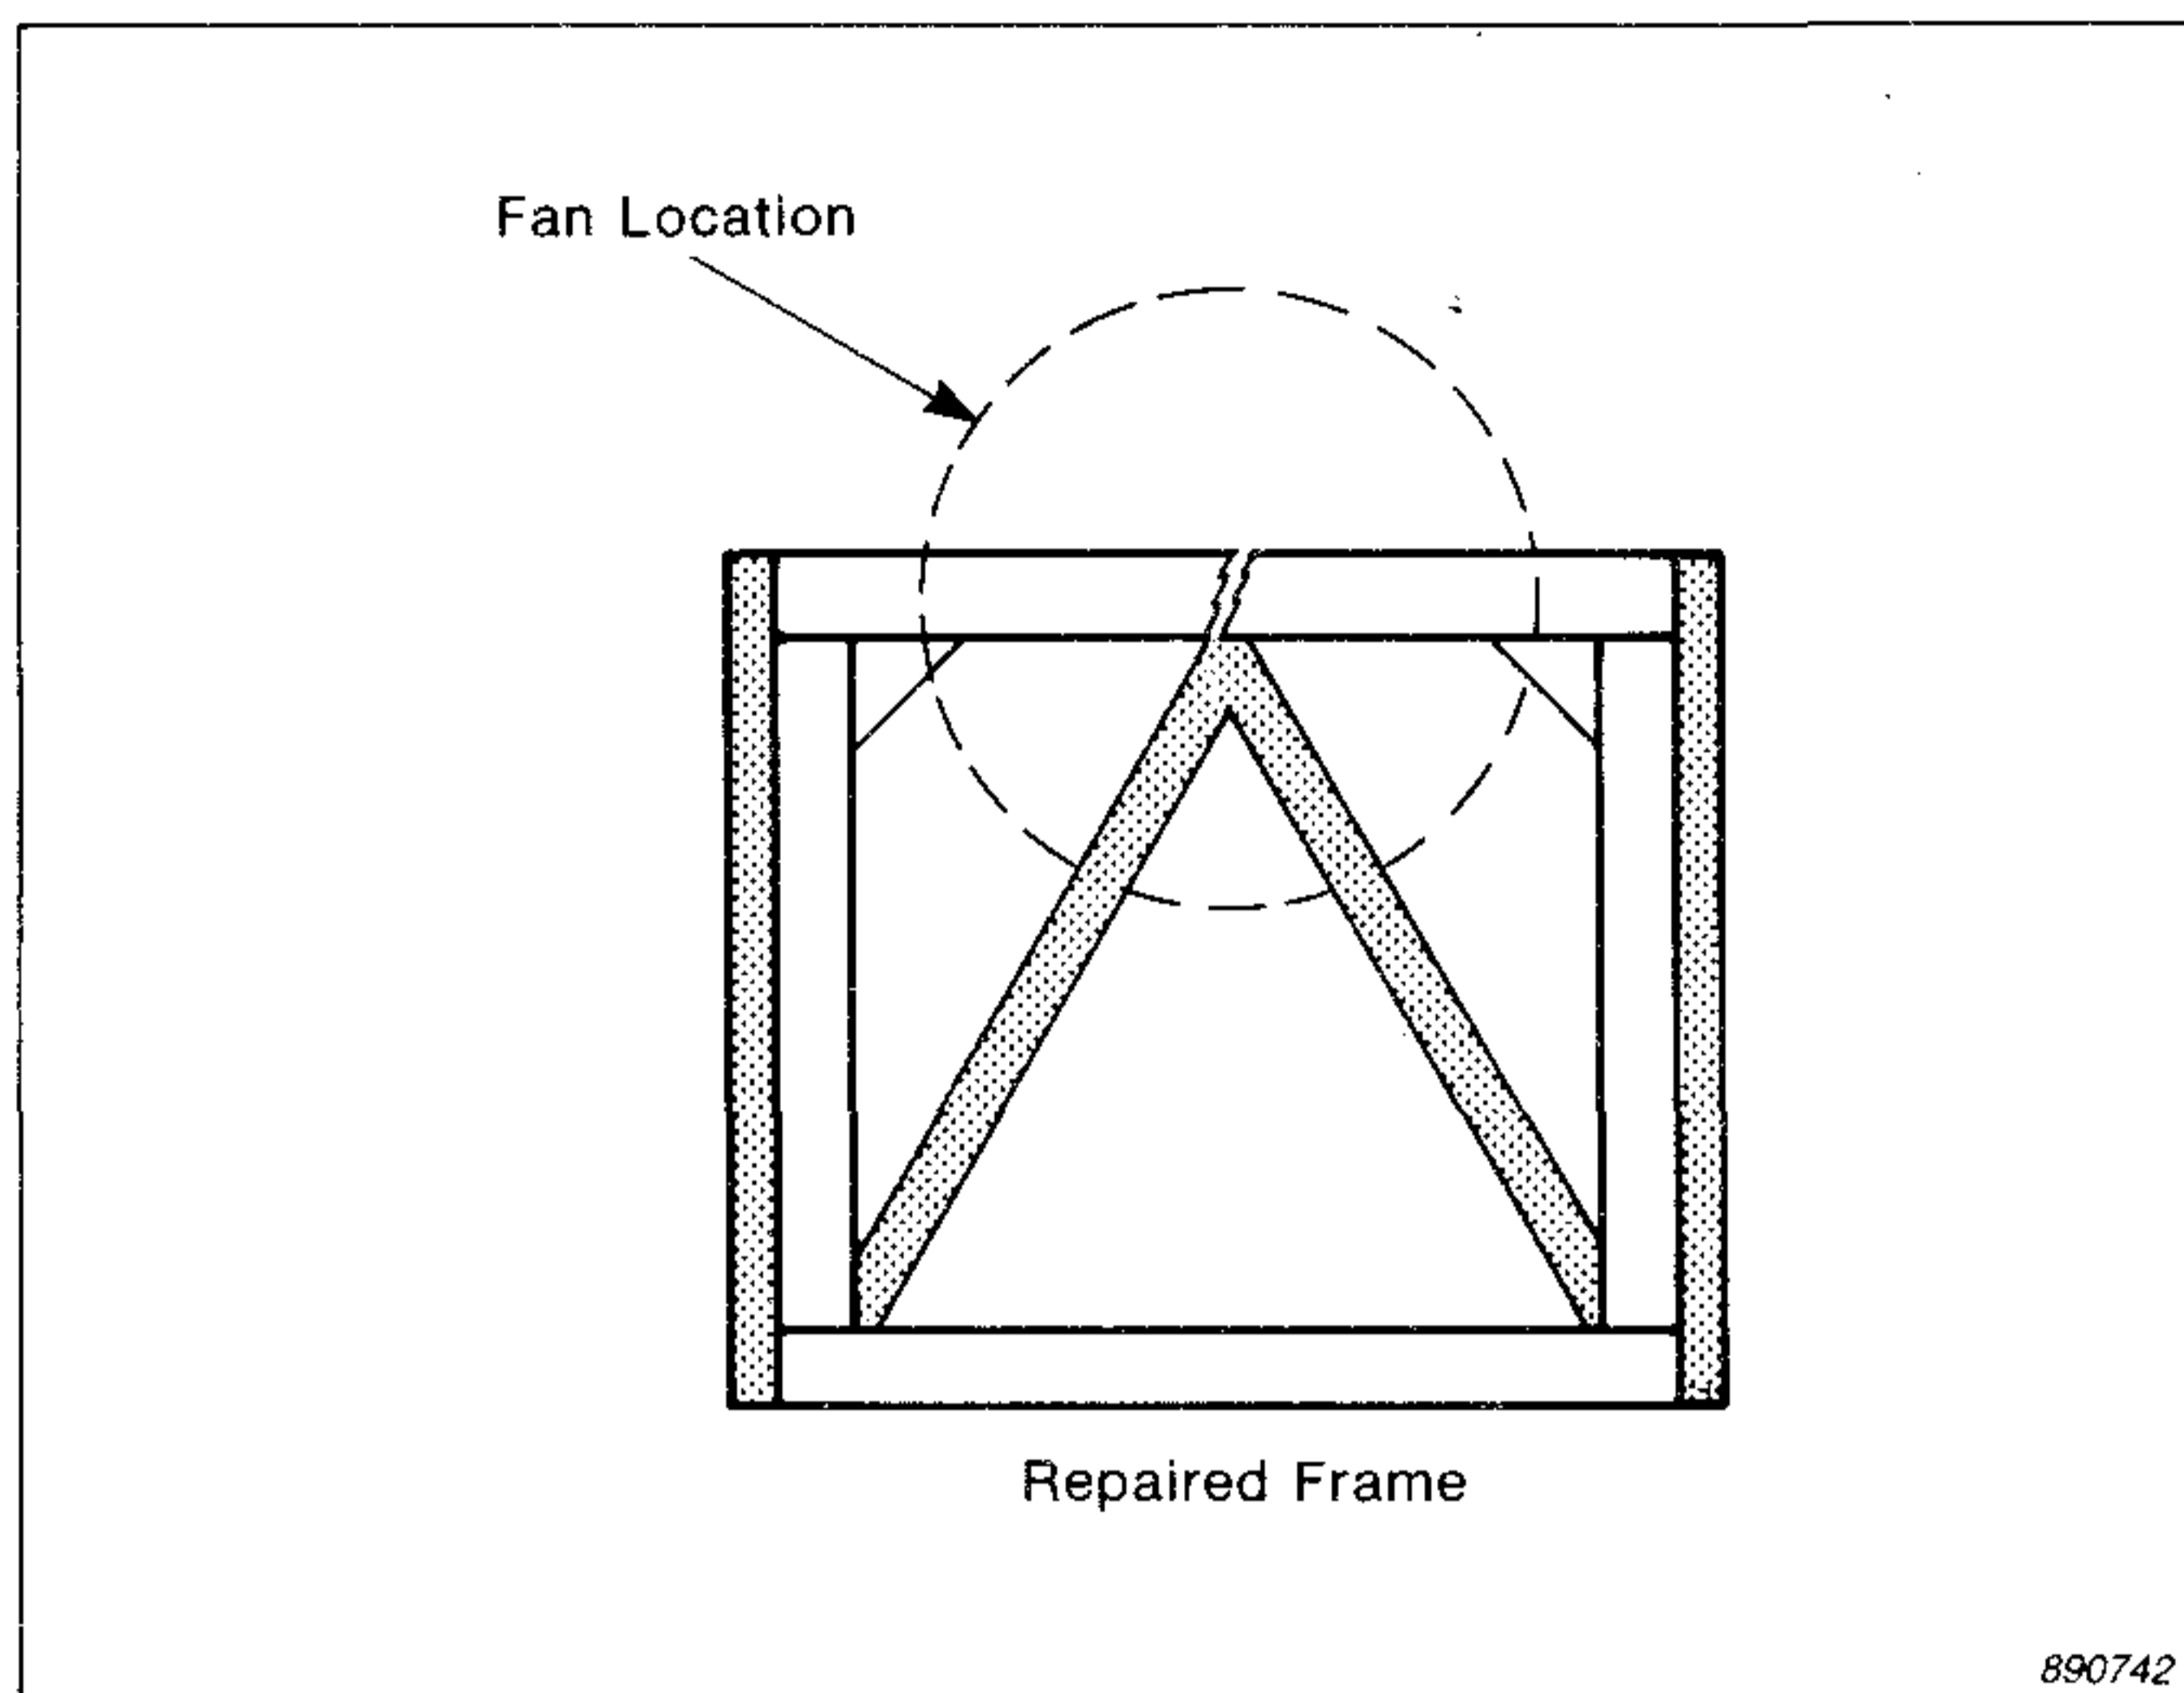
Soon afterwards the vibration level became intolerable again. Groenpol suspected a structural problem and decided to inspect the frame closely, see Fig. 11. On sand-blasting, they found a large crack at the top. This had caused a low-frequency resonance in the frame, near the fan rotation frequency. They advised the company to weld the crack, add stiffeners, and fill the frame with concrete.

Fig. 11. The original frame had a crack near the top. This was welded and stiffeners (shaded sections) were added

The company stiffened the frame as shown in Fig. 11 and this increased the

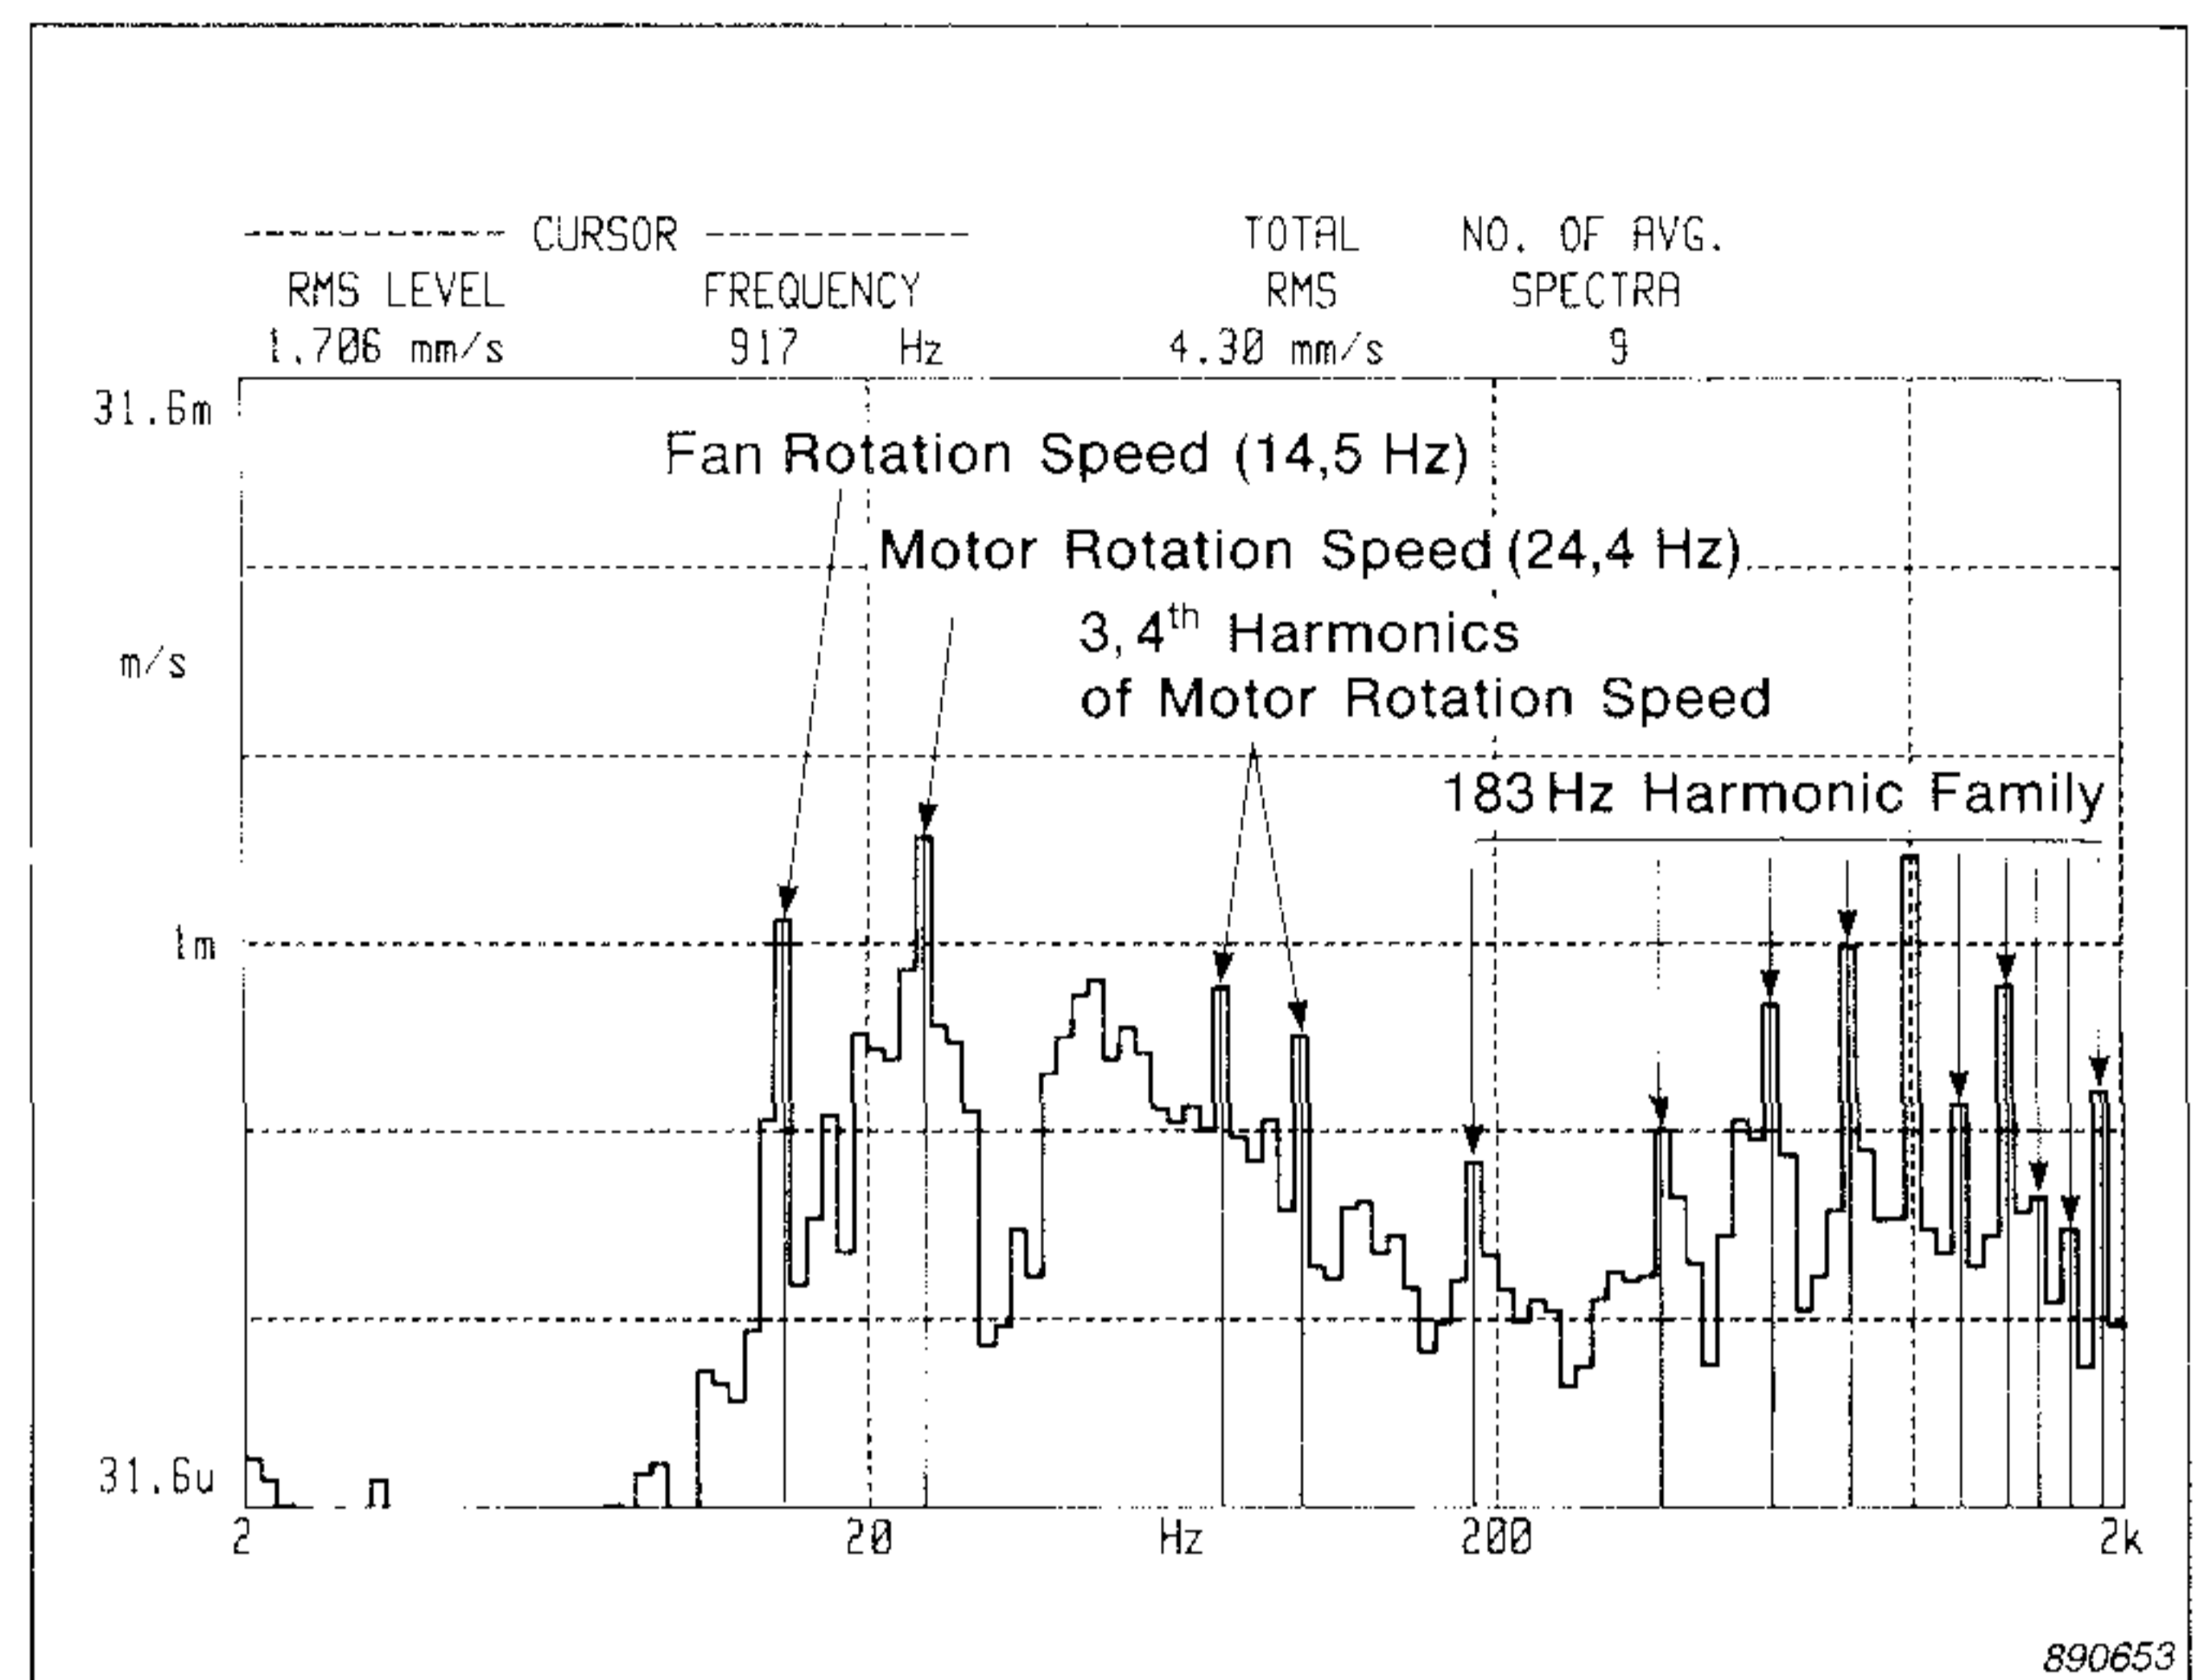
After the repairs were finished, Groenpol measured a horizontal, 2 kHz, 6% CPB spectrum at the bearing casing, at the driven end of the fan, see Fig. 12. The overall RMS level of 4.3 mms^{-1} was acceptably low. The origin of the main peaks in the spectrum is as follows:

Peak 1 is the fan rotation speed. This indicates residual unbalance in the fan.

Peaks 2, 3 and 4 are harmonics of the motor rotation speed. They are probably caused by the motor exciting the loose frame.

Peaks 5 to 11 are also members of a harmonic family. Peak 5 is the fundamental with a frequency of 183 Hz. This does not correspond to any shaft rotation speeds. Instead it is probably

a characteristic ball-passing frequency of a roller element bearing, which indicates bearing fault. The harmonic family is prominent because it is amplified by resonances in the machine.

Fig. 12. Horizontal, 2kHz, 6% CPB spectrum. This was measured at the bearing casing, at the driven end of the fan shaft, after the frame was repaired. Note the two harmonic families

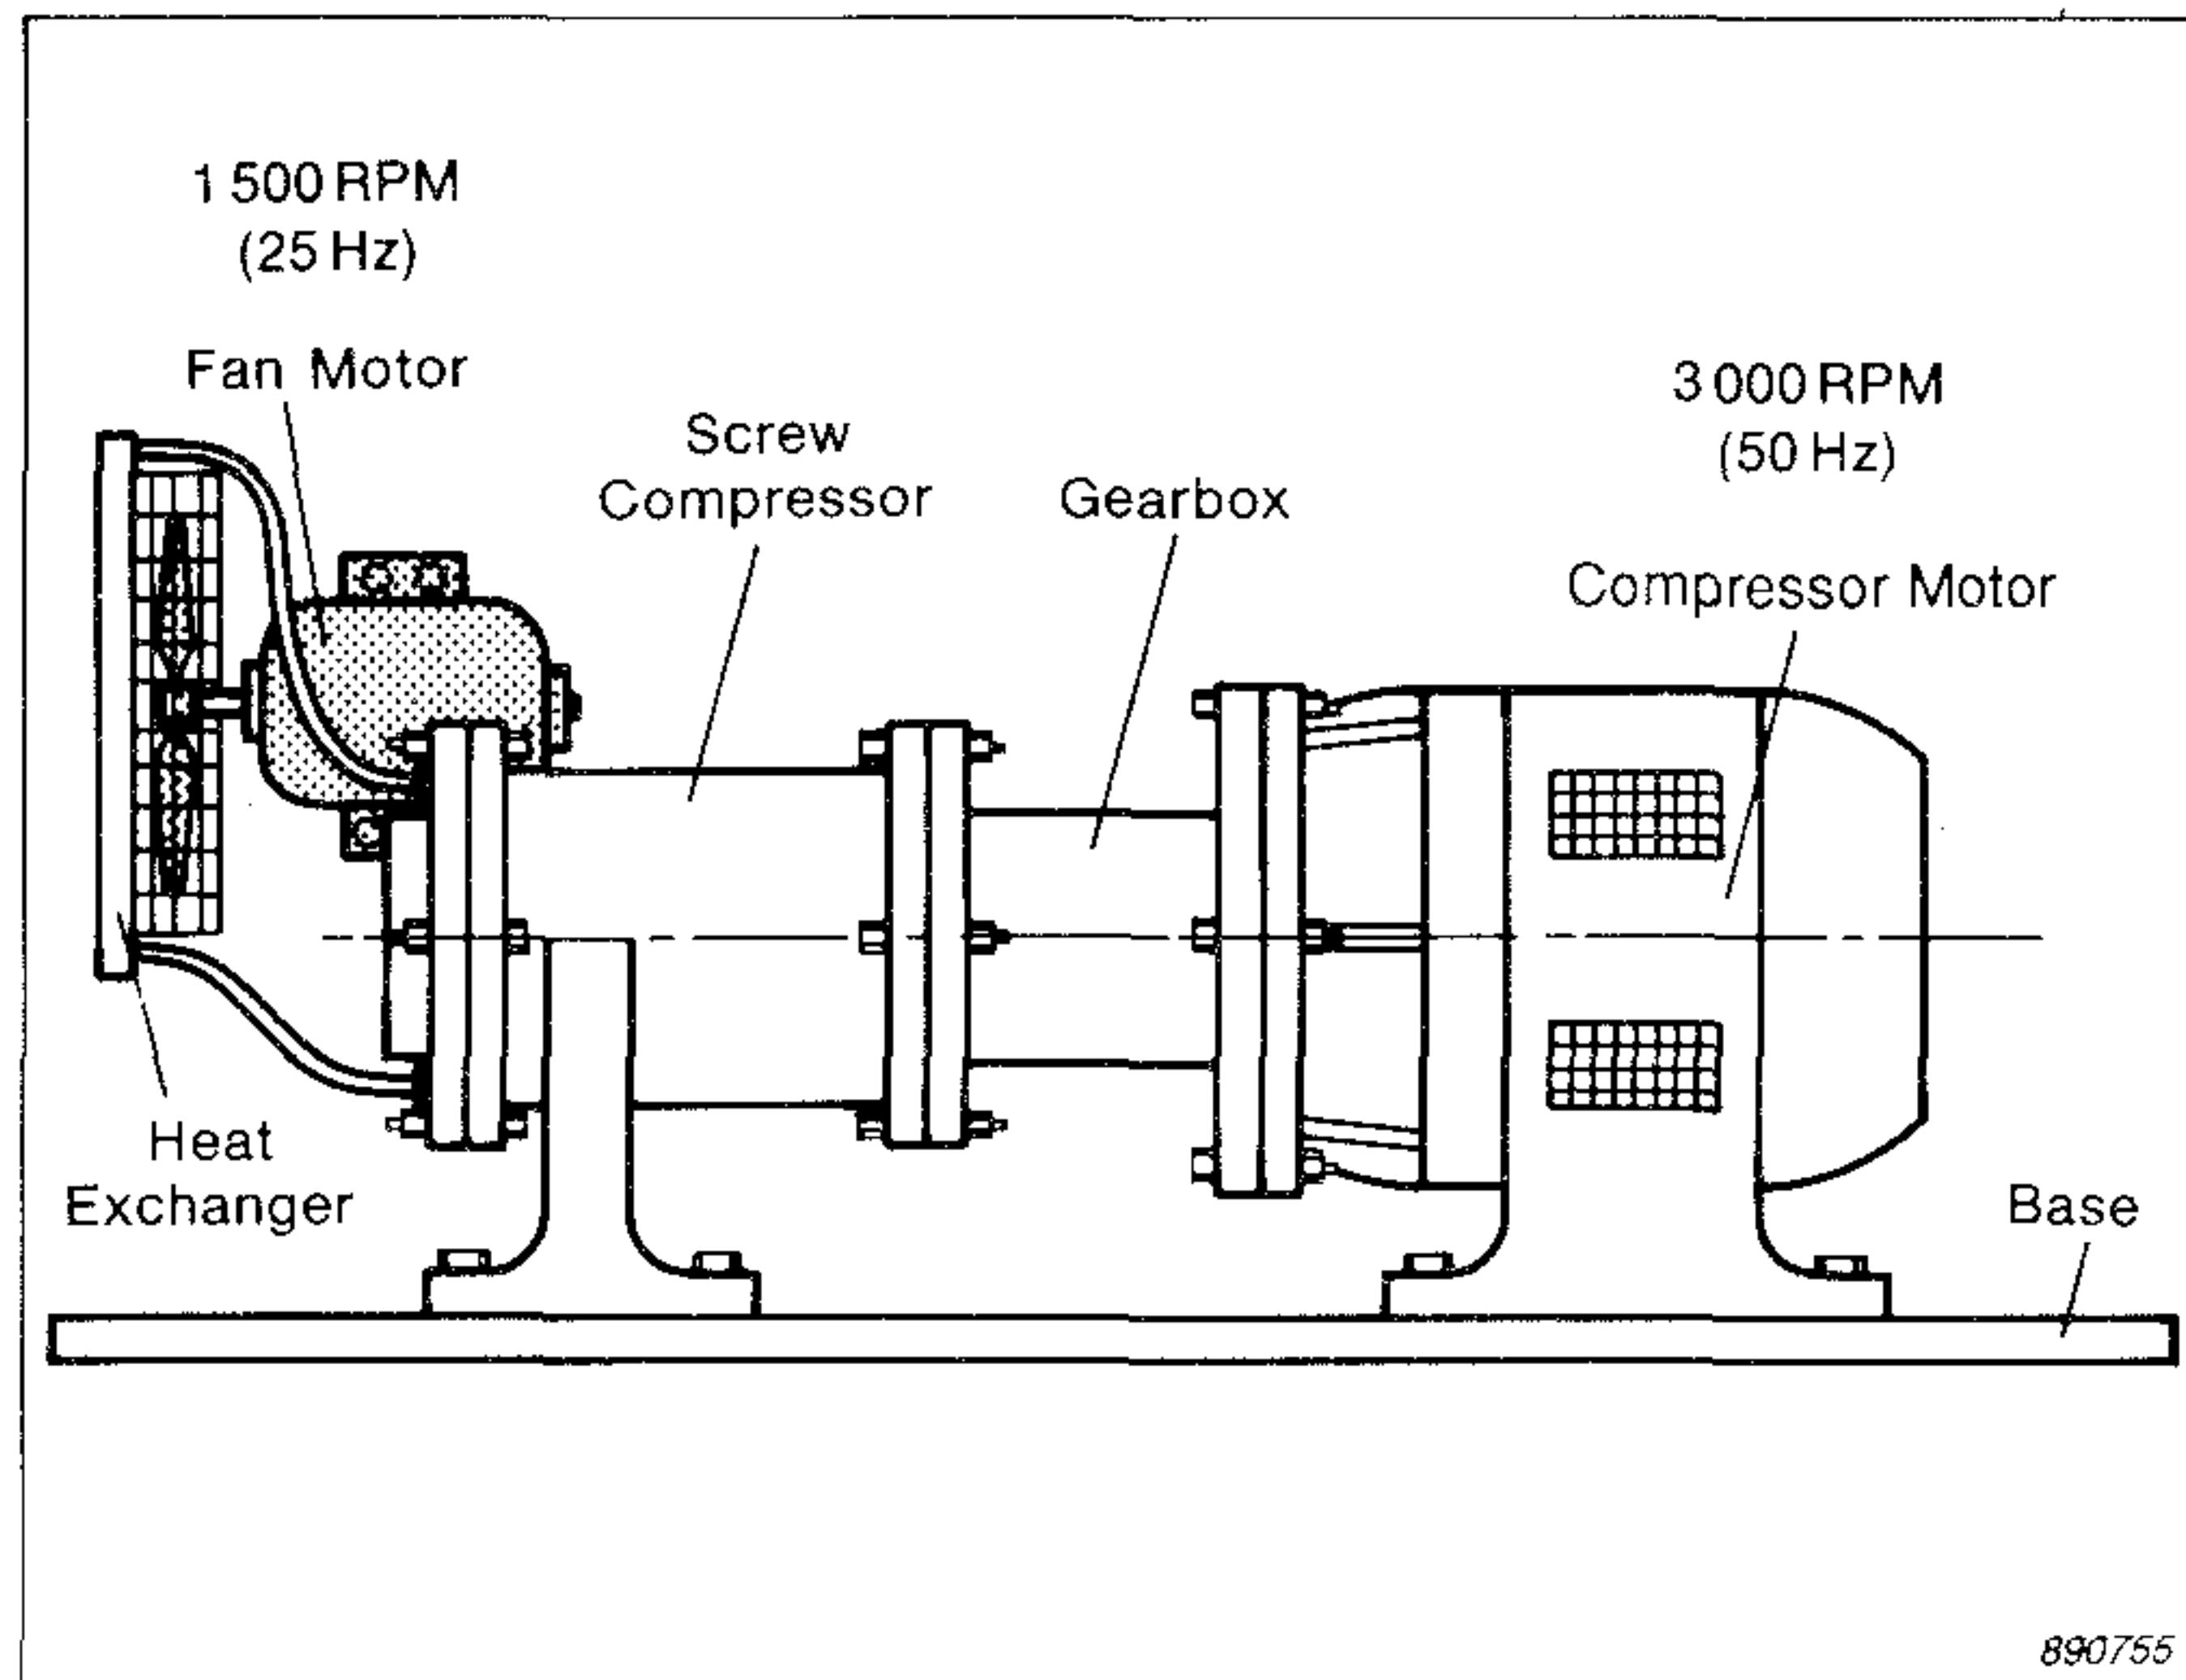
The compressor in question is mounted as shown in Fig. 14. When the company noticed high noise and vibration levels, they asked Groenpol to correct the problem. Groenpol found the spectrum shown in Fig. 15 when they mea-

Fig. 14. The compressor unit which consists of the compressor motor, gearbox and screw compressor, and a smaller motor which drives a cooling fan
