Diagnosis of Vibration Problems in Holland

Case Studies from the Groenpol Vibration Consultancy

Matt o'Sullivan
Mechanical Engineer
Brüel and Kjær, Denmark

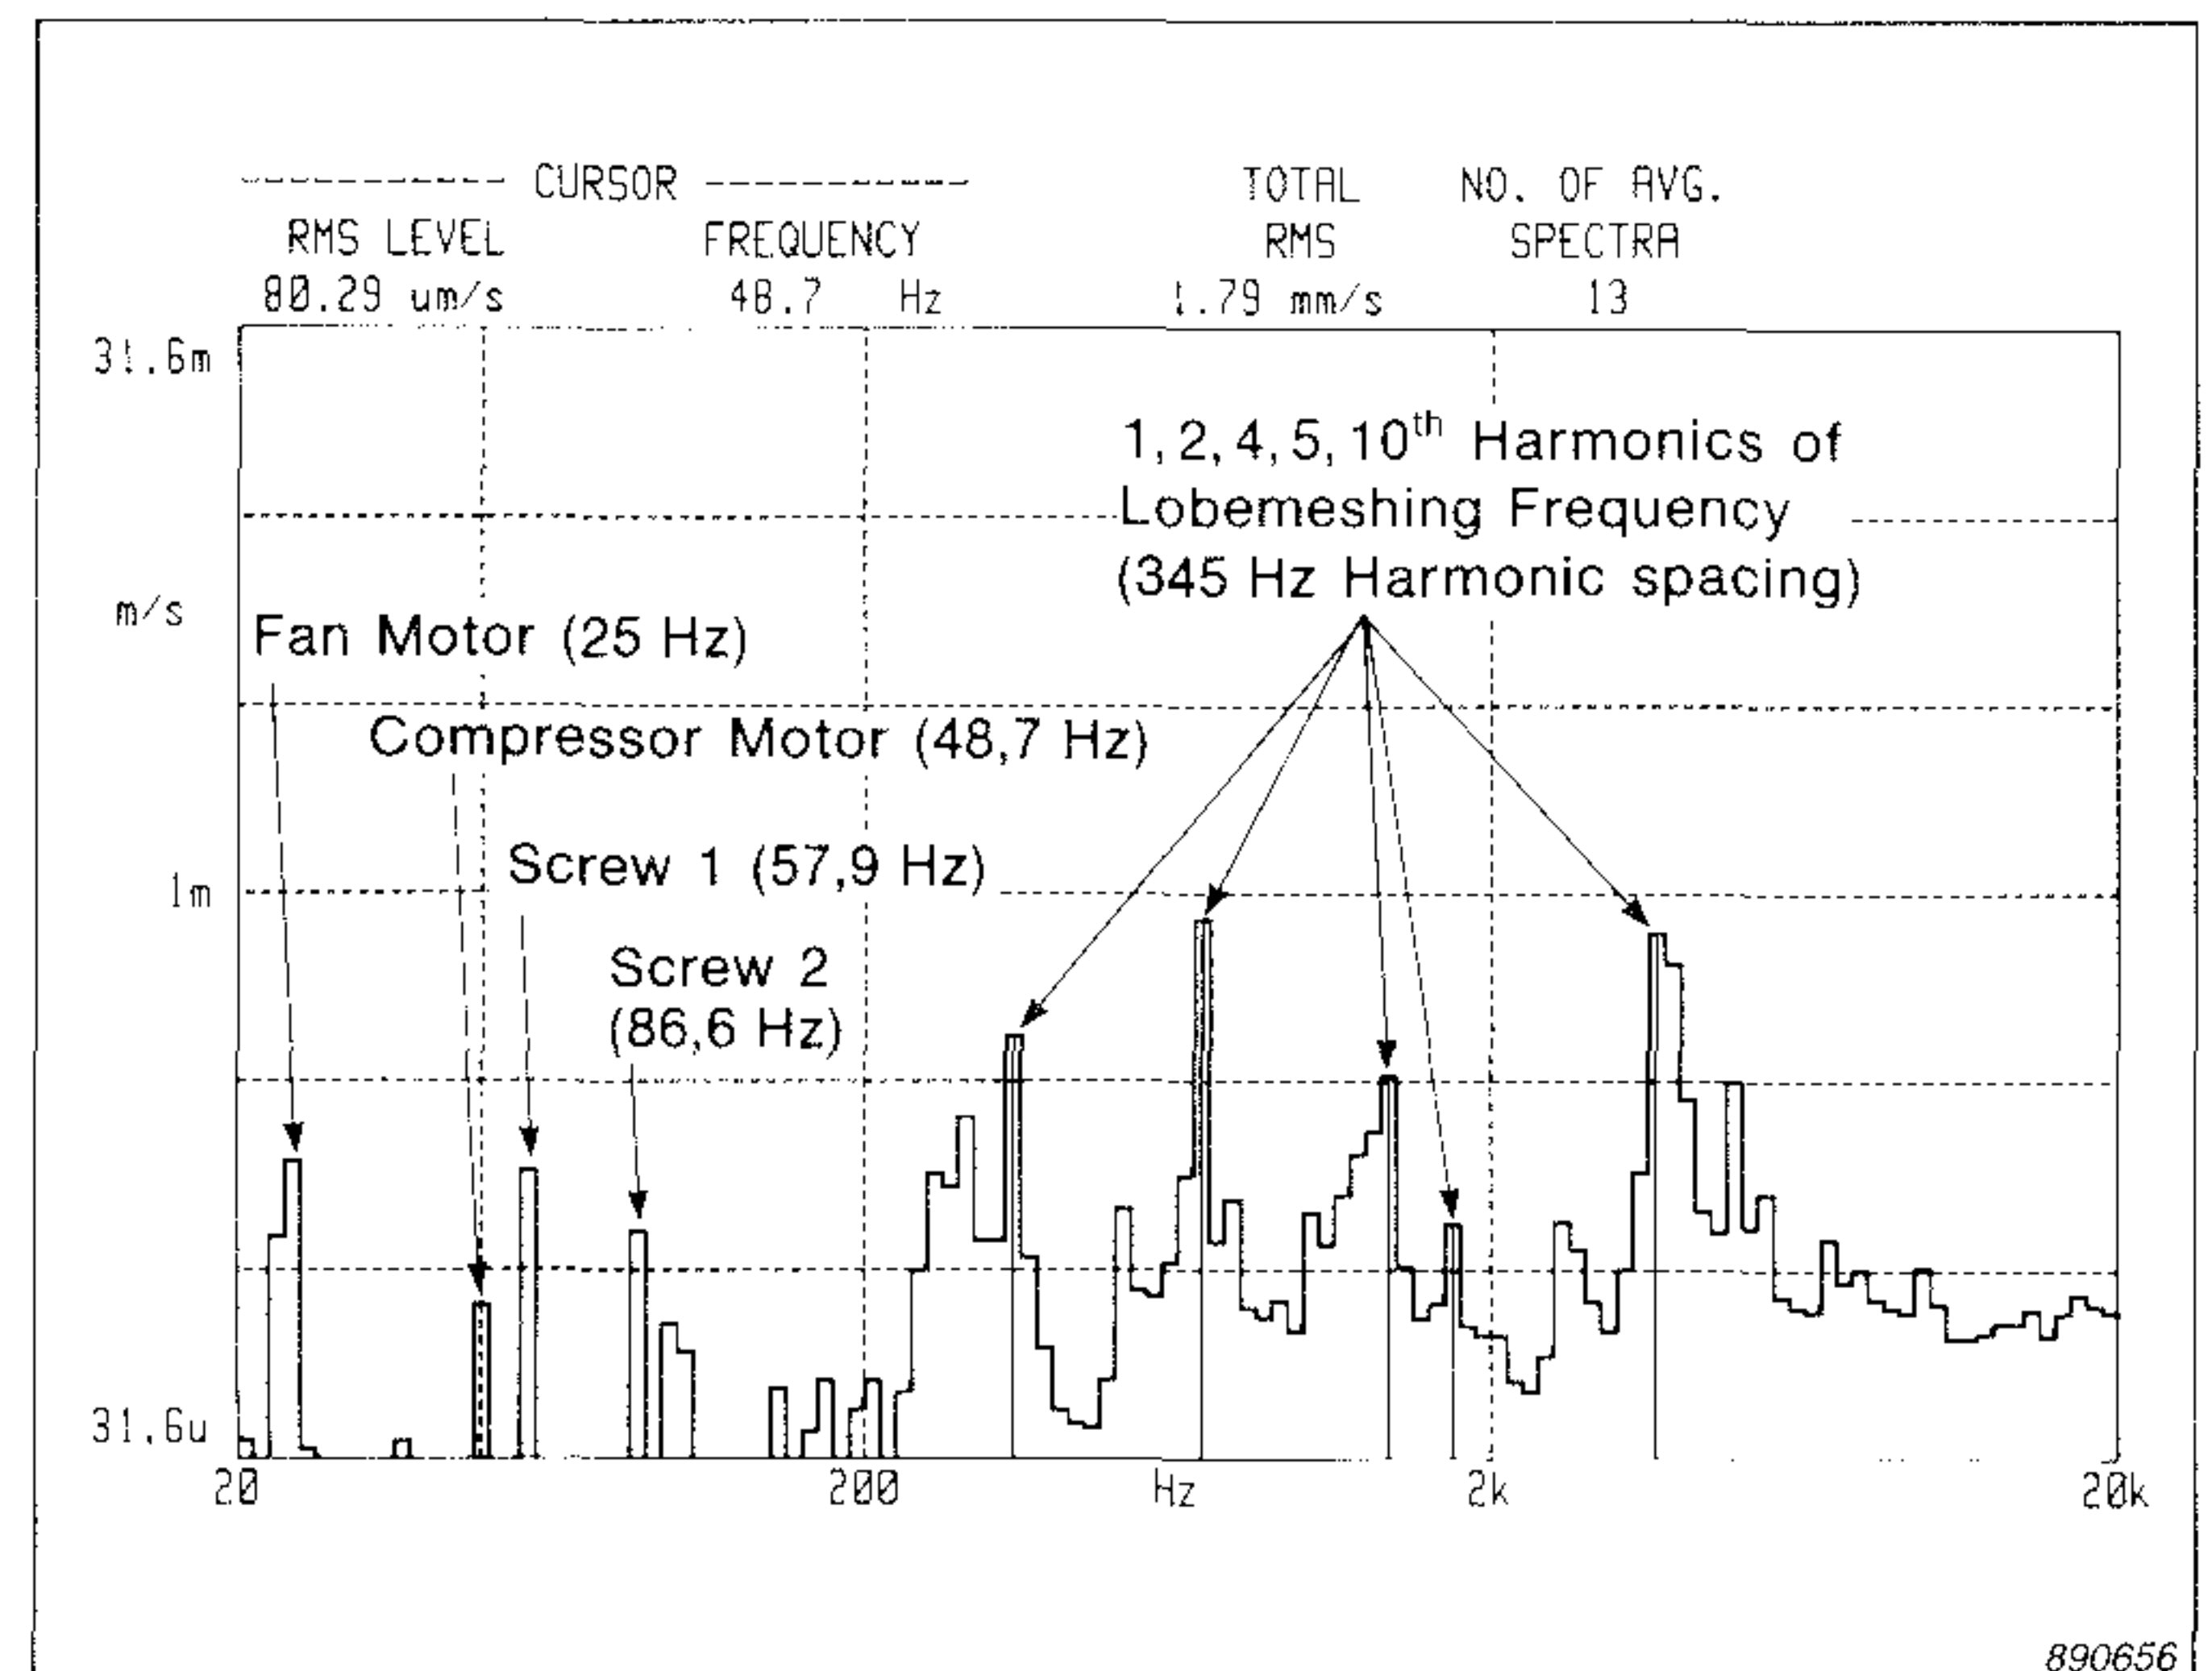
The lobemeshing frequency harmonics are the highest peaks in the spectrum. According to manufacturers of screw compressors, this indicates thrust-bearing damage. When the mechanics removed the thrust bearing they found the suspected damage.

Fig. 15. Axial, 20 KHz, 6% CPB spectrum. Measured at the non-drive end of the compressor motor. Note the harmonic family of the lobemeshing frequency. This is a symptom of thrust-bearing damage

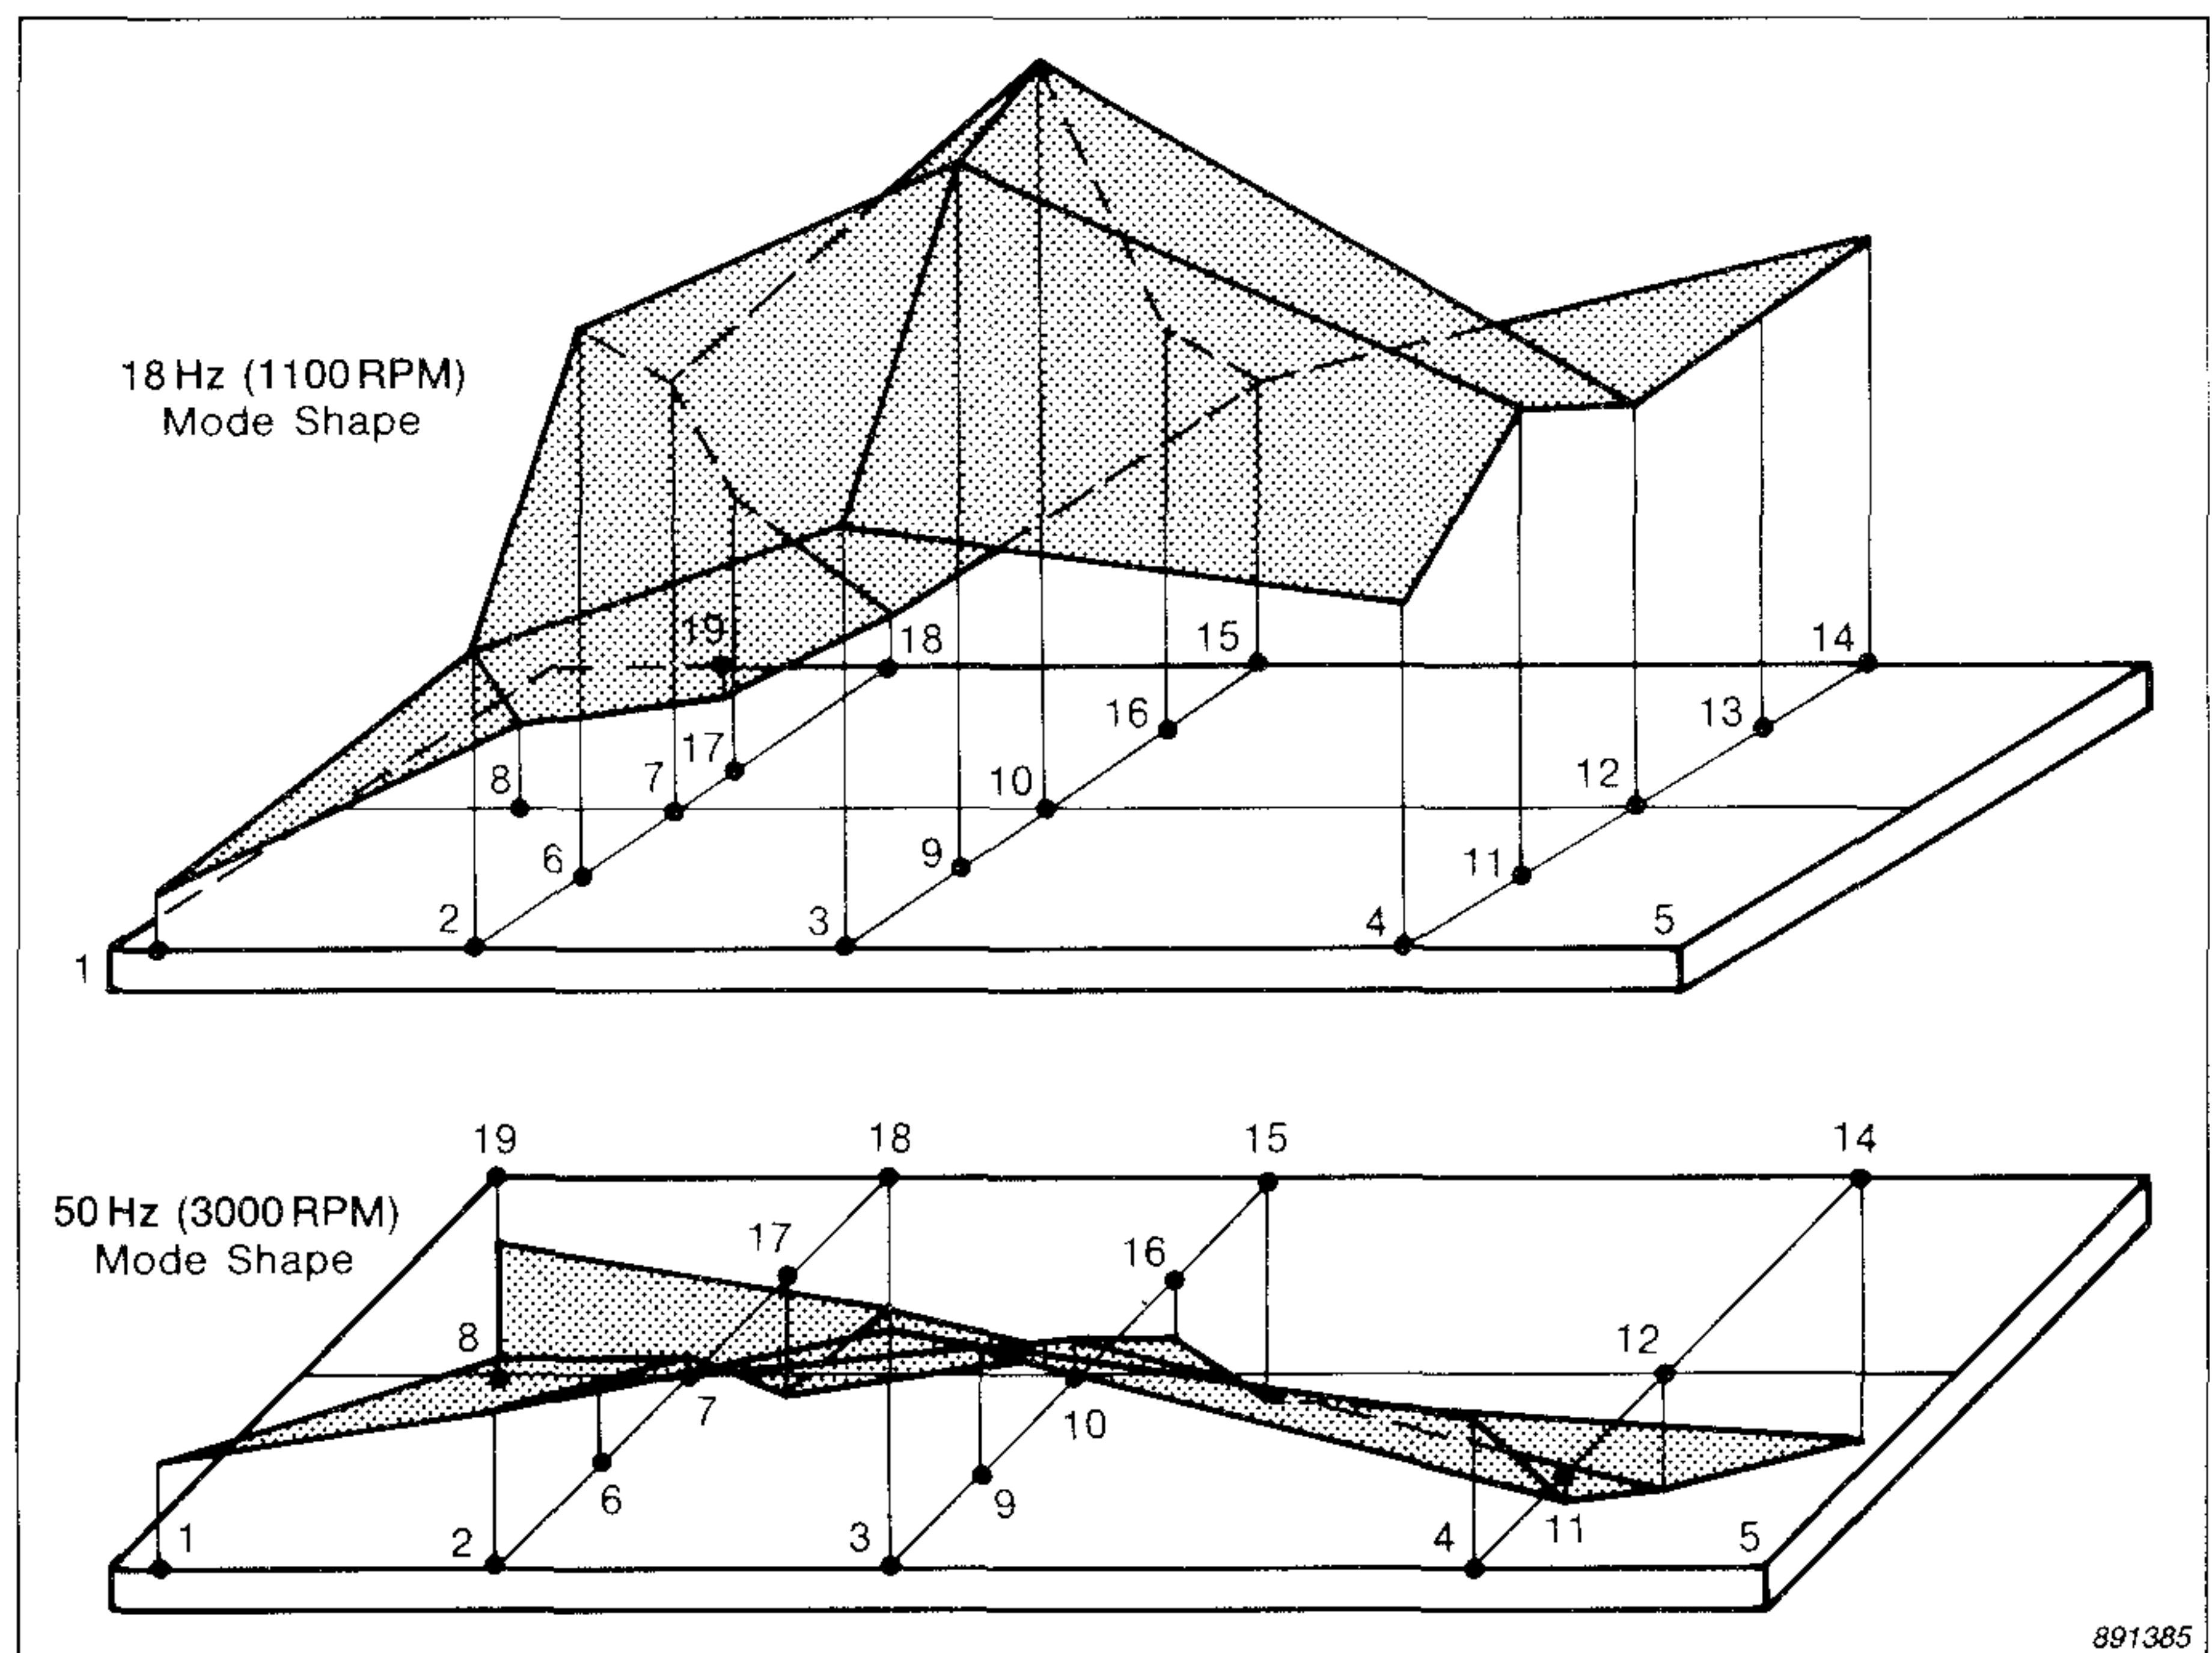
Groenpol decided to investigate the vibration modes of the frame. They used a vibration exciter to shake it sinusoidally and found resonance frequencies at 18 Hz and 50 Hz. They measured the phase with their balancing instrumentation and used the results to plot the mode shapes, see Fig. 16. These show that the frame bent in the middle at the gearbox.

By an unlucky coincidence, the compressor motor speed of 48.7 Hz was exciting the 50 Hz resonance frequency of the frame.

Fig. 16. The 18 Hz and 50 Hz mode shapes of the compressor frame. The 50 Hz mode is excited by the 48.7 Hz rotation speed of the compressor motor

The company could not afford to modify the frame further, so Groenpol decided to insert vibration dampers between the motor and the frame in an attempt to dissipate the 48.7 Hz vibration being transmitted from the motor to the frame. This was successful. The vibration of the frame dropped to an acceptable level and the machine functioned normally.
