**MODEL:** GP 605

**SUBJECT:** Faint / Blank Copies

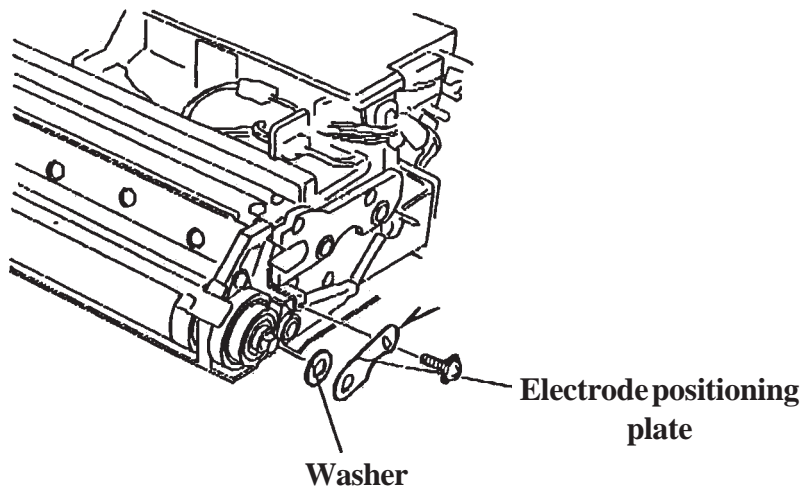
With increasing copy volume the image becomes fainter and eventually blank. This occurs approximately 6cm from the leading edge.

The washer between the electrode positioning plate and developer sleeve becomes worn over time. The resulting shavings cause a bias leakage which gives the above symptom.

Remove the offending washer it is not required.
