MODEL: **GP 605**

SUBJECT: **Paper Jam Prevention**

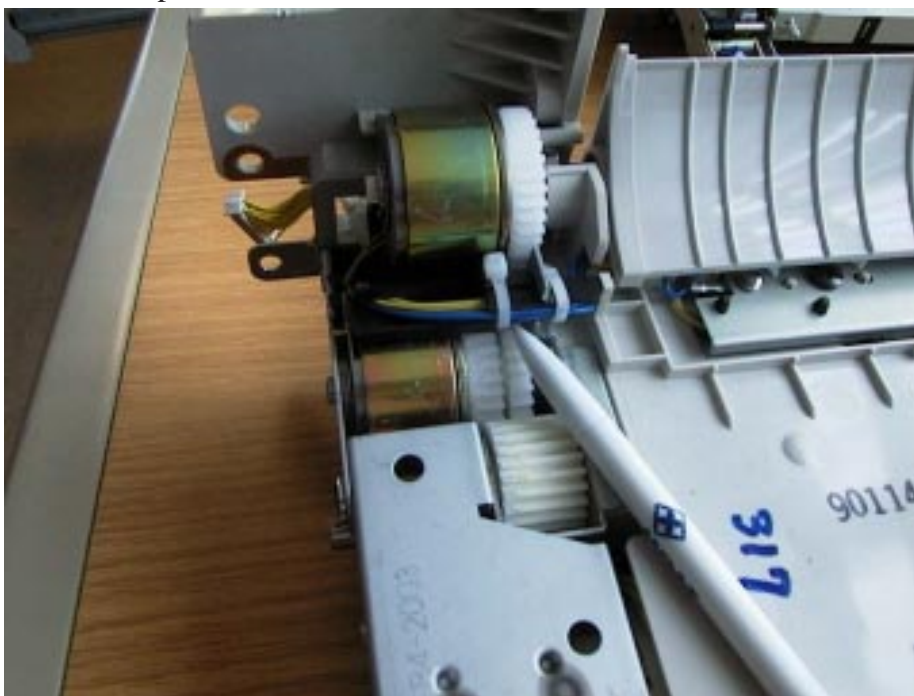
Unusual noise is generated from around the pick-up assembly and paper pick-up may fail.

There is a tie wrap which secures the wiring of the right front deck pick-up assembly. This tie wrap can become cut when the duplex unit is inserted or withdrawn. It then falls down on to the gears of the right hand deck and causes them to jam. This causes a gear in the paper assembly to fail, reference (Part No. FS6-0096-000 gear P260-14).

Remove the tie wrap as indicated.
