MODEL: **GP 605 / 555**

SUBJECT: **Delivery Jams when Double-Siding**

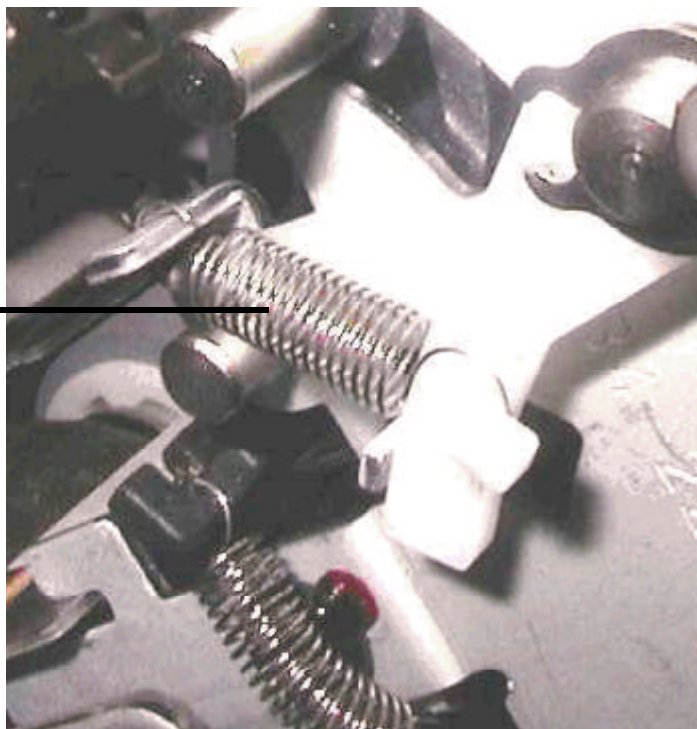
FS6-2885-000

Paper jamming at exit guide when double siding, mainly on long runs, codes shown include "010C".

Incorrect return spring (too strong) fitted to deflector, (*reference figure 351, Item 33*) in parts catalogue

Solution: Replace spring.
