Model : GP605

Ref. No. : FF-T01-K1-000020-UK2

Location : ADF PICK-UP ASSEMBLY

Subject : MEASURES FOR THE FOLDING OF THE DOCUMENT'S LEADING EDGE IN THE ADF

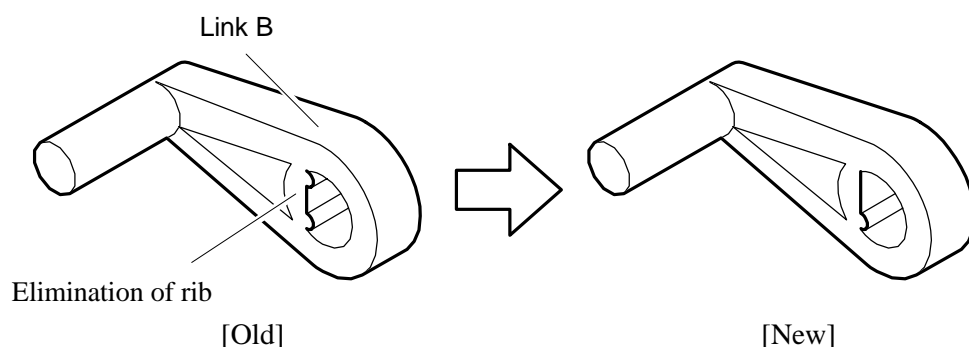
Fig. 1

Details : <Symptom>
When using the ADF to copy, there are cases where the document's leading edge becomes folded.

- In case the accumulated tolerances of the parts get too close to the limits, the document may strike the copyboard glass and the document's leading edge may become folded.
- The reversing flapper is replaced as the measure to deal with the situation of breakage consequent to the user getting his fingers caught to the reversing flapper in clearing a jam. But failing to notice during the replacement that the reversing guide has not been completely pushed in and properly seated could result in the document's leading edge to become folded.

By eliminating the rib of link B (Parts Catalog TY8-31DV-000 page 30-97) and changing to the type with a different angle, the folding up of the reversing flapper was restrained, and the striking of the document against the copyboard glass prevented.
