Service Information

Model: GP605 Ref. No.: FF-T01-K1-000003-01

Location: TRANSFER / SEPARATION CHARGING ASSEMBLY

$\textbf{Subject} \qquad \textbf{:} \quad \mathsf{PRECAUTIONS} \; \; \mathsf{TO} \; \mathsf{NOTE} \; \mathsf{IN} \; \mathsf{PREVENTING} \; \; \mathsf{DAMAGE} \; \mathsf{TO} \; \mathsf{THE} \; \mathsf{MICROSWITCH} \; \mathsf{INSIDE} \; \mathsf{THE}$

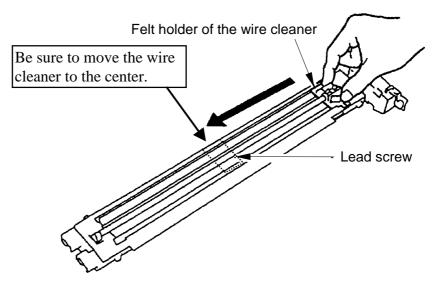
Fig. 1 Transfer / Separation charging assembly

When installation of the transfer / separation charging assembly is performed with the felt holder of the wire cleaner of this assembly at the home position, the protruding part of the felt holder comes into contact with the microswitch actuator in the registration / transfer assembly. And depending on how this contact is made, the actuator may deform or detach to result in the quality problem (error code E063).

: When installing the transfer / separation charging assembly, proceed with the installation work after moving the wire cleaner with its felt holder to the center. (See P6-59 of Service Manual for details.)

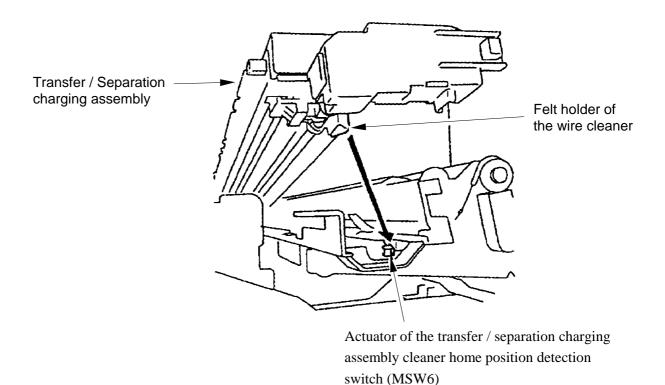
Fig. 2

* If the wire cleaner is not moved to the center, it may come into contact with the microswitch actuator at the home position as shown in the figure below, causing deformation or detachment.
