Model : GP605

Ref. No. : FF-T01-K1-000009-UK2

Location : SLIDE GUIDE (ON THE ADF PICKUP TRAY)

Subject : PREVENTING JAMS WHILE READING AN ORIGINAL

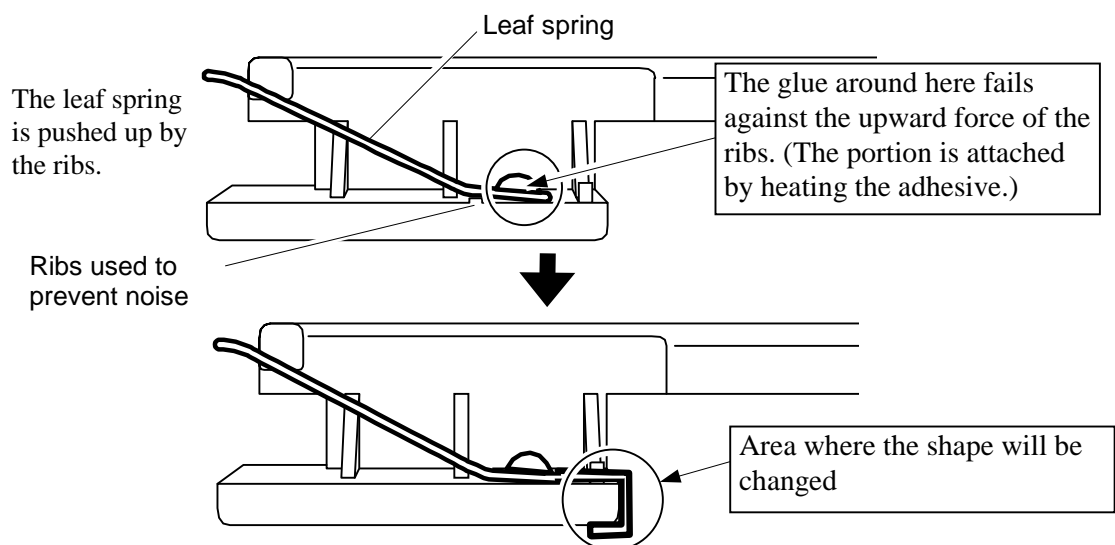
Fig. 1

A portion of the leaf spring of the slide guide (rear) found on the ADF pickup tray can fail against the upward force of the ribs found under the spring, resulting in detachment.

The ribs of the slide guide (used to prevent noise; see the figures below) are shaved off to limit the stress against the glued portion (switch-over on and after March 30, 1999).

In addition to the tentative measures above, the shape of the leaf spring will be modified to prevent stress on the leaf spring (see the figures below; switch-over on and after April 13, 1999).
