Model : GP605

Ref. No. : FF-T01-K1-000014-01

Subject : COUNTERMEASURES FOR A DEVELOPER HAVING A PROBLEM OF CAUSING LIGHT OR COMPLETELY BLANK IMAGE

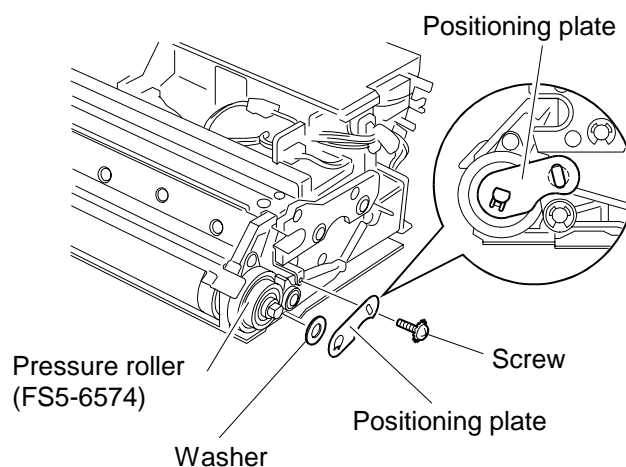
Fig. 1

A washer which has been added (to the space between the electrode positioning plate and the developer sleeve) as a countermeasure for preventing noise may scrape off over a period of time, and then the broken fragments falling into the die-cast section of the main unit could result in electrical leaks.

- 1) Remove the screw.
- 2) Remove the electrode positioning plate.
- 3) Remove the washer.
- 4) Clean the pressure roller.

Caution: There can be recurrence of the problem for developers which have had light or completely blank image occurring, and for this reason replace the pressure roller.
