Model : GP605

Ref. No. : FF-T01-K1-000020-UK2

Location : ADF PICK-UP ASSEMBLY

Subject : MEASURES FOR THE FOLDING OF THE DOCUMENT'S LEADING EDGE IN THE ADF

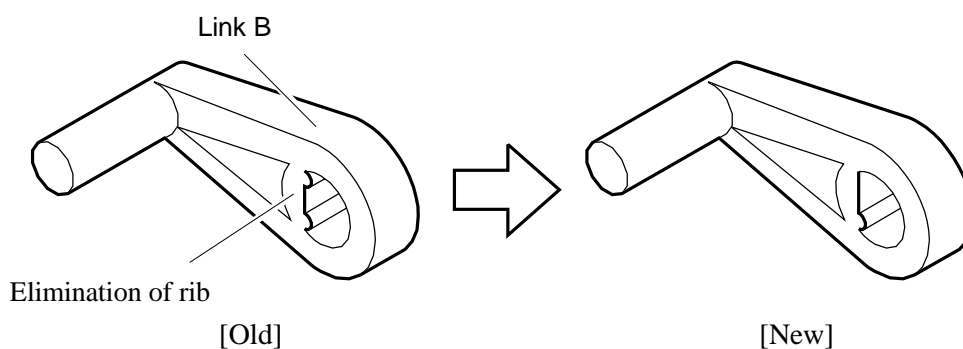
Fig. 1

- In case the accumulated tolerances of the parts get too close to the limits, the document may strike the copyboard glass and the document's leading edge may become folded.
- The reversing flapper is replaced as the measure to deal with the situation of breakage consequent to the user getting his fingers caught to the reversing flapper in clearing a jam. But failing to notice during the replacement that the reversing guide has not been completely pushed in and properly seated could result in the document's leading edge to become folded.

By eliminating the rib of link B (Parts Catalog TY8-31DV-000 page 30-97) and changing to the type with a different angle, the folding up of the reversing flapper was restrained, and the striking of the document against the copyboard glass prevented.
