Model: GP605 Series

Ref. No. : FF-T01-K1-000079-01

Location: ADF Frame Assembly

Subject: Improvement of Durability of ADF Hinge

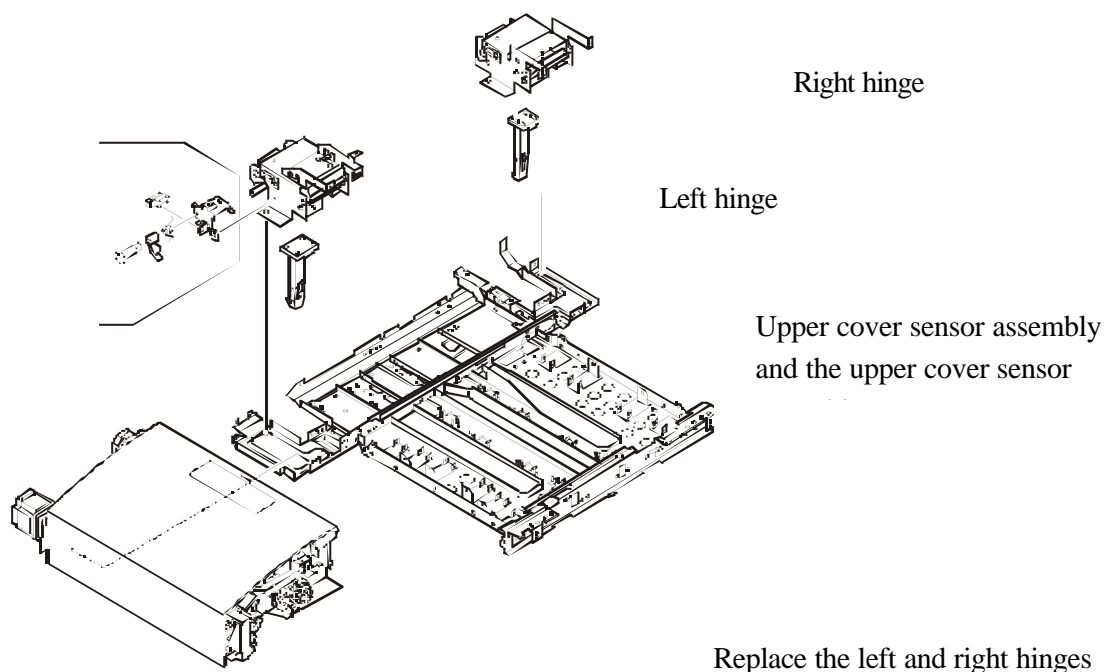
The ADF fails to stay open and falls on the main body.

Aging of ADF hinges

The left and right hinges and the upper cover sensor assembly of the ADF will be changed to the ones used for DADF-J1.

When replacing the GP605 hinges with DADF-J1 hinges, be sure to replace the left and right hinges and the upper cover sensor assembly at the same time. If the GP605 parts and the DADF-J1 parts are mixed, the ADF will not shut properly and causes troubles such as paper jam.
