Model: GP605

Ref. No. : FF-T01-K1-000083-01

Location: Pick-up Tray PCB Assembly

Subject: Preventing Damage to the Pre-Last Original Sensor

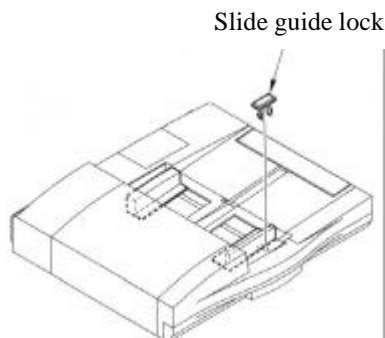
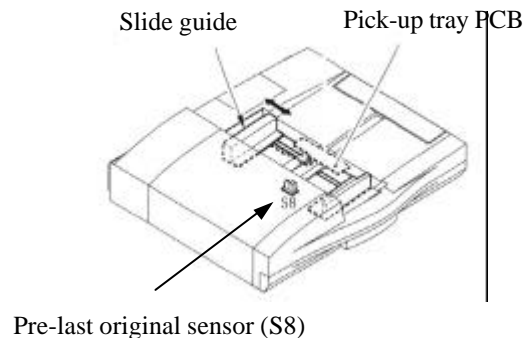
If the slide guide lock has been removed, the contact plate operating in conjunction with the slide guide can cause a short circuit between the pattern of sensor LED (mounted on the pickup tray PCB) and the pattern of photo elements.

<Identifying the Pickup Tray PCB with the Measure>

Refer to the parts number silk-screened on the PCB. Keep in mind, however, that the silk-screened parts number is different from the service parts number given to the pickup tray PCB.

PCB w/o measure: on the surface, FG2-9367; on the back, FH12447

PCB w/ measure: on the back, FG3-3025, FH13481

The pattern of the pickup tray PCB is changed so that the contact plate will not cause it to short circuit even in the absence of the slide guide lock.

If you have to remove the slide guide lock, be sure to replace it with a pickup tray PCB provided with the said measure.

If the pickup tray PCB is of the old type, be sure not to remove the slide guide lock.
