MODEL: iR2200/ 2800 / 3300

SUBJECT: Frame Breakage of Paper Pick-up Units

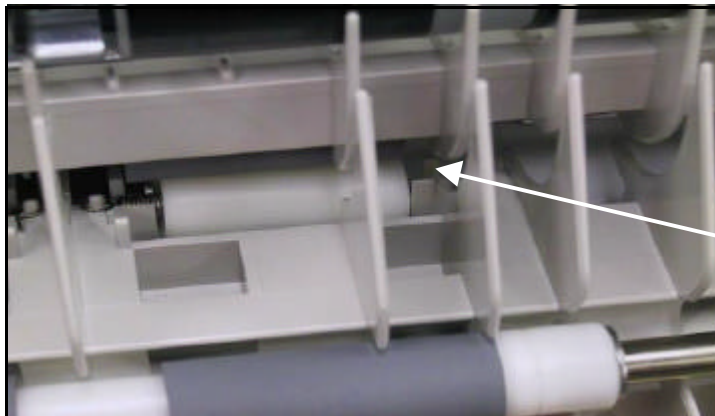
Symptoms are skew feed from the upper cassette. This is caused by a breakage to the white plastic frame, supporting a spring that runs through one of the paper feed rollers (FB3-2848-000).

Failure of Spring Support

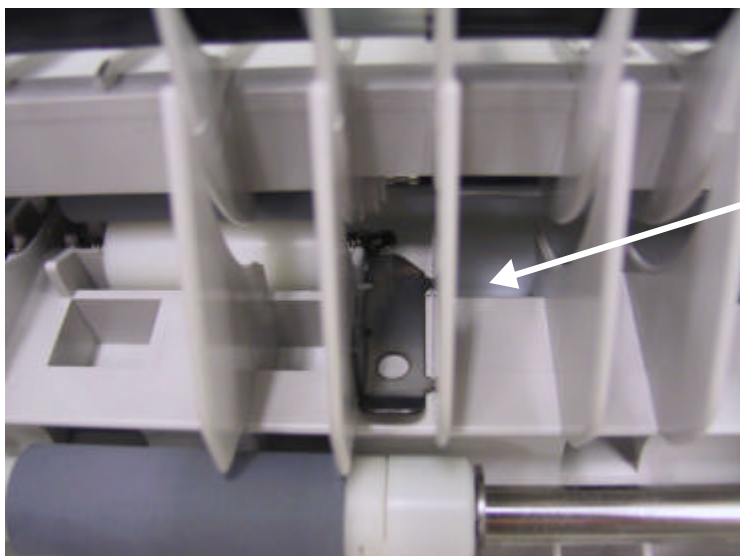
Photo of modified paper pick-up

(Rear white roller with FA9-3948-000 shown)

The front roller and rear roller require different modification parts (*see photo below*). These are fairly straightforward and are simply pushed into place.

The modified bracket is a tight fit.
