Model: iR2200/2800/3300 Series

Ref. No. : FF-T01-L5-000045-02

Location: Controller Box

Subject: Doing away with the Fan Motor

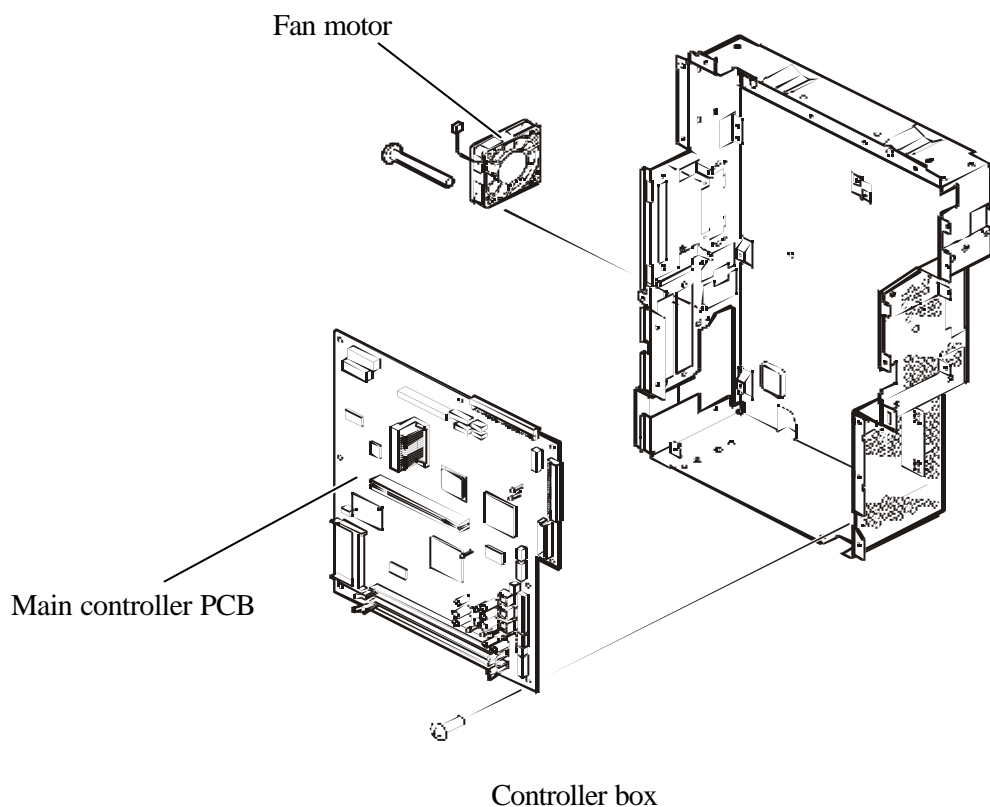
Reason: For manufacturing reasons, the fan motor on the controller box is disused.

Detail: Because of doing away with the fan motor, the fan motor circuit on the main controller PCB is also disused, thus the electrical elements are removed from the list of service parts.

The blank connector (J1028) appears after the disuse of the fan motor, and attaches the shorting connector (newly set up as a service part) to the blank connector.

To confirm the presence of the shorting connector easily, affix the shorting connector label to near the shorting connector on the main controller PCB.

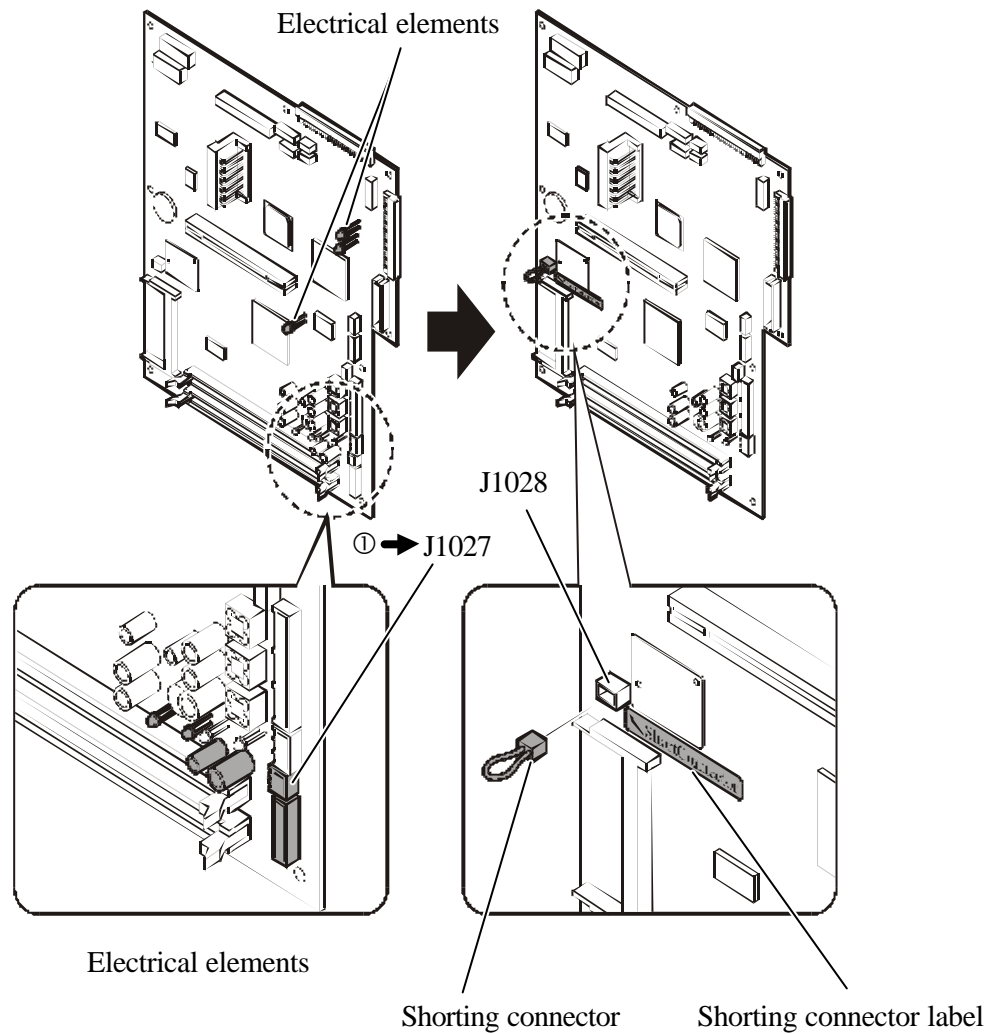
In the case of not replacing the shorting connector, the alarm code (000804-0004) “ fan motor malfunction” displays on the service mode (COPIER>DISPLAY>ALARM-2) though the machine runs properly.

- When attaching the new main controller PCB to the old controller box, detach the unnecessary fan motor from the old controller box.
- In addition, because J1027 is deleted from the new main controller PCB, there is no location to connect the harness connector. However, a machine performs properly even if the harness connector is unconnected, so do not connect the connector to anywhere on the new main controller PCB.
- Contrariwise, when attaching the old main controller PCB to the new controller box (not the fan motor mounted), replace the shorting connector from the new main controller PCB to the old main controller PCB.
