Model: DADF-J1

Ref. No. : FF-T01-X-000047-01

Location: Pick-up Tray PCB Assembly

Subject: Preventing Damage to the Pre-Last Original Sensor

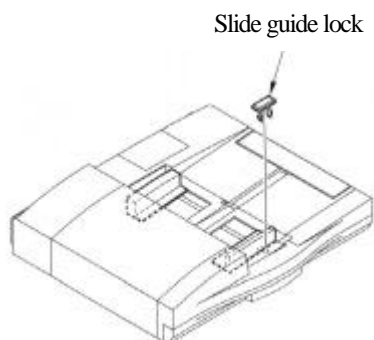
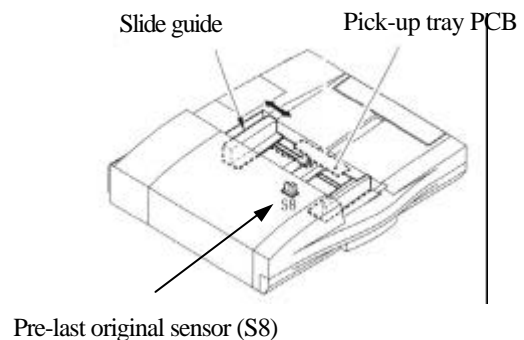
Refer to the parts number silk-screened on the PCB. Keep in mind, however, that the silk-screened parts number is different from the service parts number given to the pickup tray PCB.

PCB w/o measure: on the surface, FG2-9367; on the back, FH12447

PCB w/ measure: on the back, FG3-3025, FH13481

If you have to remove the slide guide lock, be sure to replace it with a pickup tray PCB provided with the said measure.

If the pickup tray PCB is of the old type, be sure not to remove the slide guide lock.
