Issued by Canon(UK) Limited

iR6800C  
iR6800CN

iR6800C-008  
(F2-T01-0M3-10023-01)

Point to Note when Mounting Pickup Assembly

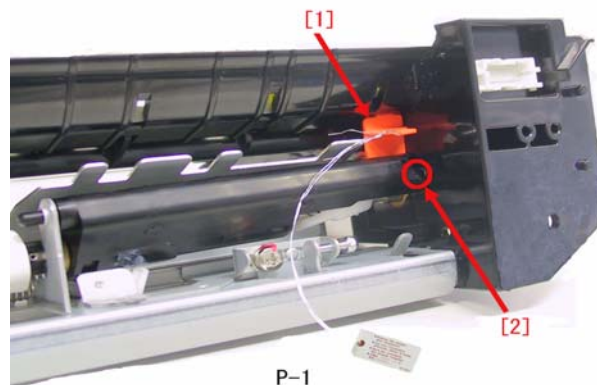
### P-1 RIGHT PAPER PICK-UP ASSEMBLY

When you fail to remove the shipping tags attached to the pressure release spacer of the separation roller of the right deck from the right cover before mounting the pickup assembly, the spacer is pulled by force in response to opening the right cover, which presses the separation roller holder of the right deck. The pressure damages the projection on the rear of the separation roller holder of the right deck, which causes the separation roller to give faulty pressure, leading to a jam at the pickup assembly. (See the P-1 below.)

[1] Pressure release spacer of the separation roller

[2] Damage on the separation roller holder

When you mount the pickup assembly, see the Service Manual and follow the procedures of Installation > Unpacking and Installation > Mounting the Pickup Assembly. Be sure to detach the shipping tags from the right cover before opening the right cover.

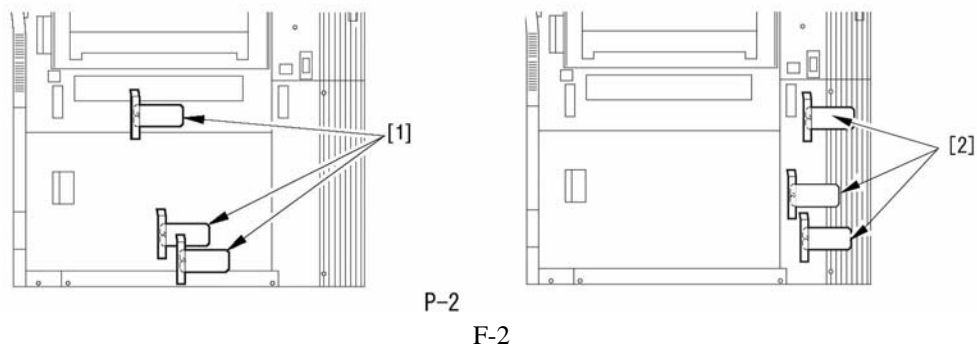
P-2 Shipping tags' positions

[1] Previous positions

[2] New positions

To prevent the damage on the separation roller holder of the right deck in response to opening the right cover with the shipping tags attached, we will move the shipping tags on the right cover to the positions shown in P-2 [2].
