MODEL: iR6800C

No.: iRC6800-011

**LOCATION: BLACK DEVELOPING ASSEMBLY**

**SUBJECT: TONER LEAKAGE**

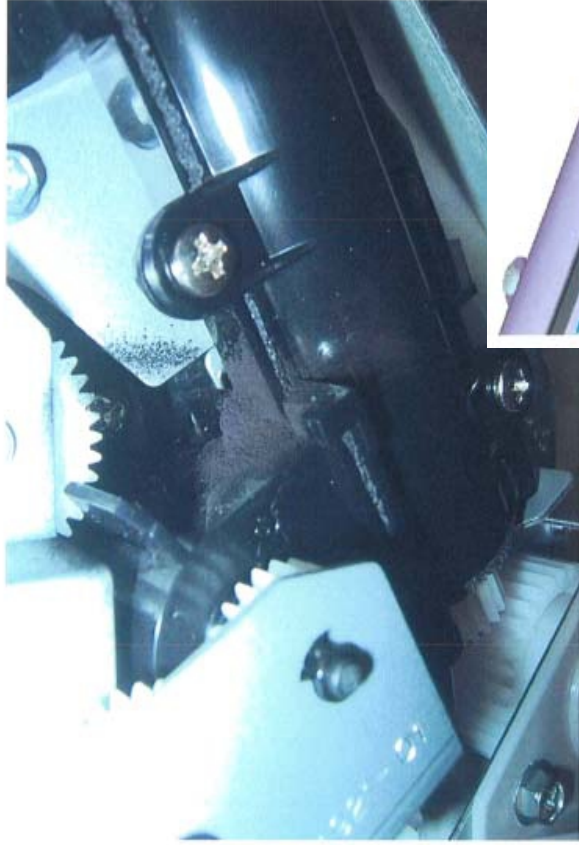
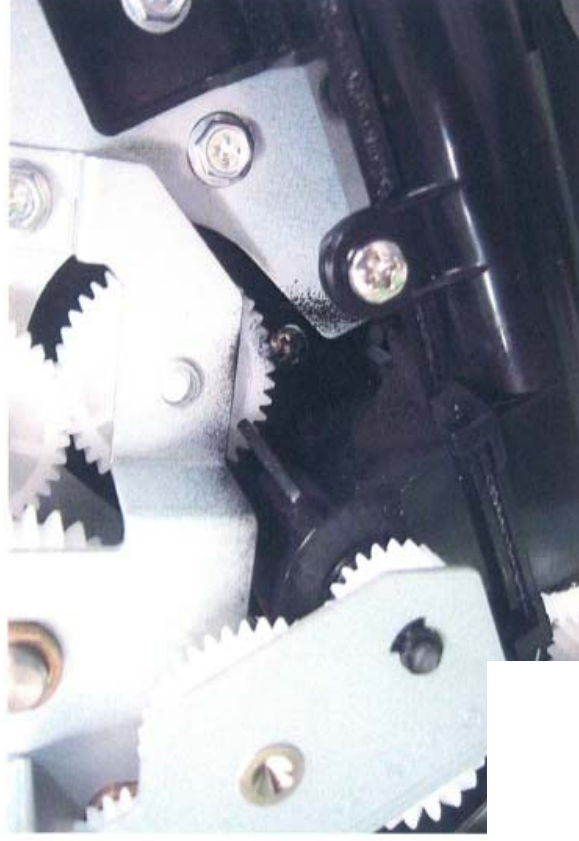
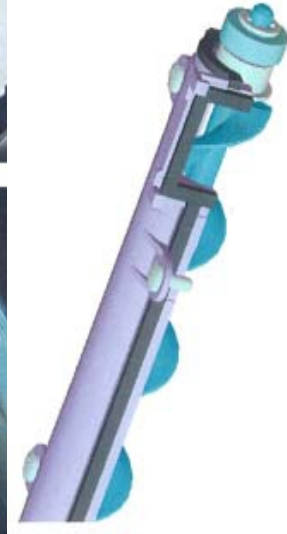
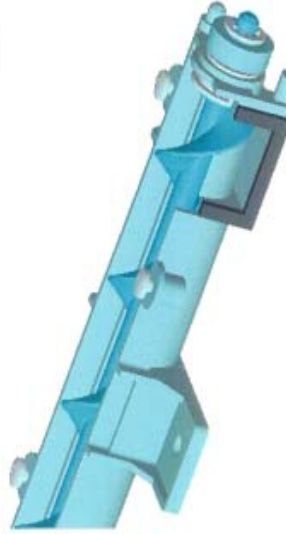
IMG\_2057.JPG

**Reason:** There is a gap of 0.5 to 1.0 mm on the seal affixed onto the pipe-jointing area. Because of this, a continuous copy/print run of a large number of high density images, will increase the toner pressure inside the pipe, consequently allowing toner to leak from around the gap on the seal.

# Black toner leakage

**Detail:** Attach new seal.

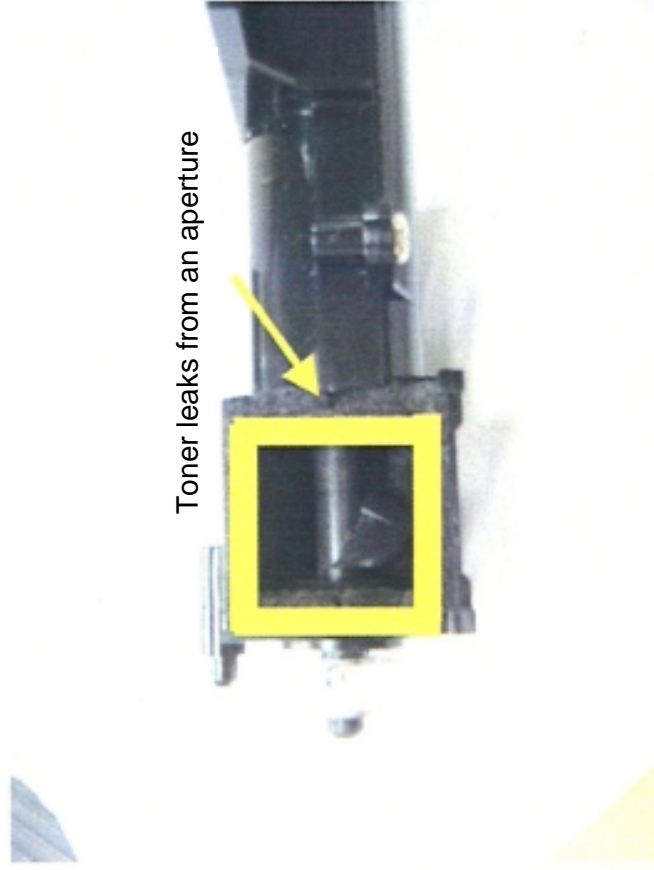
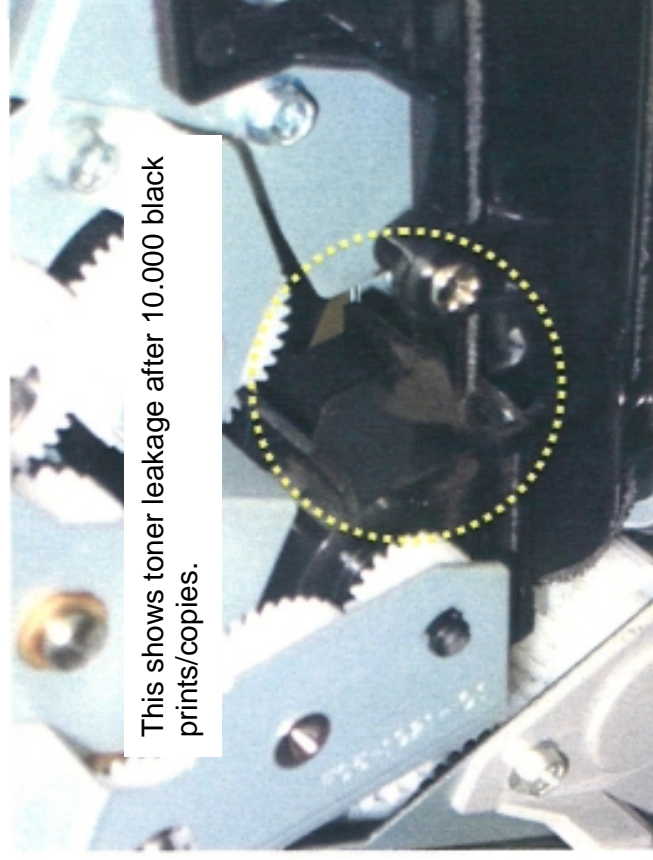
# Black toner leakage(The cause)

There is an aperture (0.1-0.5) at pipe joint section. In case you take copies with dark image (e.g. thick density) in succession, toner pressure inside the pipe is getting higher, black toner leaks from aperture of "material". However, this problem does not happen in some machines, because it is sealed differently.
