Issued by Canon (UK) Limited

iR6800C
iR6800CN

iR6800C-005
(F2-T01-0M3-10011-01)

Abnormal buzzing sound occurring from Intermediate Transfer Belt Assembly

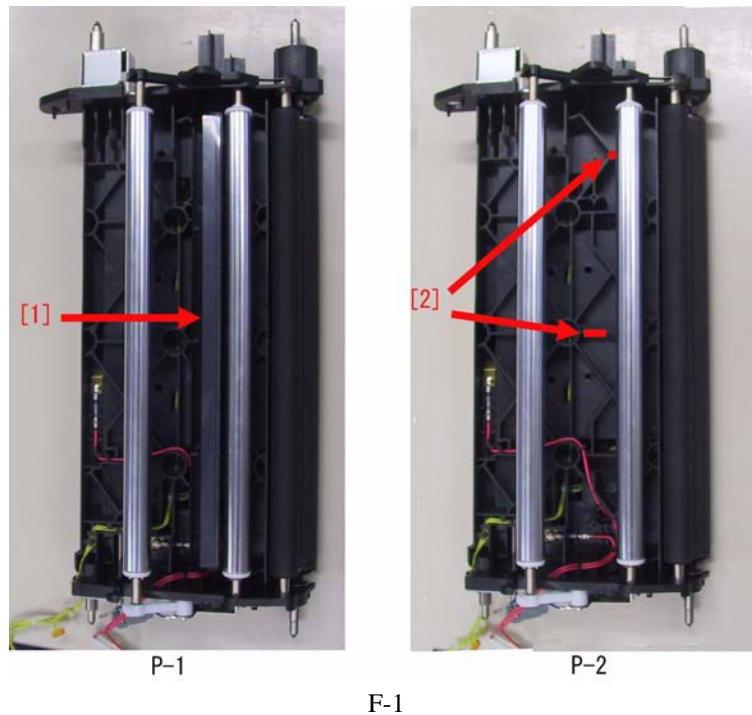
Abnormal buzzing sound occurs from the Intermediate Transfer Belt Assembly (FM2-0407).

When the edge of the Internal Scraper (FL2-0398) of the Intermediate Transfer Belt assembly is subject to adhesion of rubber residues of the rubber rollers, such as the Secondary Transfer Roller, there is an increase in the sliding frictional resistance between the Internal Scraper and the Transfer Belt, causing the scraper holder to vibrate. When the vibrating scraper holder comes into contact with the frame, a rustle occurs, leading to abnormal buzzing sound.

P-1 Intermediate Transfer Belt Assembly

P-2 Intermediate Transfer Belt Assembly (with the Internal Scraper removed)

[1] Internal Scraper

[2] Points where the scraper holder comes into contact with the frame

A double-sided tape is applied to the points where the internal scraper holder comes into contact with the frame, so that the holder will be securely attached to the frame. This measure can prevent such vibrations of the holder as will cause an abnormal sound.
