Issued by Canon(UK) Limited

**iR6800C**  
**iR6800CN**

iR6800C-007  
(F2-T01-0M3-10017-01)

Light-colored Image (BK) due to Poor Connection of BK Toner Level Sensor Connector

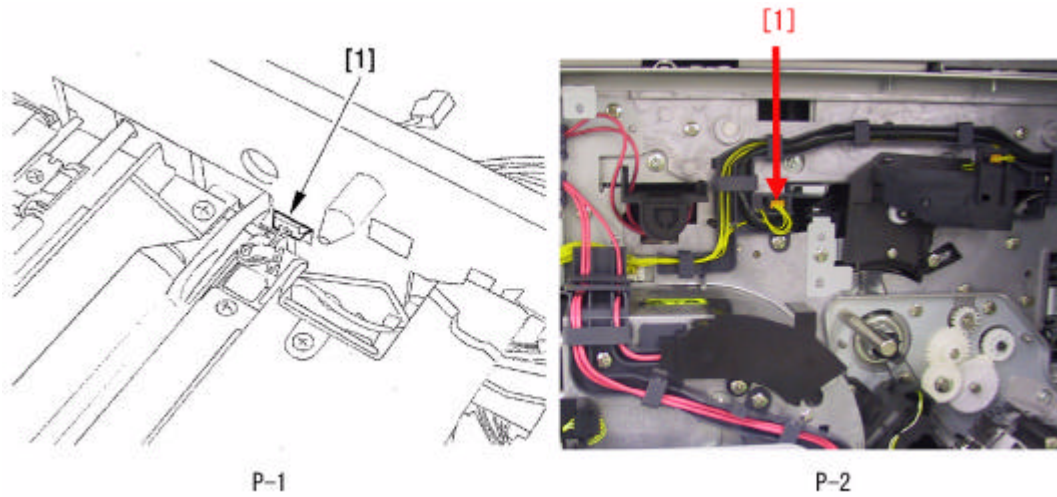
F-1

If you fail to completely connect the BK toner level sensor (TS1) connector to the snap connector (J209) while installing the BK developing assembly, the machine improperly detects Toner Full when there is no toner remaining in the developing assembly, preventing the toner from being supplied to the developing assembly.

P-1 Connection of the connector (a view from the BK developing assembly)

P-2 A view after releasing the hopper assembly

[1] Snap connector (J209)

4. If the value shows OL (OVER LIMIT), it means that the toner level sensor connector is disconnected. Then, pull out the process unit and securely connect the toner level sensor connector. (See P-1 [1] below.)  
If the value does not show OL (it shows several M\$), it means that the toner level sensor connector is properly connected. Then, check for another cause.
