**Model** : Finisher D1

**Ref. No.** : FF-T01-W-000053-01

**Date** : April 21, 1999

**Subject** : Countermeasures to prevent the upper feeder assembly of the Finisher D1 from opening on impact

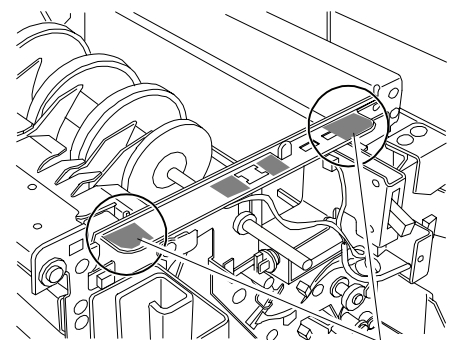
Fig. 1

Because of some faults with the shape of the upper feeder assembly, two of the shaded areas (out of the four locations for the magnet catches) make contact first, causing a difference of approx. 0.25 to 0.5mm. This results in weaker contact for the other two areas, and the problem of upper feeder assembly to open from receiving an impact.

These areas make contact first.
