**Model** : Finisher D1

**Ref. No.** : FF-T01-W-000056-01

**Subject** : CORRECTING MISALIGNMENT IN THE FINISHER-D1 (DURING SORTING)

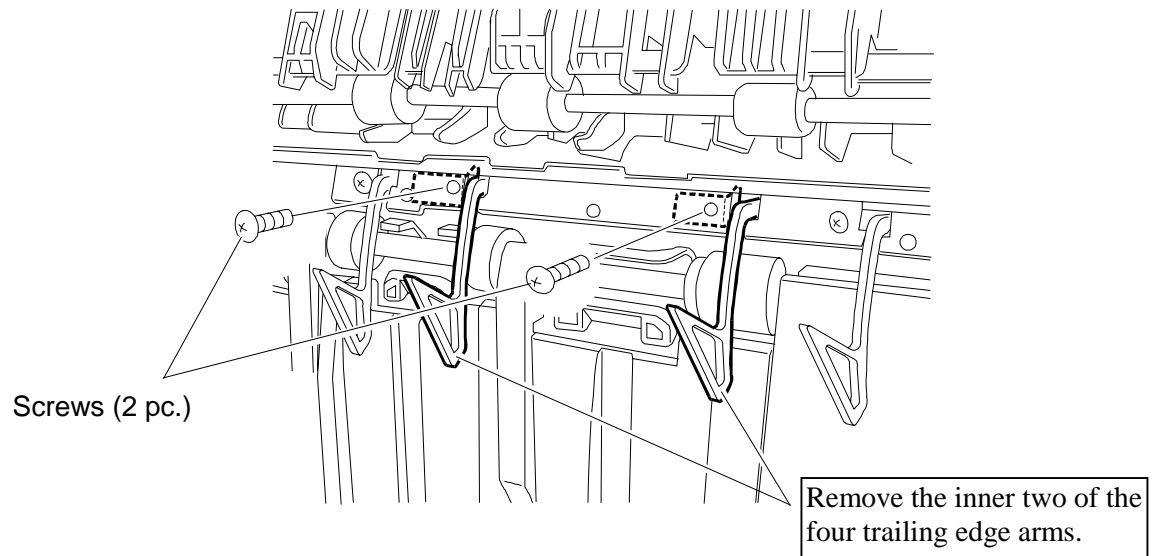
Fig. 2

The weight of the trailing edge arms in the sorting guide assembly can cause paper to curl downward during delivery. If the paper is moist, the downward curling will increase, resulting in misalignment during staple sorting.

- 2) While holding up the swing guide, remove the inner two of the four screws. At this time, take care not to drop the screws inside the machine.
- 3) Of the four trailing edge arms, remove the inner two from the front of the finisher.
