Model : Saddle Finisher -D2**Ref. No.** : FF-T01-W-000114-01**Date** : July 7, 2000© Canon (UK) Limited

Location : SADDLE FINISHER**Subject** : MEASURE TO PREVENT CREASE IN FOLDING MODE**Reason** : The shape of the folding roller is to be modified due to possible crease in folding mode.**Details** : <Symptom>
Crease in folding mode.

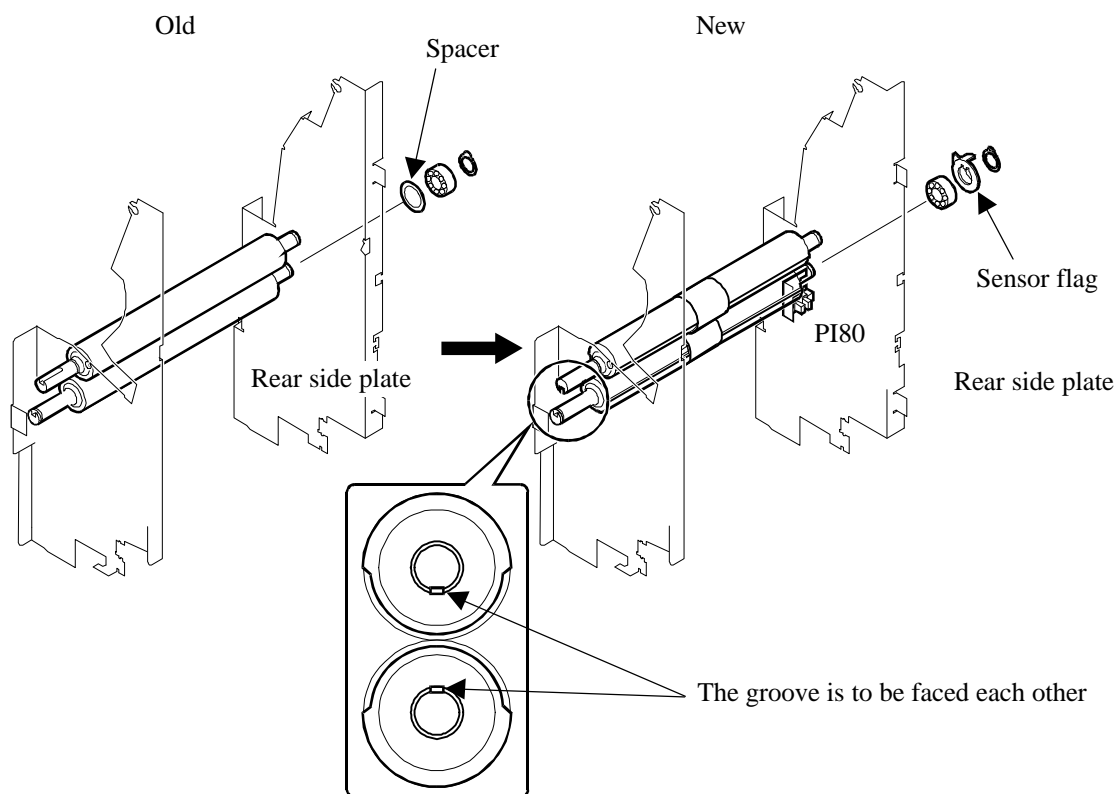
Figure 1. Folding roller in the saddle finisher

Direction of the upper/lower part of the folding roller in attachment.

- When the folding roller is removed in the modified machine as above-mentioned, the gear is to be attached, with the upper part of the grooves of the folding roller shaft facing the lower part of the groove without fail. When the upper part of the groove is not opposing to the lower part, the following defect may occur:

- “Defective folding” due to the deviation of the position of folding roller surface.
(In this case, the E5F102 is displayed.)
Note: The defective folding, here, means that paper is folded properly in the middle but folded defectively in both sides.

- Deformation in the middle of folding roller.
- Do not attach the folding roller whose shape was modified to the machine in the field without the above modification conducted.
(Due to no hole for screws or no cable for connection, the sensor detecting the position of the roller surface PI80 cannot be attached to the rear side plate without the above modification.
Due to this fact, the above-mentioned defect may occur if the shape-modified folding roller is attached, because the position of the roller surface cannot be detected. Note that the rear side plate and cable are not established as a service part.)

The shape of the folding roller surface is to be modified so that slack escapes at the end of the folding roller when paper is slackened off.

1. The sensor detecting the position of the roller surface P180 and the sensor flag (at the lower back of the folding roller) are to be added.
(Due to the addition of P180, the hole for screws to attach the sensor to the rear side plate and cable are to be added in the saddle finisher.)
2. The circuit of the saddle controller PCB is to be modified (addition of J18-3Pin).
Due to the modification in circuit, the PCB no. FH1-2800 is to be changed to FH1-3093.
3. The software is to be modified. (ROM Ver. 3)
Refer to S. Info. FF-T01-W-000110 for the modification of ROM Ver. 3 (FF3-3636-030).
