Model : GP605 Series**Ref. No. : FF-T01- K1-000037-01****Date : January 11, 2000**© Canon (UK) Limited

Location : ADF REVERSE FLAPPER**Subject : ADF REVERSE FLAPPER STUCK OPEN COUNTERMEASURE ADF****Reason :** After a document jam has been cleared, if the reverse flapper is touched, it may remain open. A countermeasure to this problem was implemented (FF-T01-K1-000011-03), but even with this modification, excess strength may cause the same problem to occur, so a further countermeasure has been implemented.**Details :** <Symptom>

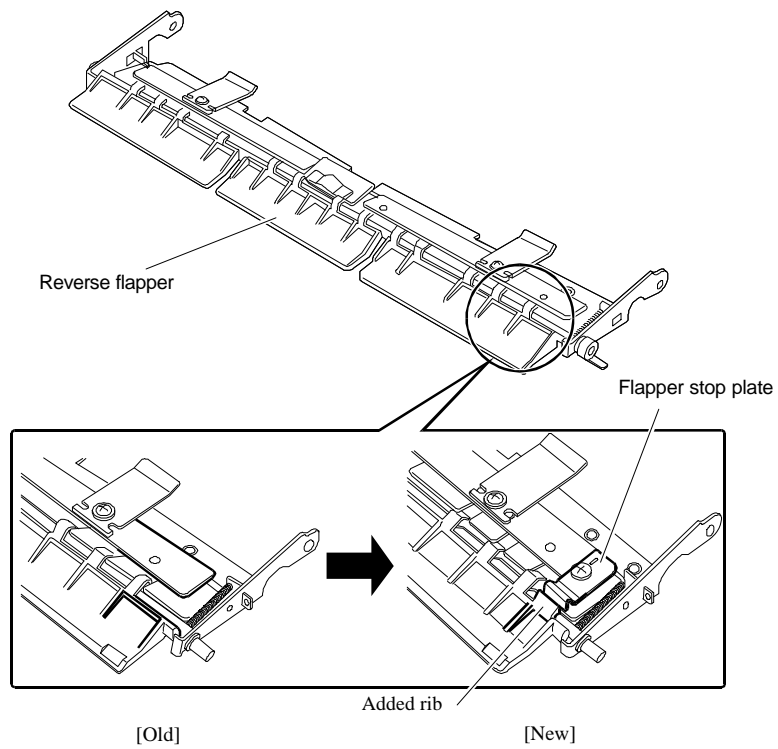
1. When attempting to clear a document jam, pressure is applied by hand to open the lower flapper in the lower section of the ADF, the flapper may get stuck in the open position. A countermeasure was implemented, but it was discovered that, even with this modification, the application of undue force would cause the same problem.
2. Further, in pre-reverse paper pickup, the link piece that makes the reverse flapper rotate has very little margin for error in between the parts dimensions and variations in the assembly accuracy, so that sometimes it may not be in the specified position. Therefore, the reverse flapper is controlled so that it drops downward, and there is a possibility that that it may touch the copyboard glass, resulting in a bent corner.

1. The flapper remains stuck in the open position because the physical force used to clear jams in the field may be greater than anticipated by Design. Also, with the previous countermeasure part, once the reverse flapper is opened, the lower guide plate, which is in contact with the reverse flapper, gets bent out of shape, and is prone to open.
2. The cause of the bent corner is the lack of margin for error in the part dimensions.

1. A reinforcing rib will be added to the reverse flapper, and a flapper stopper added to the lower guide, in order to strengthen the flapper rotation.

Servicing : If the flapper stuck open problem occurs, replace the whole unit.
Also, if document corners are getting bent, replace the three links simultaneously.
