Model : GP605
GP605P

Ref. No. : FF-T01-K1-000039-02

Location : LASER SCANNER UNIT

Subject : Countermeasure to image unevenness caused by scanner unit lens soiling.

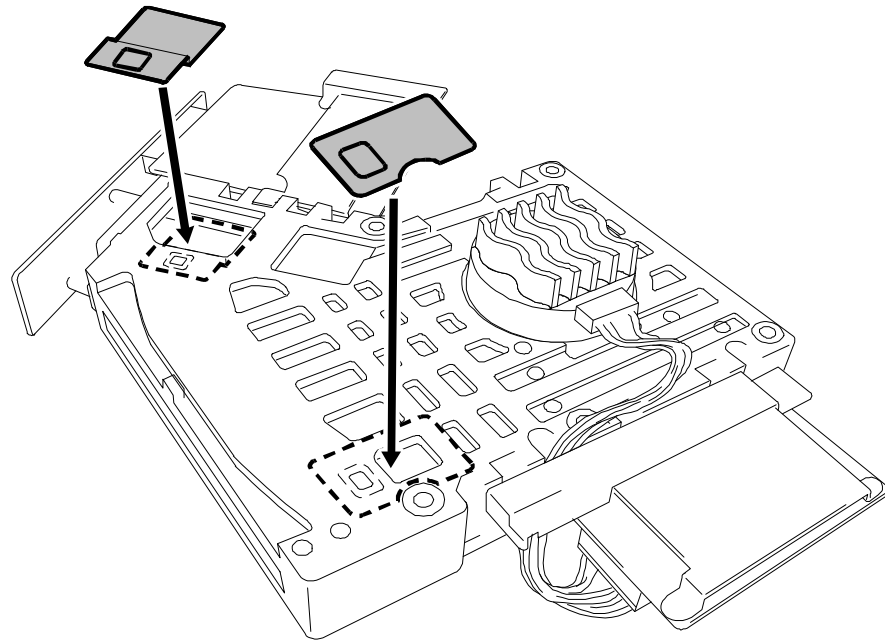
Dirt and dust particles penetrate the laser scanner unit and adhere to the plastic lens. This blocks the light from the laser, and may result in light or uneven images.

There are two holes in the outer frame at the back of the laser scanner unit, and dirt and dust particles get in through them and adhere to the inside of the plastic lens.

- 3) Clean the area around the holes with alcohol.
 - 4) Remove the backing paper from the mylar.
 - 5) Fit the cutaway section of the mylar strip around the round projection to the side of the hole (A), and attach the mylar strip. Check that the transparent section (without adhesive) of the mylar strip is covering the hole.

- 6) Fold the mylar strip against and lay it along the wall section, so that it is covering the hole (B), and stick it on. The sticky side is not flat, so make sure it is well stuck down, leaving no gaps.
