Model : GP605

Ref. No. : FF-T01-K1-000049-01

**Location** : ADF FEEDER ASSEMBLY

**Subject** : PREVENTION OF DAMAGE TO THE BELT GUIDE.

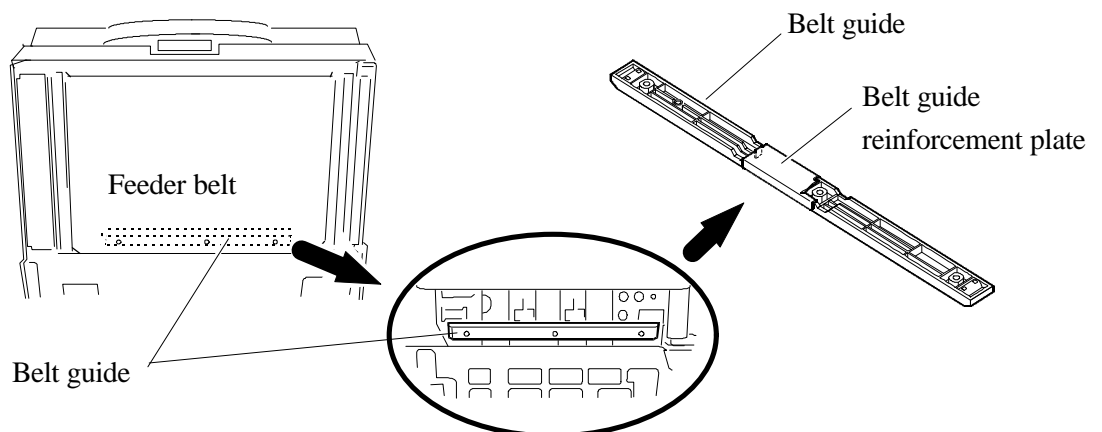
Fig. 1

Cases of damage to the inner belt guide when copying thick books.

There were cases of damage due to overload when the ADF was closed in instances where a thick book document was set in such a way that the back moved into a 37mm gap in the stay which holds the belt guide.

Addition of a Belt guide reinforcement plate to the belt guide in the stay gap so that it will not be damaged even if the back of a book bumps into it.
