**Model** : GP605

**Ref. No.** : FF-T01-K1-000050-01

**Location** : CADF SEPARATION ASSEMBLY

**Subject** : PREVENTION OF 00EA JAMS CAUSED BY ADF DOUBLE FEEDING.

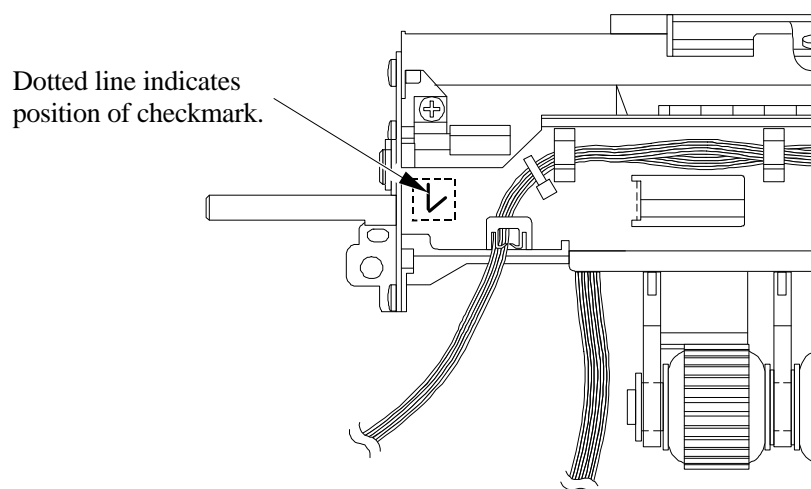
Fig. 1 Separation assembly (FG6-2746-050)

Soiling of the separation assembly feed rollers causes a deterioration of the feed performance, leading to document double feeding which in turn leads to a 00EA jam.

Deterioration of the feed performance has been prevented by modifying the distance between the separation assembly shafts. Note that a checkmark on the upper part of the assembly will be used to identify modified parts.
