Model : Saddle Finisher -D2**Ref. No.** : FF-T01-W-000112-01**Date** : July 3, 2000© Canon (UK) Limited

Location : SADDLE ASSEMBLY**Subject** : PREVENTING BLACK STRIPES IN IMAGES (CAUSED BY TONER SMEAR)**Reason** : Black stripes can occur in images of a double-sided copy made in 'fold mode'. The symptom may be corrected as instructed herein.**Details** : <Symptom>
Black stripes occur on double-sided copies because of a toner smear.

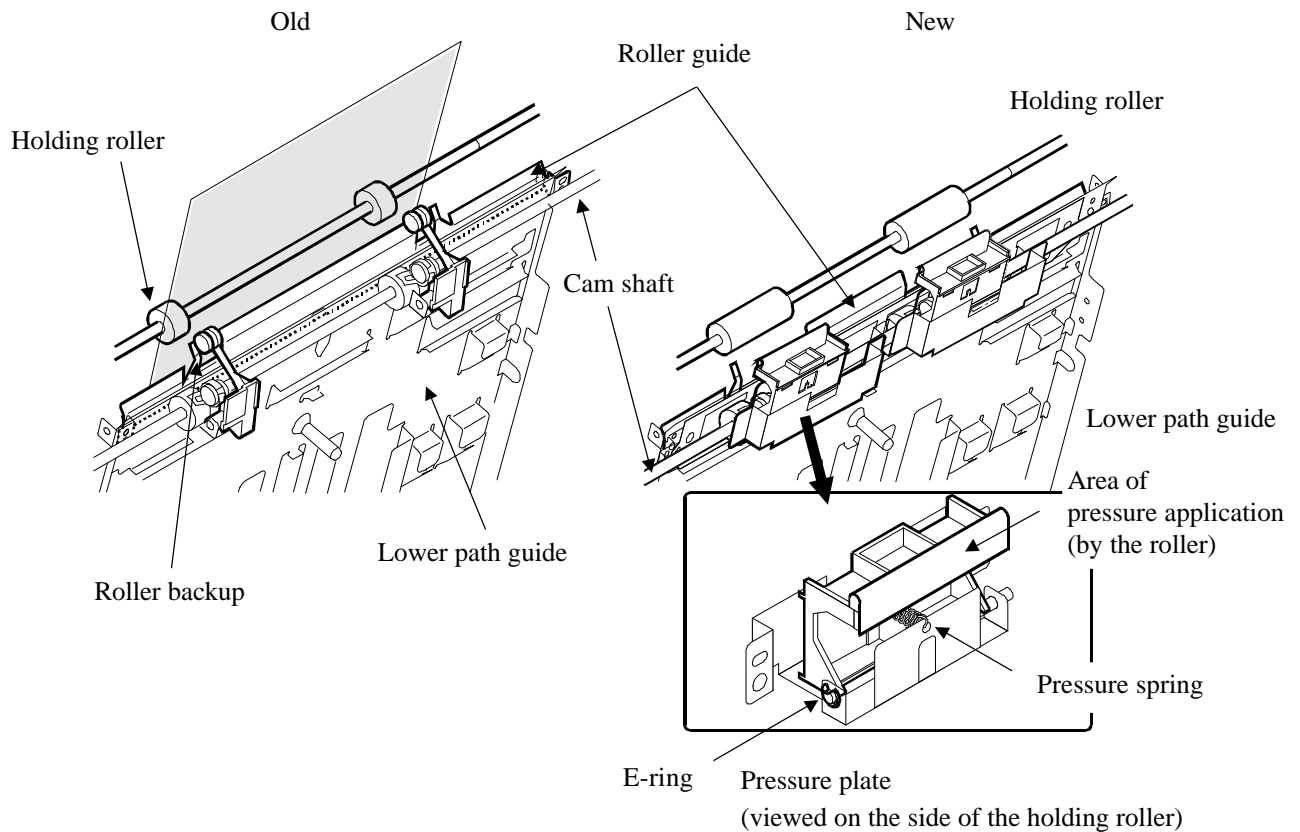
Fig. 1. Saddle Holding Roller Assembly

When paper is being moved in 'fold mode', the holding roller (FB3-7920) and the roller backup (FB3-7927) cause a smear on the paper, resulting in black stripes in copy images at intervals of about 185 mm, corresponding to the location of the roller.

The following changes will be made to distribute the pressure imposed by the roller backup while paper remains in contact with the holding roller, thereby reducing the occurrence of black stripes caused by toner smears:

1. Instead of the roller backup, a pressure plate (equipped with cushion sponge) will be used.
2. To accommodate change 1 above, the width of the holding roller will be increased to 60 mm from about 10 mm, (thereby ensuring the present feeding power).

3. To accommodate change 1 above, the cam of the cam shaft will be relocated so that the pressure will be applied to the center for the pressure plate.

4. To accommodate change 1 above, the screw hole used to mount the pressure plate of the lower path guide will be relocated. (The replacement may prove to be difficult and, therefore, the lower path guide is not made available as a service part.)

5. To accommodate change 2, the cut-off of the roller guide will be enlarged.
6. To reduce the time during which the holding roller remains in contact with paper and, thereby to reduce the distance over which the paper rubs against the roller, the software will be revised (ROM Ver. 3*).
